Airworthiness Directive Schedule

MD Helicopters 600N

26 March 2020

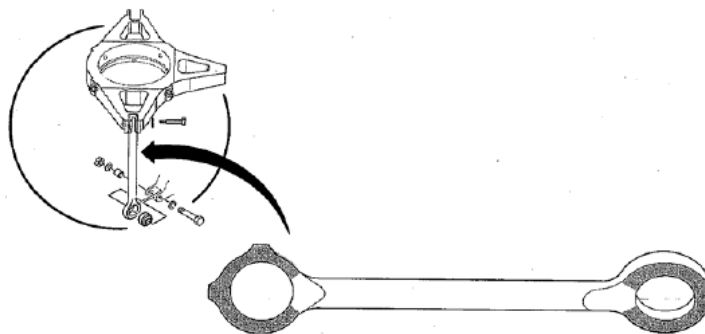
Figure 1

- Applicability:** All model MD600N aircraft fitted with a lateral mixer output link assembly (mixer link), P/N 600N7636-1, -3, -9 or -11.
- Requirement:** To prevent cracks in the mixer link, which could result in failure of the mixer link and subsequent loss of control of the aircraft, accomplish the following:
Remove each mixer link and visually inspect the shaded areas around the bearing bore for any crack as depicted in figure 1. Use a bright light and a 10x or higher magnifying glass.

Bearings have been removed for clarity.

Accomplish an eddy current inspection on each mixer link in the bearing end areas. Replace cracked mixer links, before further flight. Before installing mixer links held as spares, accomplish an eddy current inspection.

Accomplish these requirements per MDHI Service Bulletin No. SB600N-044, dated February 16, 2007.
(FAA AD 2007-05-51 refers)
