Airworthiness Directive Schedule

Helicopters

MD Helicopters 600N

25 June 2020

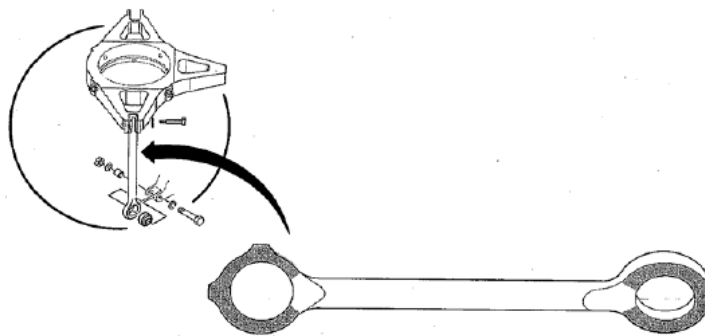
Figure 1

- Applicability:** All model MD600N aircraft fitted with a lateral mixer output link assembly (mixer link), P/N 600N7636-1, -3, -9 or -11.
- Requirement:** To prevent cracks in the mixer link, which could result in failure of the mixer link and subsequent loss of control of the aircraft, accomplish the following:
Remove each mixer link and visually inspect the shaded areas around the bearing bore for any crack as depicted in figure 1. Use a bright light and a 10x or higher magnifying glass.

Bearings have been removed for clarity.

Accomplish an eddy current inspection on each mixer link in the bearing end areas. Replace cracked mixer links, before further flight. Before installing mixer links held as spares, accomplish an eddy current inspection.

Accomplish these requirements per MDHI Service Bulletin No. SB600N-044, dated February 16, 2007.
(FAA AD 2007-05-51 refers)
