# Airworthiness Directive Schedule

## Helicopters

### Robinson R44 Series

26 March 2020

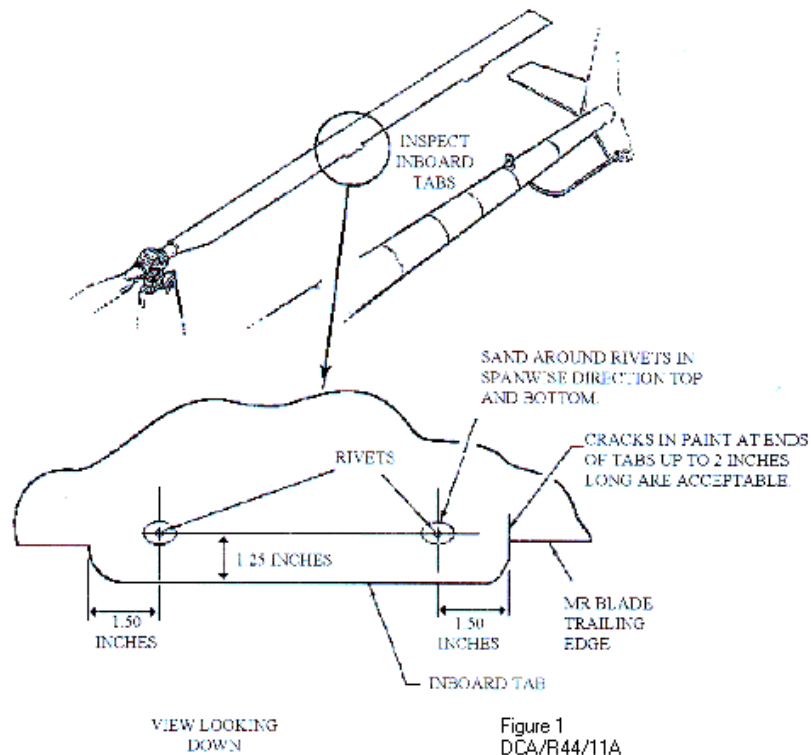
1. Perform a dye-penetrant inspection of the main rotor blade skin around both inboard trim tab alignment rivets as follows, referring to Figure 1.

a) Remove all paint around both rivets, exposing an area of approximately 3/4" in diameter, at the inboard trim tab on the top and bottom of each main rotor blade (4 places per main rotor blade). Use 180 grit or finer abrasive paper, followed by 600 grit or finer paper to eliminate coarse sanding marks. Sand only in a spanwise direction. Do not use chemical paint strippers.

b) Inspect the main rotor blade skin around the rivets on the upper and lower surfaces (4 locations) using a dye-penetrant inspection method.

**Note 1:** Chord-wise cracks in the paint up to 2 inches long which are located along either inboard or outboard edge of the trim tab are acceptable.

2. Using a 5-power or higher magnifying glass, visually inspect both upper and lower main rotor blade skin surfaces around the inboard trim tab rivets (4 locations) for cracks. If a crack is found, replace the main rotor blade with an airworthy main rotor blade before further flight.

3. Install a set of main rotor blades, P/N C016-2. This constitutes terminating action for the inspections required by this AD.

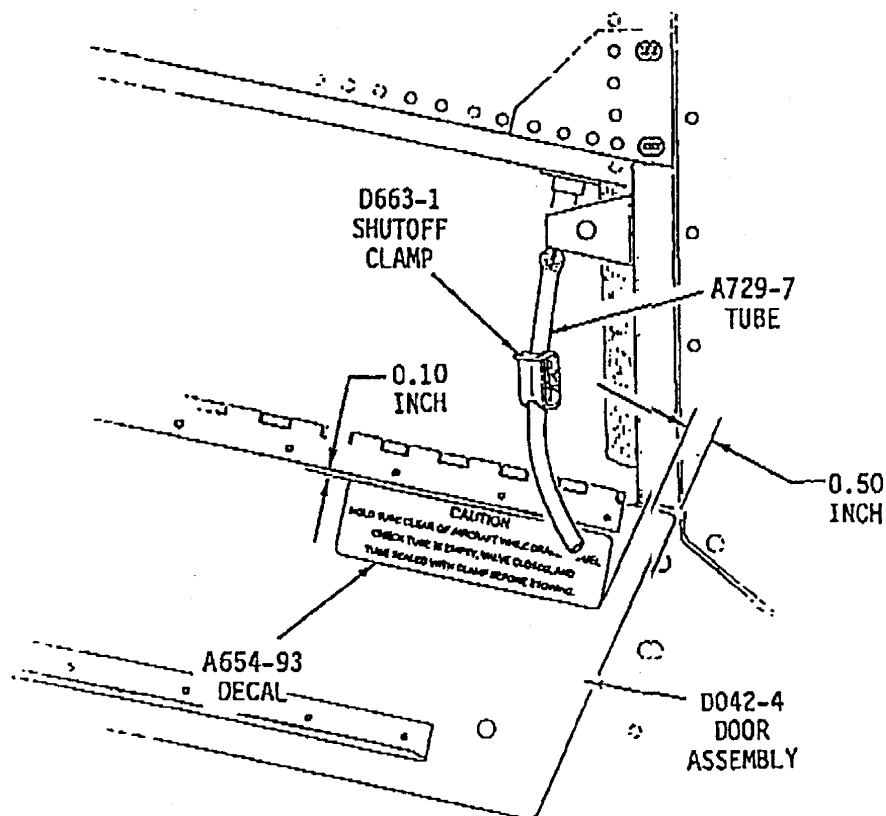
FIGURE 1  
AD 99-13-11

**Requirement:** To prevent fuel leaks from the auxiliary fuel tank sump drain, which could cause a fire and subsequent loss of the helicopter, accomplish the following:-

Install placard decal, P/N A654-93, as shown.

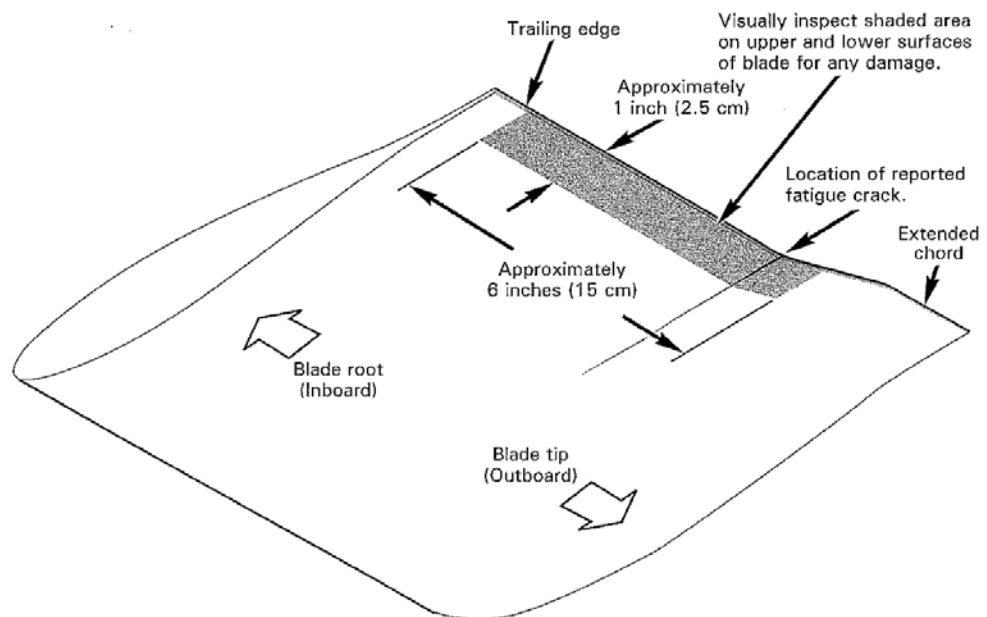
*Figure 1 – Section of MRB P/N C016-7 (View of blade lower surface)*

1. Inspect the upper and lower surfaces of each main rotor blade in the area shown in Figure 1. Inspect for any damage which may initiate a fatigue crack. A stepladder may be required to inspect the blades.

If the inspection reveals any damage or unusual marks, then the blades must be inspected by a maintenance engineer before further flight.

If any unusual rotor system vibration is detected in flight, land immediately and inspect the main rotor blades in the area shown in Figure 1. If the inspection reveals any damage or unusual marks, then the blades must be inspected by a maintenance engineer before further flight.

2. Modify the main rotor blades per the instructions in Robinson Helicopter Company R44 Service Bulletin SB-89 dated 30 March 2015.
