Airworthiness Directive Schedule

Helicopters

Bell 212 Series

30 May 2019

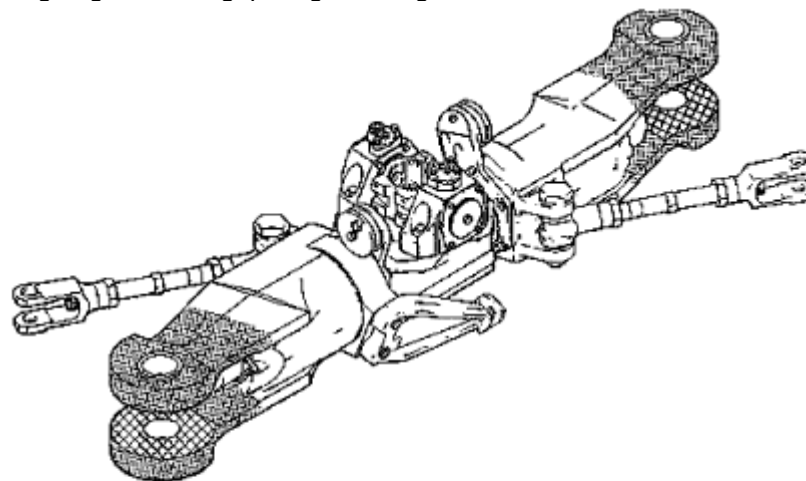
Figure 1. Inspection of Main Rotor Hub Grip Tangs

INSPECT BUFFER PAD FOR DELAMINATION (IF INSTALLED)
  AREA TO BE INSPECTED UPPER AND LOWER TANGS ALL EXPOSED SURFACES

4. Remove each main rotor blade, and inspect each grip buffer pad on the inner surfaces of each grip tang for delamination (see Figure 1 of this AD). If there is any delamination, remove the buffer pad and inspect the grip surface for corrosion or other damage. This inspection interval coincides with the main rotor tension-torsion strap replacement times.

5. Remove each main rotor blade. Remove each grip buffer pad (if installed) from the inner surfaces of each grip tang. Inspect the grip surfaces for corrosion or other damage. Fluorescent-penetrant inspect (FPI) the grip for a crack, paying particular attention to the upper and lower grip tangs. When inspecting grips, P/N 204-011-121-005, -09, and -113, pay particular attention to the leading and trailing edges of the grip barrel. FPI procedures are contained in Bell Helicopter Textron's Standard Practices Manual, BHT-ALL-SPM.

Note: Before further flight replace any cracked grip with an airworthy grip. Replace or repair any grip with any corrosion or other damage which is within the maximum repair damage limits. The maximum repair damage limitations are found in the applicable Component and Repair Overhaul Manual. Bell Helicopter Textron Operations Safety Notice 205-85-9, dated November 14, 1985, also pertains to the subject of this AD.

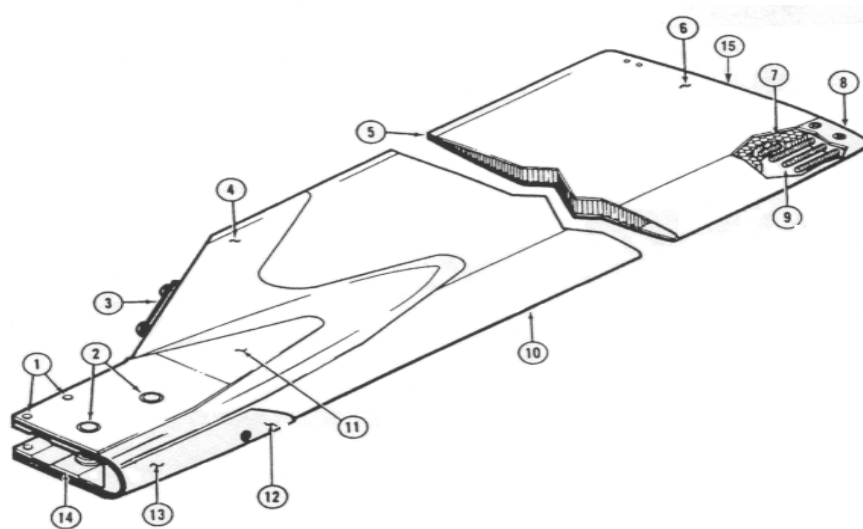
Figure 1 - T/R Blade Assembly

Visually inspect each T/R blade using a bright light and a 3X or higher magnifying glass. With reference to figure 1 in this AD, inspect the blade skins, leading edge spar, doublers, grip plates and trailing edge for cracks, corrosion and any other damage including nicks, scratches and dents. Corrosion may be indicated by blistering, peeling, flaking, bubbling or cracked paint. Pay particular attention to both sides of each T/R blade in the area located 16 to 26 inches from the T/R blade tip (i.e. blade station 25 to 35 - the T/R blade tip is located at blade station 51), and inspect the inboard blade butt area near the attachment of the external balance weights and screws. Also pay particular attention where snags from the cloth are visible, as this may indicate a crack or paint chip that could lead to corrosion. If any blistering, peeling, flaking, bubbling or cracked paint is found, remove the paint from the affected area and visually inspect the area for corrosion or a crack, using a 10X or higher magnifying glass. If any corrosion is found, measure the depth of the corrosion. A digital optical micrometer can be used for this measurement. If a nick, scratch or dent is found, visually inspect for a crack using a 10X or higher magnifying glass and measure the depth of the damage. A digital optical micrometer can be used for this measurement. If a crack is found, replace the T/R blade before further flight. If any corrosion, nicks, scratches, dents or other damage is within the maximum repair limits specified in the applicable maintenance manual, repair or replace the T/R blade before further flight. If any corrosion, nicks, scratches, dents or any other damage exceeds the maximum specified repair limits specified in the applicable maintenance manual, replace the T/R blade before further flight.

Note 2: Blade repair procedures are specified in the applicable maintenance manual, component repair and overhaul manuals.
(FAA AD 2008-10-03 refers)
