Airworthiness Directive Schedule

Helicopters

Bell 412 Series

27 February 2020

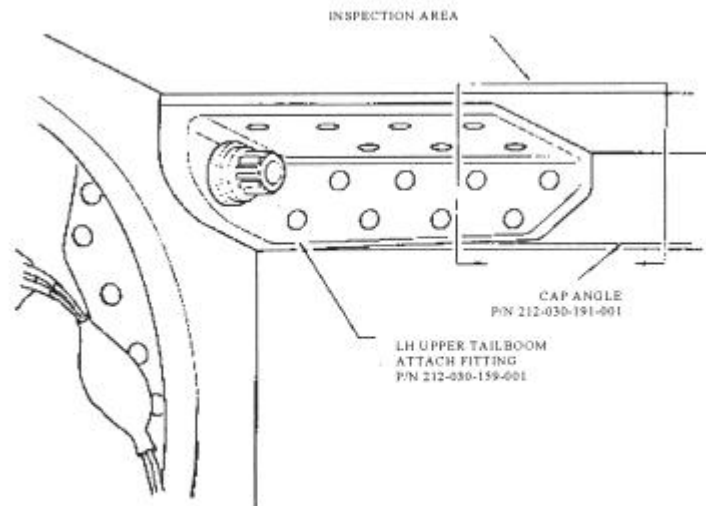
Figure 1 Fuselage tailboom attachment inspection

DCA/BELL412/3 Tailboom Attachment Cap Angle - Inspection

Requirement: To prevent failure of a cap angle, loss of the tailboom, and subsequent loss of control of the helicopter, inspect the cap angle and adjacent structure for a crack in the area shown in figure 1. Use a 10-power or higher magnifying glass. If a crack is found in the cap angle, replace it with an airworthy cap angle before further flight. Repair any crack found in the adjacent structure before further flight.

Compliance: Within 25 hours TIS and thereafter at intervals not to exceed 100 hours TIS.
