Airworthiness Directive Schedule

Helicopters

Sikorsky S-76 Series

24 October 2019

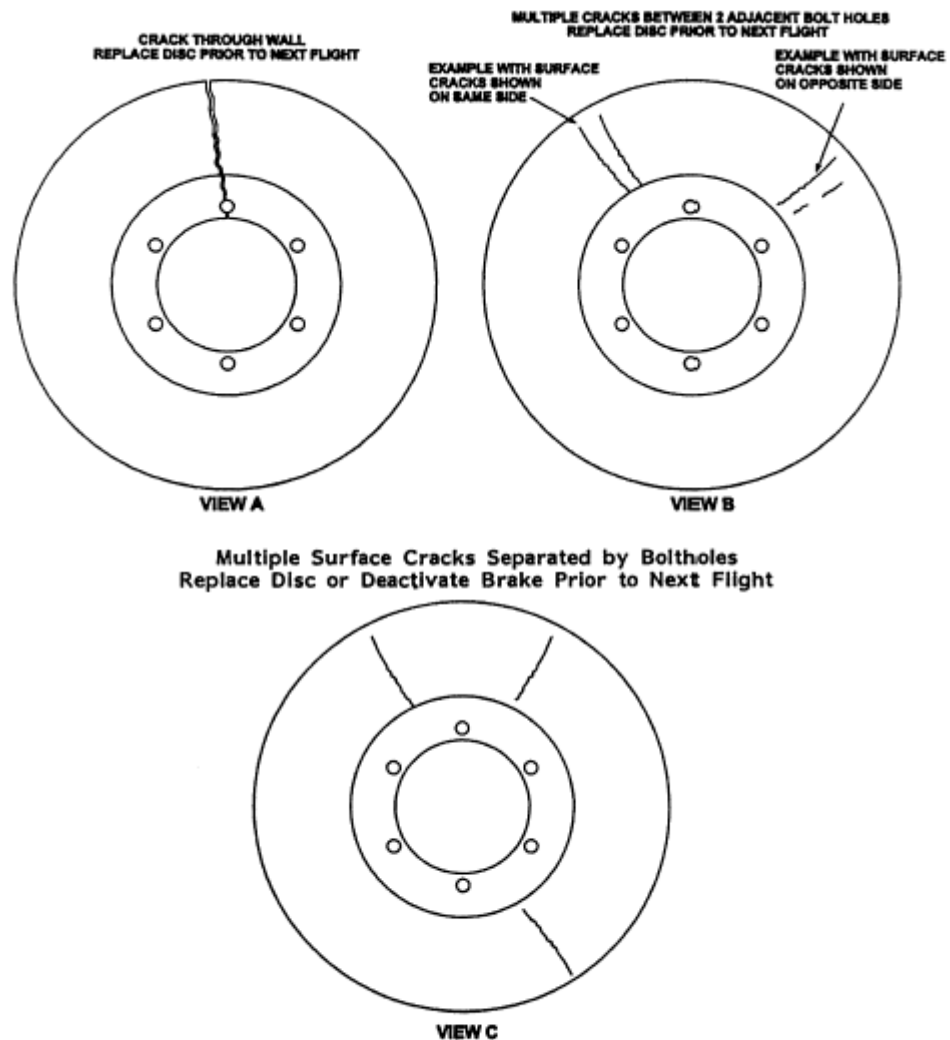
**RBD INSPECTION LIMITS
FIGURE 1.**

2. Visually inspect each RBD, P/N 76363-09103-104, for a crack, and perform the following actions. See Figure 1.
- If you find a crack through the entire RBD thickness as shown in Figure 1, View A, replace the RBD with an airworthy RBD, other than P/N 76363-09103-104, before further flight.
 - If you find two or more surface cracks between adjacent boltholes as shown in Figure 1, View B, replace the RBD with an airworthy RBD, other than P/N 76363-09103-104, before further flight.
 - If you find a surface crack or surface cracks separated by the boltholes as shown in Figure 1, View C, replace the RBD with an airworthy RBD, other than P/N 76363-09103-104, or deactivate the RBD before further flight.

3. Replace PHC RBD, P/N 76363-09103-104, with an airworthy RBD by 31 May 2003. Any replacement RBD, P/N 76363-09103-104, is not airworthy. (FAA AD 2003-04-15 refers)
