# Airworthiness Bulletin

**AWB 32-029 Issue 1 – 10 Nov 2025**

## **Supplementary Type Certificated Amphibian Float Main Gear Slide Wear in Marine Environments**

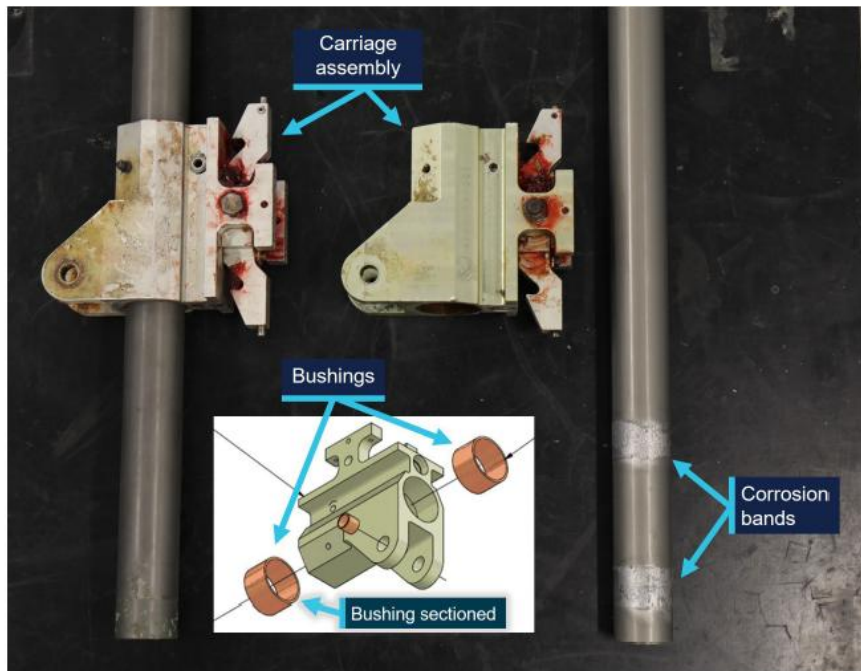
On disassembly, the ATSB noted the anodised surface of the slide tube exhibited wear consisting of longitudinal marks caused by the movement of the main gear carriage, in addition to two distinct corrosion bands around the periphery of the slide tube where the main gear carriage sits at the fully extended position, reference Figure 1.

Figure 1. Source ATSB investigation report - AO-2024-055 (used with permission, annotated by the ATSB).

‘The slide tube corrosion pattern was consistent with galvanic corrosion between the exposed bushing bronze layer and the aluminium slide tube base metal, in the presence of salt from coastal operations’.

- Support the aircraft so that the main gear carriage can be moved away from the fully extended position.
- Ensure the main gear carriage can be hydraulically moved away from the fully extended position and is not seized in position.
- Carry out a visual inspection of each main gear slide tube’s hard anodised surface for evidence of wear, erosion/nicks/protrusion damage that exposes the parent aluminium beneath the anodised surface, caused by entrapment of grit (gravel/sand/debris) in the carriage bushings and to inspect each slide tube for evidence of corrosion,
- If evidence of wear/damage/corrosion of the slide tube is found, it is recommended to take appropriate action to restore serviceability.

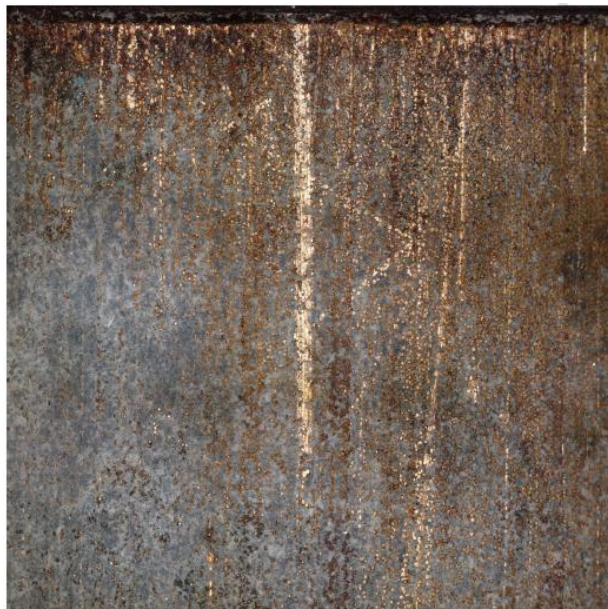
Further investigation by the ATSB found that the main gear carriage bushings, on examination, identified areas where the PTFE sliding surface was not present, exposing the sintered bronze layer of the bushings which also exhibited evidence of scoring, refer Figure 2.

Figure 2. Source ATSB investigation report - AO-2024-055 (used with permission).

**Note:** Possible disassembly of the main gear carriage may be required to inspect the condition of the carriage bushing surfaces for wear if wear/damage/corrosion of the slide tube is found.

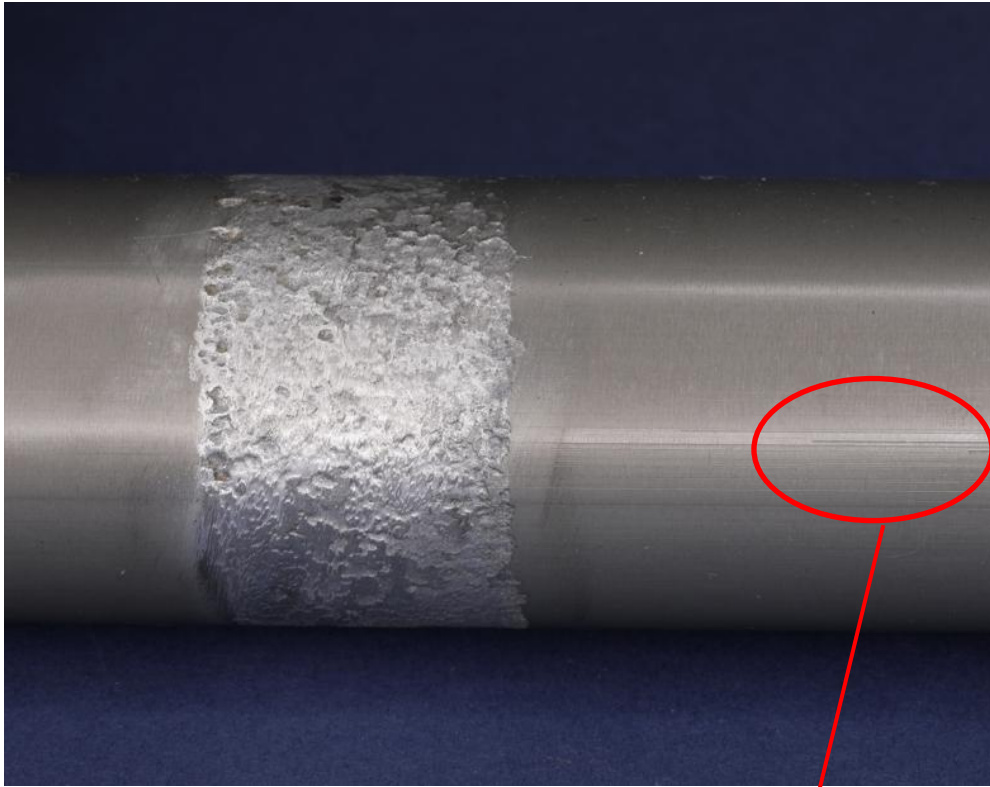
Figure 3. Corrosion Band under main gear carriage bushing, with longitudinal scoring of slide tube anodised surface evident. Source ATSB investigation report - AO-2024-055 (used with permission).

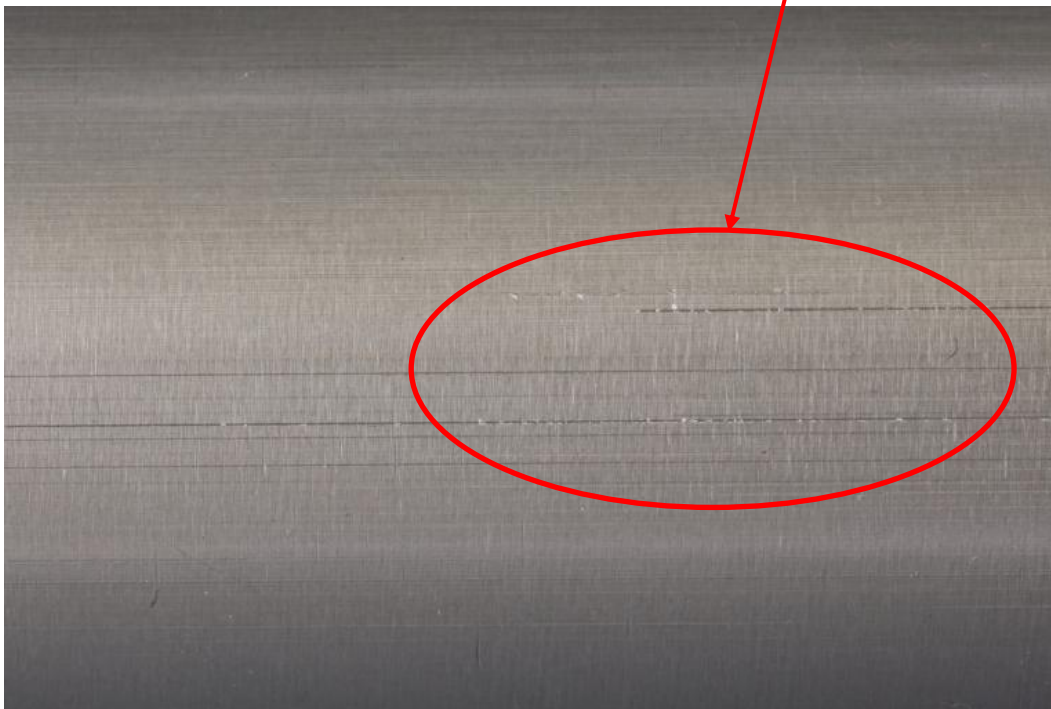
Figure 4. Close up view of Figure 3 longitudinal scoring of slide tube anodised surface with evidence of exposed base metal inside red circle. Source ATSB investigation report - AO-2024-055 (used with permission).
