Airworthiness Concern Sheet

<p>Reply to: Name: Nikholas Brito-Ross Title: Aviation Safety Engineer Office: East Certification Branch Street Address: 107 Charles W. Grant Pkwy City, State, ZIP: Hapeville, GA 30354 Telephone: 404-474-5528 Electronic Mail: ECB-COS@faa.gov</p>	<p>Make: Piper Aircraft, Inc. (Piper) Model / Series: PA-28, PA-32, PA-34, and PA-44, specifically those called out in SAIB AIR-21-10 Serial Numbers: All Serial Numbers Reason for Airworthiness Concern: Forward Wing Spar Attachment Corrosion</p>
--	--

SPECIAL AIRWORTHINESS INFORMATION BULLETIN

SUBJ: Wing, Attach Fittings (JASC 5740)

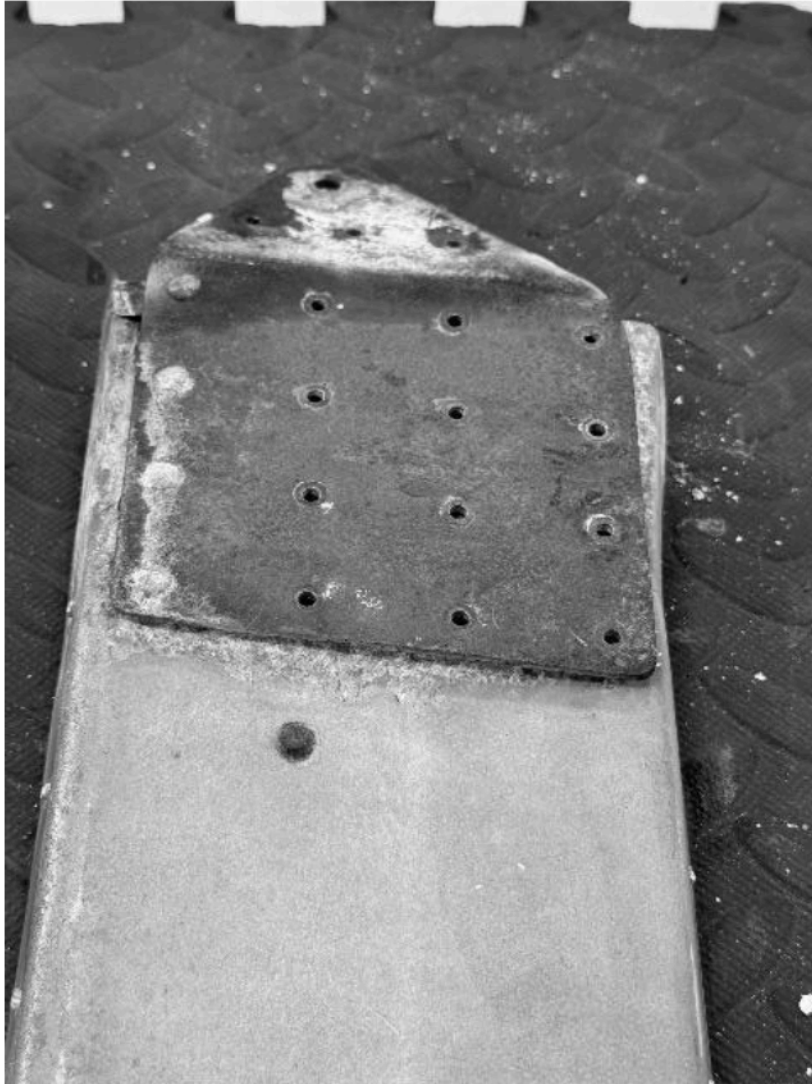
The FAA recently received a report of severe corrosion on the left-hand forward wing spar attachment, specifically the forward spar through to the forward fuselage attachment fitting and on the rivet heads of said attachment, on a Piper PA-28-161 (Figures 1&2). Further inspection of that fleet located four more airplanes with corrosion, although less severe than the aforementioned airplane. The corrosion was found during a general visual inspection of the area; but, to conduct a full evaluation, disassembly of the area was necessary. The corrosion was found by following the recommended inspection discussed in Special Airworthiness Information Bulletin (SAIB) AIR-21-10 (attached below). It has been found that accessing the location discussed in the SAIB is difficult, and the full extent of corrosion, if present, may not be apparent without disassembly.

Figure 1: Forward Spar, Attachment Fitting, and Rivets with Corrosion from a PA-28-161.

Piper has released Service Bulletin (SB) No. 1400A, dated March 13, 2026, and is available at www.piper.com/technical-publications/. The subject of Piper SB No. 1400A is "Forward Wing Spar-To-Fuselage Attach Fitting Corrosion Inspection" and it affects the same models as this Airworthiness Concern Sheet. This SB provides inspection, removal, and replacement instructions for the involved areas.

We recommend operators inspect this area, as detailed in Piper SB No. 1400A, and we request they provide information, including a description of any corrosion found, environment of regular operation and storage, available photos, airplane serial number, and time in service. Additionally, the FAA is interested in receiving feedback on any difficulty completing the inspection instructions in Piper SB No. 1400A.

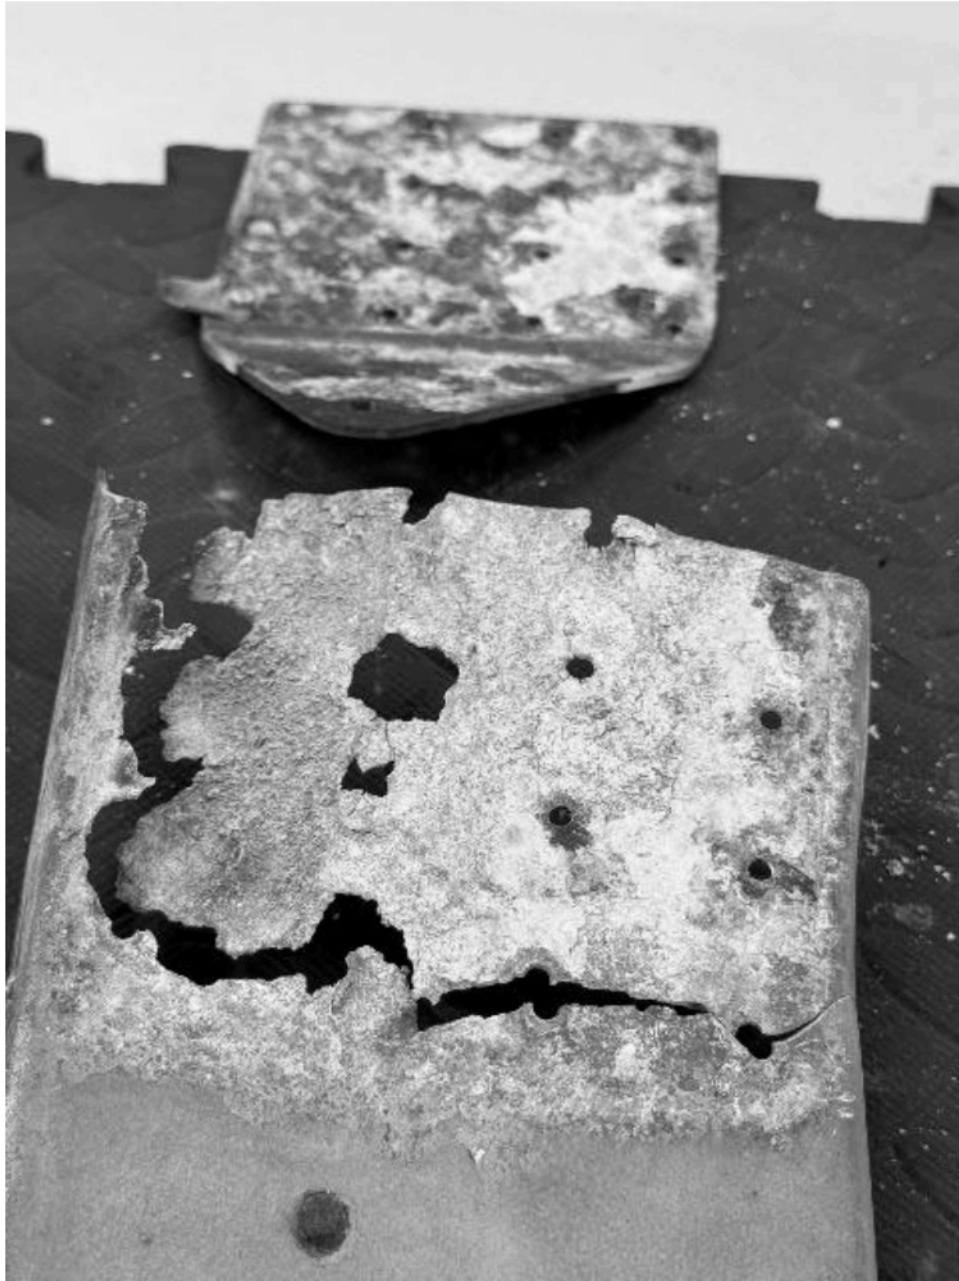
Figure 2: Attachment Fitting (top) and Forward Spar (bottom) from a PA-28-161.

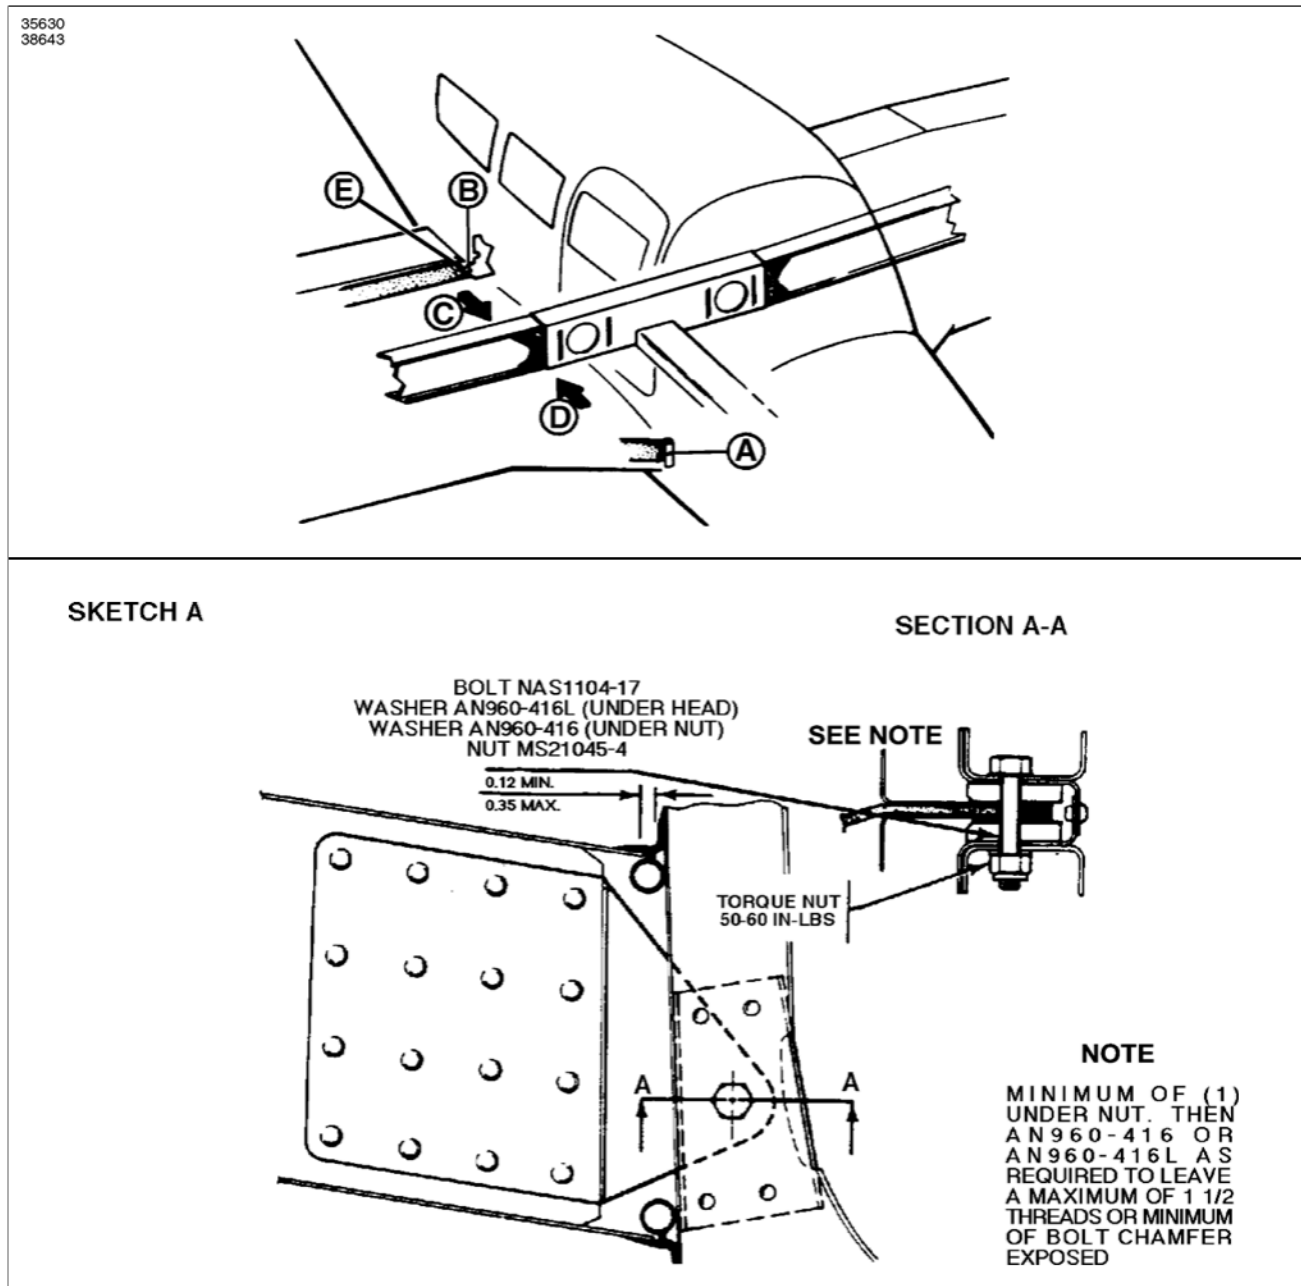
Since then, the FAA became aware of several cases of severe corrosion on the forward attach fittings from operators in Florida. While no evidence exists of water intrusion at the forward locations, the potential exists for galvanic corrosion between the dissimilar metals of the steel fittings and aluminum spar. Due to the restricted accessibility of the forward attach fittings in some airplanes, owners may be neglecting to have this area inspected. See Figures 1 through 3 depicting corrosion location and characteristics.

Figure 1. Forward Attach Fitting

The FAA is recommending that owners take special care to ensure that the forward wing attach fittings are visually inspected during annual or 100-hour inspections in accordance with the applicable Piper Aircraft, Inc. Maintenance Manual. Some operators have had inspection panels or borescope inspection holes installed to facilitate inspection (contact Piper Aircraft, Inc. for acceptable options). “Powdery” rivets in the attach fitting are indicative of corrosion between the

steel and aluminum surfaces. Particularly susceptible are those airplanes operating in coastal or otherwise corrosive environments.

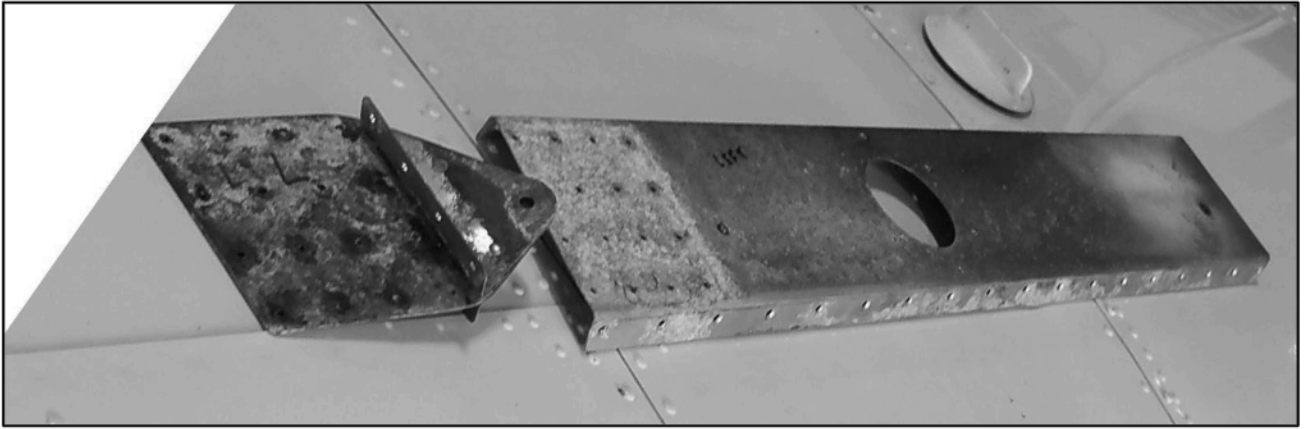
Figure 2. PA-28 Corroded Forward Attach Fitting and Spar Section (removed)

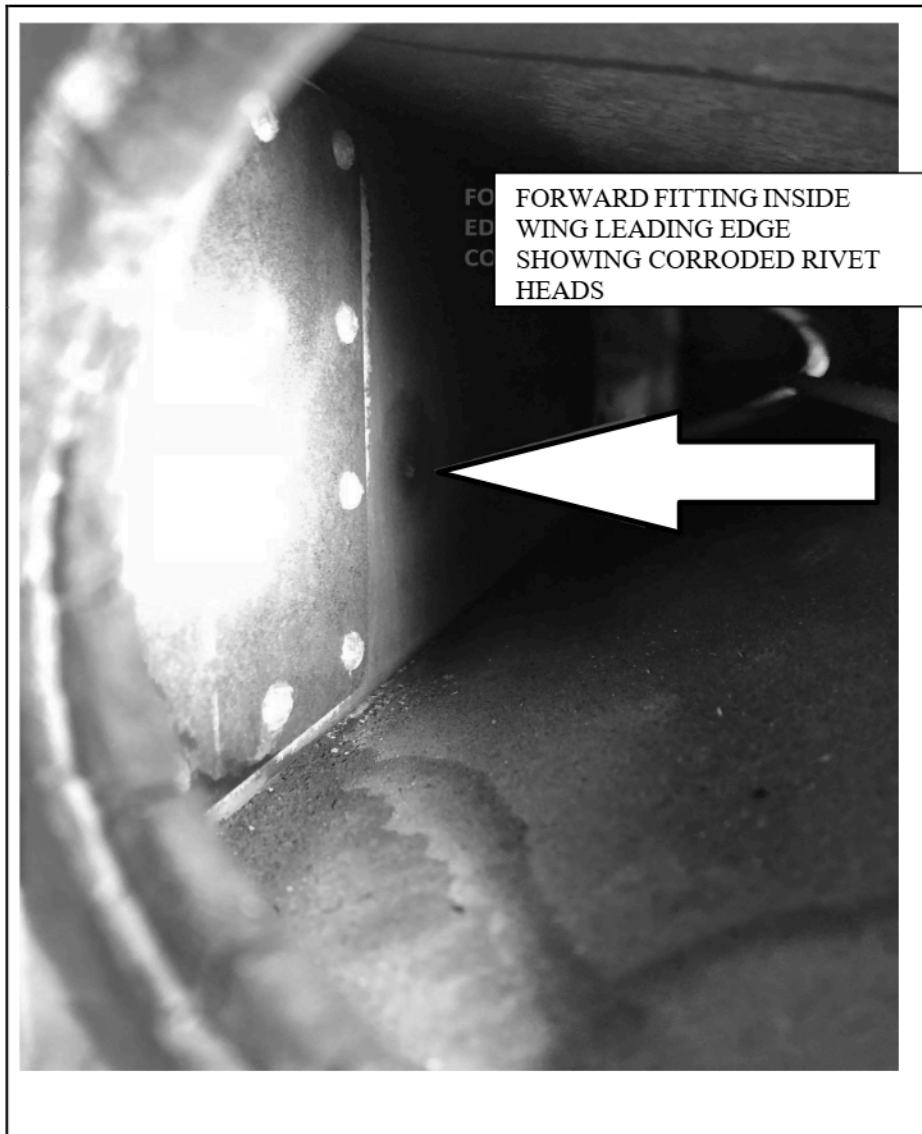
Figure 3. Wing Interior Showing Galvanic Corrosion
