# Airworthiness Concern Sheet

| <b>Reply to:</b><br><b>Name:</b> Ramanpreet Singh<br><b>Title:</b> Aviation Safety Engineer<br><b>Office:</b> AIR-755<br><b>Street Address:</b> 1701 Columbia Ave<br><b>City, State, ZIP:</b> College Park, GA 30337<br><b>Telephone:</b> (516) 228-7300<br><b>Electronic Mail:</b> ecb-cos@faa.gov | <b>Make:</b> Tempest Aero Group<br><b>Model / Series:</b> N/A<br><b>Serial Numbers:</b> N/A<br><b>Reason for Airworthiness Concern:</b><br><br>Cracking of Tempest Spark Plugs at Hot lock Assembly |

**SERVICE BULLETIN SB-012****August 7<sup>th</sup>, 2026**

This Service Bulletin describes a potential cracking problem in specific lot numbers of Tempest® Spark Plugs manufactured between May 5, 2026 and July 29, 2026. It recommends immediate inspection of the affected spark plugs prior to your next flight and replacement of any cracked spark plugs. No action is required for Tempest® Spark Plugs purchased prior to May 5, 2026.

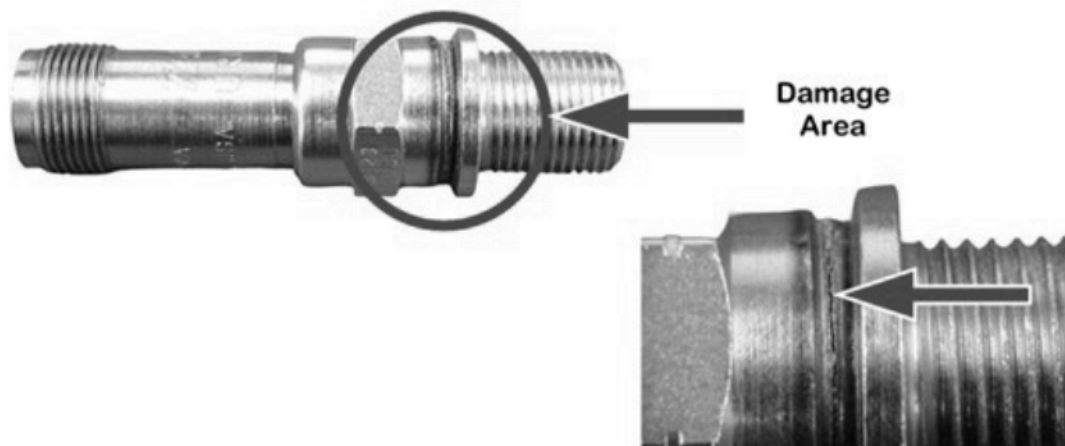
| <b>Federal Aviation Administration (FAA) Description of Airworthiness Concern</b><br><p>On July 27, 2026, the FAA received notification of a failed Tempest spark plug, part number (PN) UREM38E, which was discovered following an event of engine roughness and subsequent partial loss of power. Service Difficulty Report (SDR) ECPR20260731001 is enclosed for reference. Further inspection by the operator revealed full separation between the spark plug's seat and hexagonal nut, also known as the hot lock assembly. The FAA identified similar SDRs which were recently submitted to report circumferential cracking on new or low time Tempest spark plugs.</p> <p>Upon notification of the issue, Tempest released <u>Service Bulletin (SB)-012</u> dated August 7, 2026, which is also provided as an enclosure. The service bulletin recommends immediate visual inspection before further flight of Tempest spark plugs manufactured between May 5, 2026 through July 29, 2026, and provides a list of suspect part and lot numbers. The service bulletin also provides illustrations of the suspect area to inspect for cracking, which is also shown in Figure 1.</p> <p>Failed spark plugs may lead to damage to the engine, possible loss of power, and subsequent loss of control of the aircraft. The FAA is currently investigating this concern.</p> | |

Figure 1: The suspected area of damage on the spark plugs

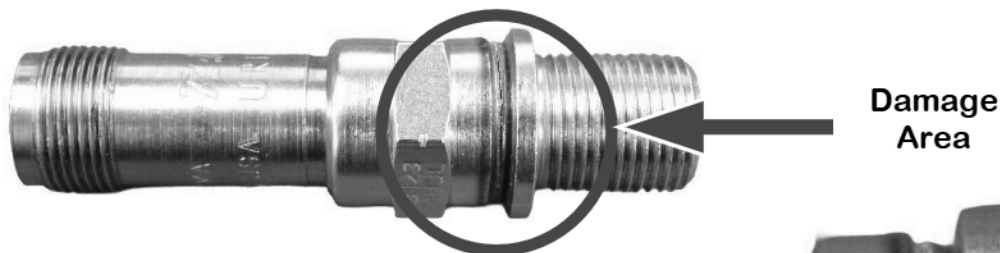
**Figure 1**

There have been field reports of cracks in Tempest® spark plugs. The area of damage is shown in Figures 1 & 2.

3. If an affected spark plug is found to be installed, remove the affected spark plug(s) from the engine and visually inspect for cracks as shown in Figures 1 and 2. Similarly, inspect any affected spark plugs in inventory.

5. If cracks are found, replace the spark plug(s). If replacing with new Tempest® spark plug(s), verify the new spark plugs carry compliance stamp SB012 as shown in Figure 4 or are outside the part number and lot numbers listed in Table 1 above.

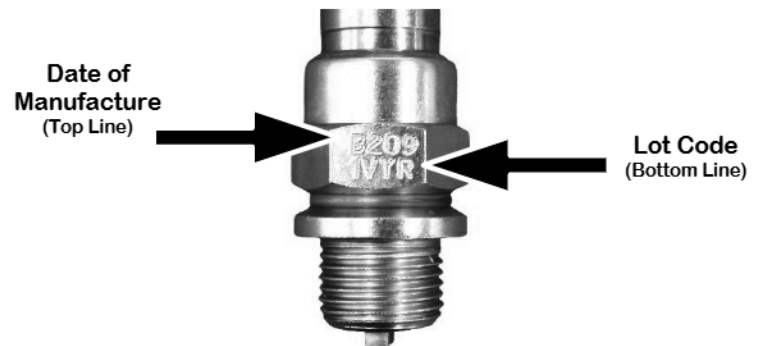
Visually inspect the spark plug for lot code per Figure 3. The lot code is stamped on the hex of the spark plug body as shown. Compare the stamped lot code to the affected part numbers and lot numbers listed in Table 1. Physical inspection of spark plugs is required. Remove from engine as required to confirm part number a lot code.

1. Determine if a spark plug is included in the affected lots (Table 1) using a visual inspection as shown in Figure 3 or by referencing an FAA 8130 from the latest spark plug installation as shown in Figure 5.
