Airworthiness Concern Sheet

<p>Reply to: Name: Eduardo Orozco Title: Aviation Safety Engineer Office: AIR-772 Street Address: 3960 Paramount Blvd, Suite 100 City, State, ZIP: Lakewood, CA 90712 Telephone: 562-627-5264 Electronic Mail: Eduardo.Orozco-Duran@faa.gov</p>	<p>Make: Robinson Helicopter Company Model / Series: R44/R44 II/R66 Serial Numbers: All Reason for Airworthiness Concern: Separated Push-Pull Tube</p>
--	---

Federal Aviation Administration (FAA) Description of Airworthiness Concern

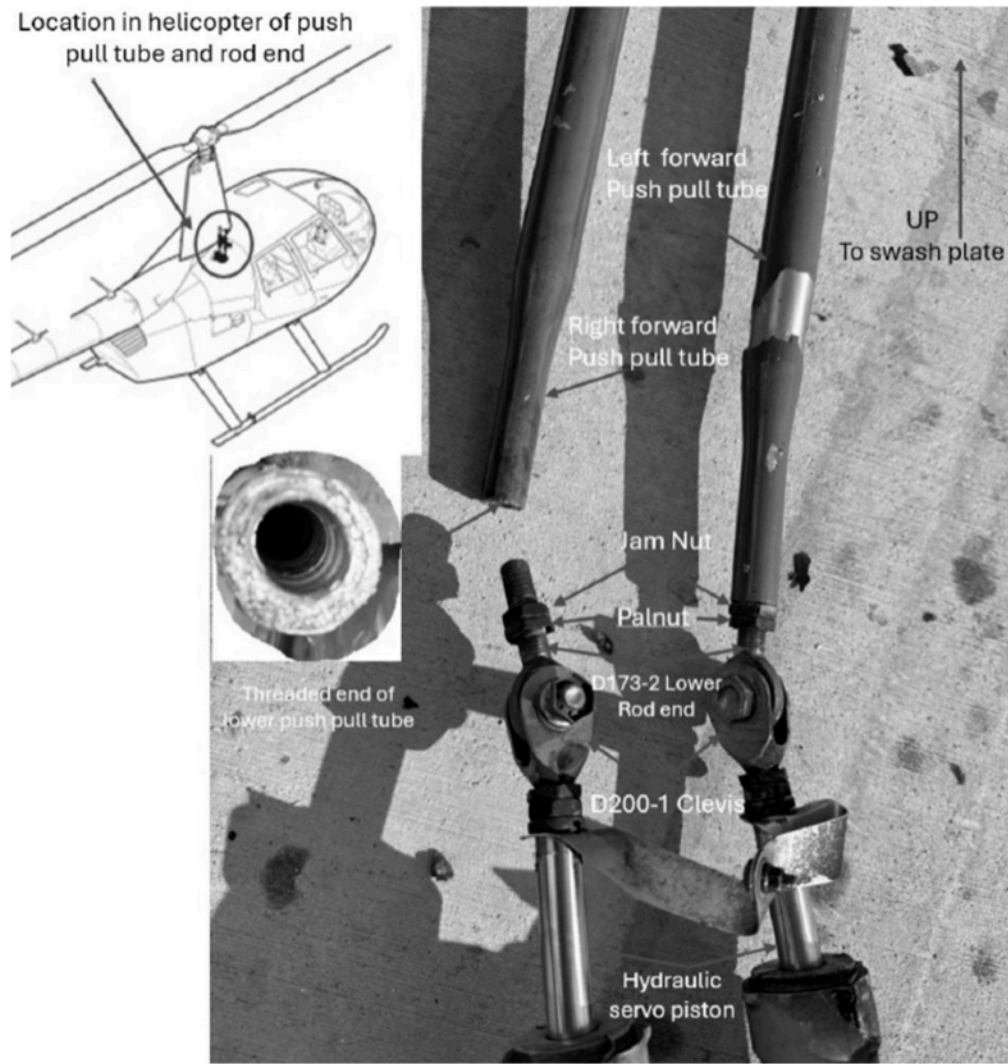
On March 23, 2026, a Robinson Helicopter R44 rotorcraft (N478AT) impacted the roof of a warehouse facility in Boynton Beach, Florida. During the NTSB’s on-site examination of the main rotor flight controls, the upper right push-pull tube was found separated from the lower rod end (part number D173-2), which remained attached to the upper hydraulic servo piston shaft at the clevis (part number D200-1).

The palnut and jam nut that secure the upper right push-pull tube to the rod end could not be rotated by hand on the rod end threads. The upper right push-pull tube was observed to be elongated at the threaded end (see figure 1). Remnants of torque stripe paint were present on the push-pull tube, palnut, and jam nut. The palnuts and jam nuts on the left and aft lower rod ends and below the hydraulic servo clevis were found to be finger tight. Reference NTSB preliminary report ANC26FA021 for more information.

Figure 1. Upper Right and Left Push-Pull Tubes and Rod Ends.

We recommend operators perform Robinson R44 Service Bulletin SB-119 and R66 Service Bulletin SB-45 dated May 11, 2026 or later revisions. If completed, please provide the information requested in Step 12 of the bulletin to the FAA.

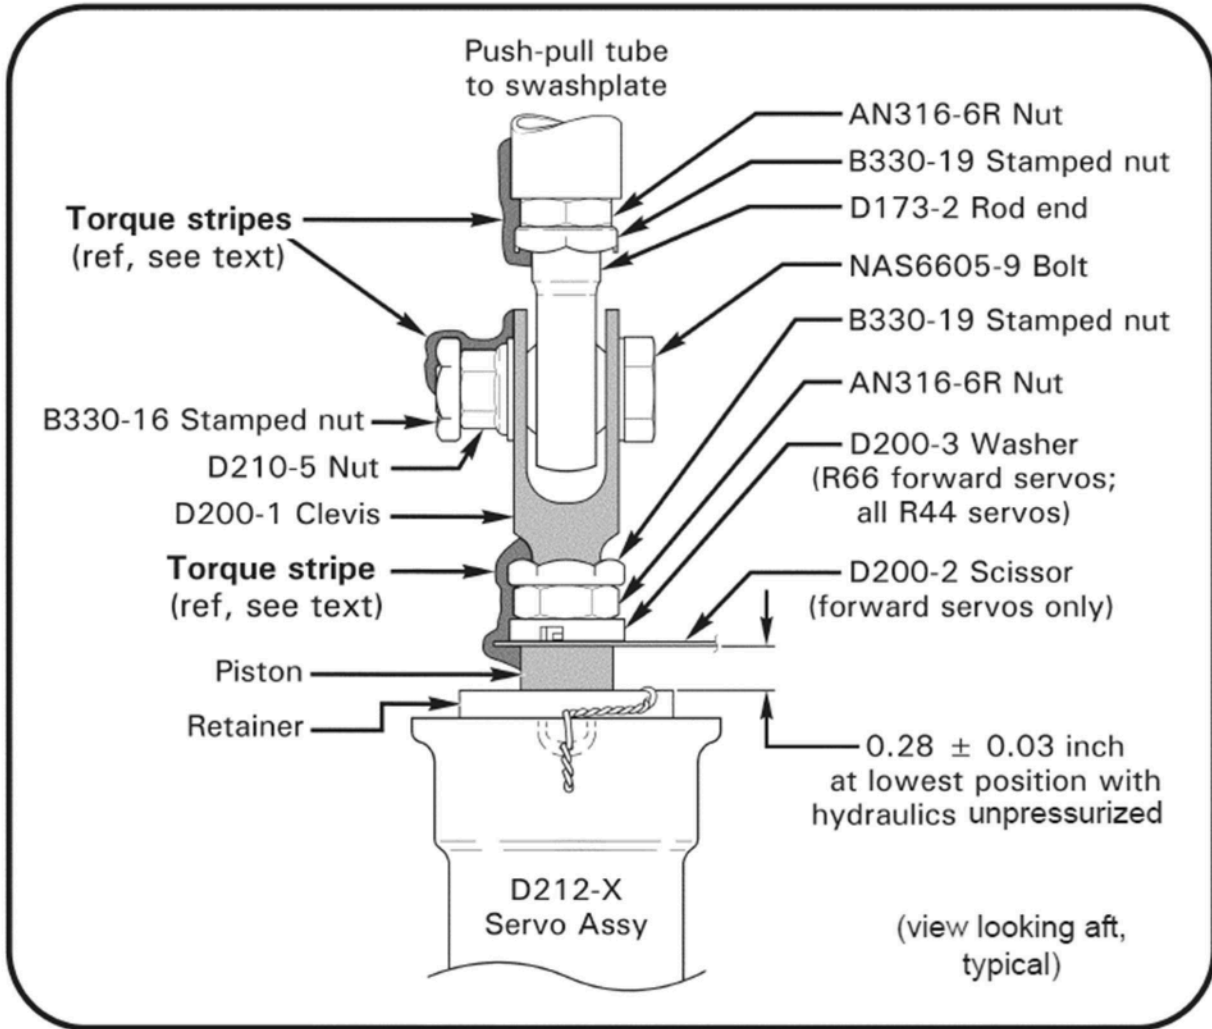
The FAA is interested in receiving information of abnormal damage around the hydraulic servo-to-swashplate push-pull tube connection (see figure 2), including but not limited to:

- loosening hardware
- broken, missing, or inadequate torque striping
- palnut or jam nut damage
- corrosion
- fretting dust or damage to the internal threads of the servo clevis or push-pull tube

Figure 2. Hydraulic Servo-to-Swashplate Push-Pull Connection (3 Places).
