SPECIAL AIRWORTHINESS INFORMATION BULLETIN

SAIB: 2026-10

SUBJ: Equipment / Furnishings - Restraint Systems

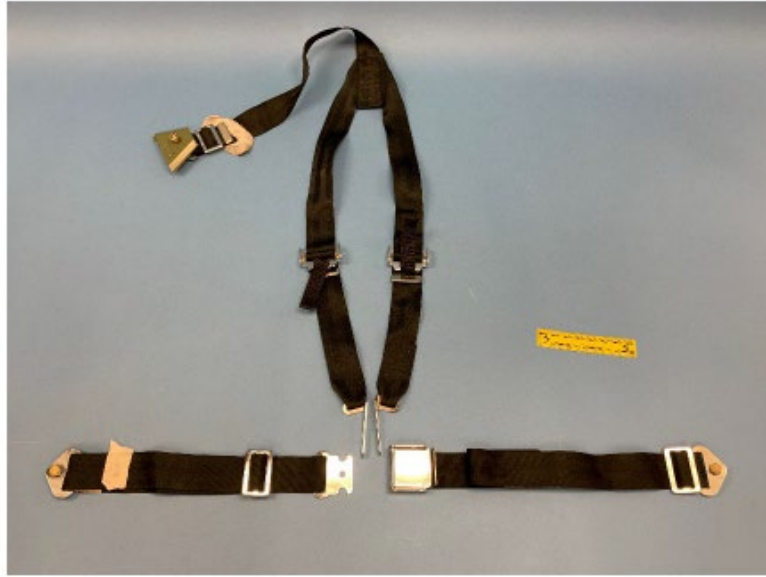
One related accident as documented in NTSB Accident No. CEN12FA601 occurred on September 16, 2014, when an Aeronca 7AC airplane impacted terrain after losing control during takeoff. The pilot sustained serious injuries, and the passenger sustained fatal injuries. The investigation revealed that the pilot's Aero Fabricators four-point restraint assembly model H-702-300, see Figure 1, separated at the shoulder harness Y-junction threading that separates the two shoulder straps and connects to the fuselage attach strap behind the pilot's head as shown in Figure 2. The NTSB performed additional testing on these restraints as documented in the accident docket's "Survival Factors Factual Report" dated September 16, 2014, and concluded that the shoulder harness failed at loads below those prescribed in current Technical Standard Orders (TSOs).

Figure 1
Four-point restraint assembly

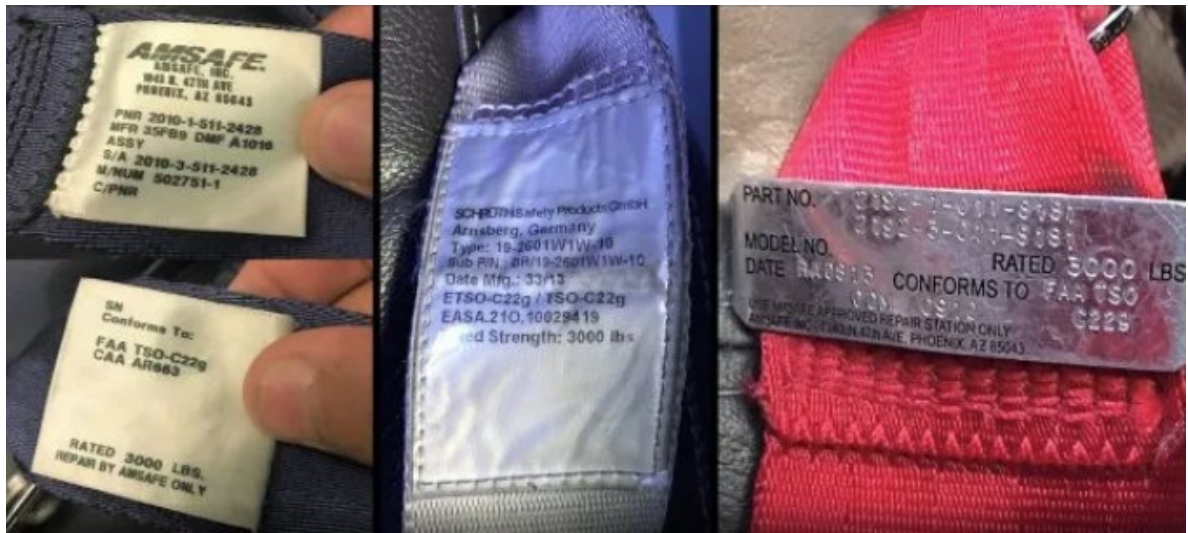
Figure 3
 Example label markings of restraints that do meet TSO-C114 or TSO-C22g requirements
 (Photo credit: AeroSavvy Aviation Insight)

- Positively identify that their restraints meet these minimum performance requirements through visual inspection of the manufacturer's label markings on the restraint assemblies. These markings may list the TSO numbers and/or the rated strength of the restraint assembly. The assembly's rated strength to meet the current performance requirements is 3000 lbs or more. Figure 3 and Figure 4 show examples of label markings of restraints which do and do not meet TSO-C114 or TSO-C22g requirements.

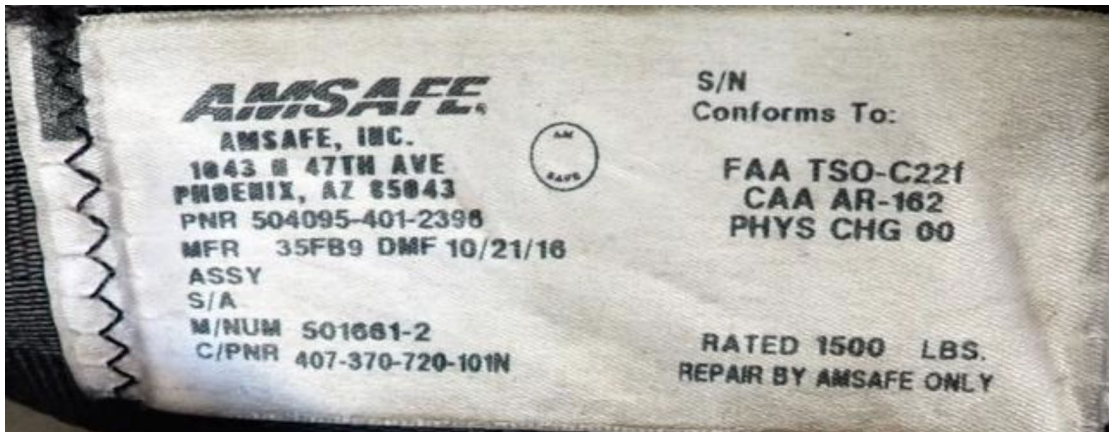
Figure 4
 Example label marking of restraint that does not meet TSO-C114 or TSO-C22g requirements

- Replace torso and pelvic restraints which are not labeled as meeting TSO-C114 or TSO-C22g or later revisions, respectively; which do not meet or exceed an assembly rated strength of 3000 lbs or more; or which have a missing, illegible, or unreadable label or marking on the restraint with a restraint which meet these TSO minimum performance requirements.
