**FAA  
Aviation Safety**

## **SPECIAL AIRWORTHINESS INFORMATION BULLETIN**

**SAIB:** 2026-10R1

**SUBJ:** Equipment / Furnishings - Restraint Systems

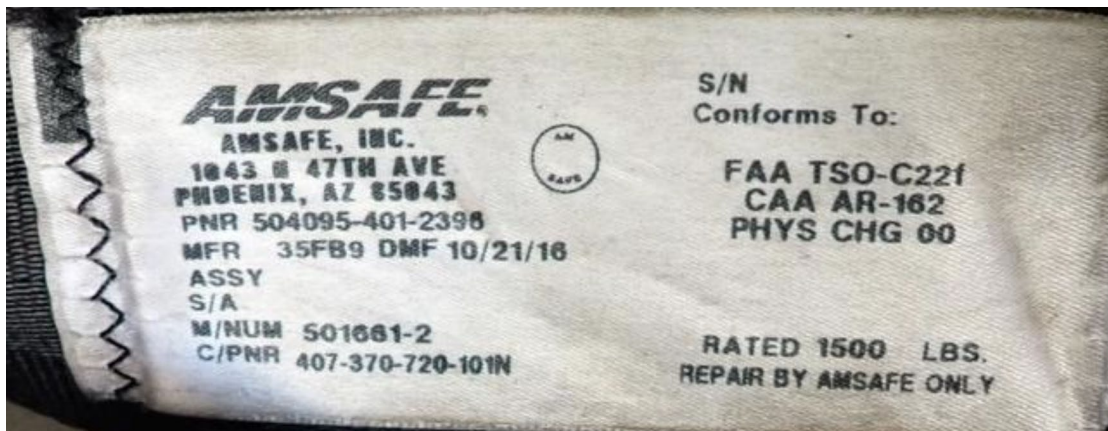
Figure 4  
Example label marking of restraint that does not meet TSO-C114 or TSO-C22g requirements

- Replace torso and pelvic restraints which are not labeled as meeting TSO-C114 or TSO-C22g or later revisions, respectively; which do not meet or exceed an assembly rated strength of 3000 lbs or more; or which have a missing, illegible, or unreadable label or marking on the restraints with restraints which meet these TSO minimum performance requirements.
