Airworthiness Directive Schedule

Propellers & Propeller Governors

Hartzell Series

26 July 2018

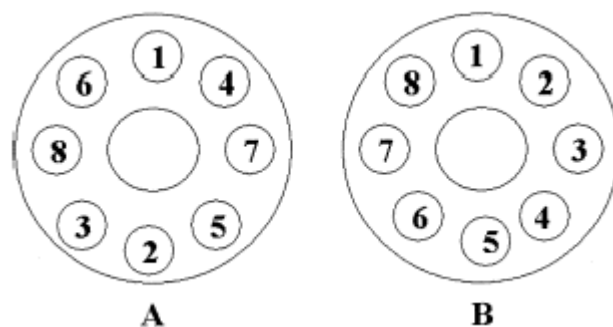
Requirement: To prevent propeller attaching bolt failures or improperly secured propellers, which could lead to separation of the propeller from the aircraft, accomplish the following:

1. On propellers presently installed with P/N A-2047 attachment bolts, check the torque of all eight propeller attaching bolts (with washers installed) with a torque wrench and an appropriate adapter. The torque should be 100 ft.lbs to 125 ft.lbs, with dry threads. Do not use any lubricant with the P/N A-2047 bolts.
 If the torque of each P/N A-2047 bolt is within the 100 ft.lbs to 125 ft.lbs torque range, safety wire lock all attaching bolts in a manner approved by the manufacturer. At next propeller disassembly, remove all eight bolts and washers and replace with P/N B-3339 bolts and P/N A-2048-2 washers, or other equivalent manufacturer approved serviceable bolts and washers, per requirement 2 of this AD.
 If the torque of any one of the bolts is found to be less than 100 ft.lbs, remove all eight bolts and washers and replace with P/N B-3339 bolts and P/N A-2048-2 washers, or other equivalent manufacturer approved bolts and washers, per requirement 2 of this AD.

- (c) Apply MIL-T-83483 Petrolated Graphite, or Hartzell Lubricant P/N A-3338 to threads of the eight P/N B-3339 attaching bolts (and remainder of bolt if desired) and to the flat surfaces of the eight P/N A-2048-2 washers, or other equivalent manufacturer approved serviceable bolts and washers, and install the attaching bolts and flat washers through the engine flange and into the propeller flange.

(d) Torque all attaching bolts with a torque wrench and an appropriate adapter, to 40 ft.lbs, and then to 80 ft.lbs, following sequence "A" (shown below). Final torque all attaching bolts using sequence "B" (shown below) to 100 ft.lbs to 105 ft.lbs. Safety wire lock all attaching bolts in a manufacturer approved manner.
