## Report on aircraft accident

Case no: **M-01313/AIG-09**

Location: **Keflavik Airport (BIKF)**

Description: **Runway excursion during flight testing**

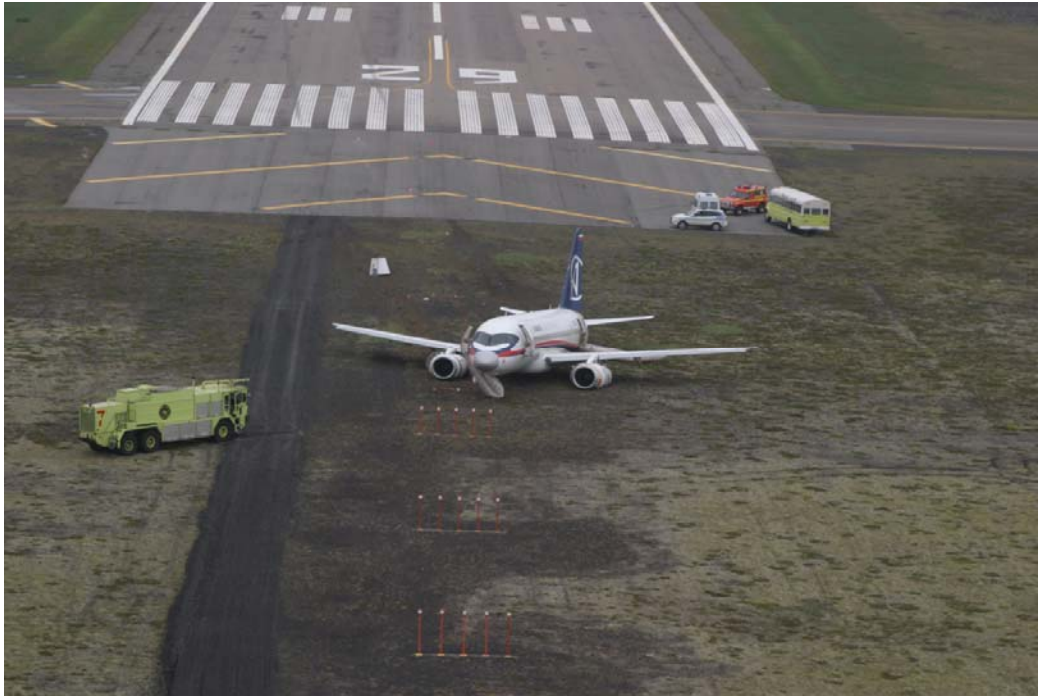
The airplane skidded off the end of RWY 11 and came to rest at 05:24:25 after having passed 163 meters beyond the threshold of RWY 29. See Figure 5.

**Figure 5: The airplane came to rest beyond the threshold of RWY 29**

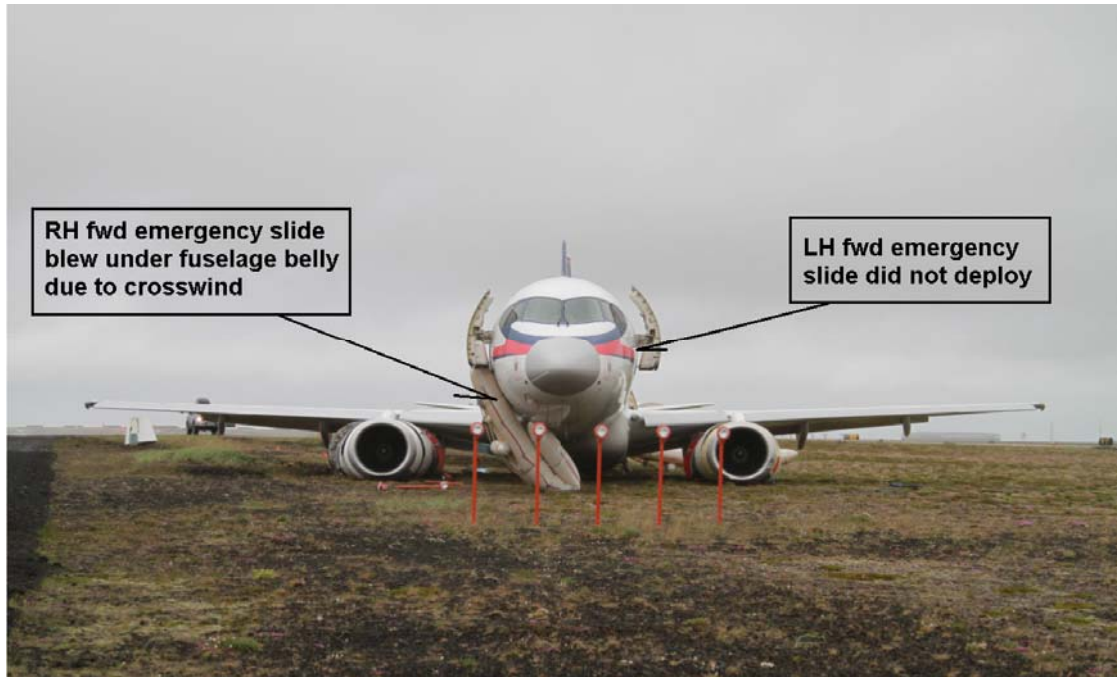
**Figure 6: Forward RH emergency escape slide unusable**

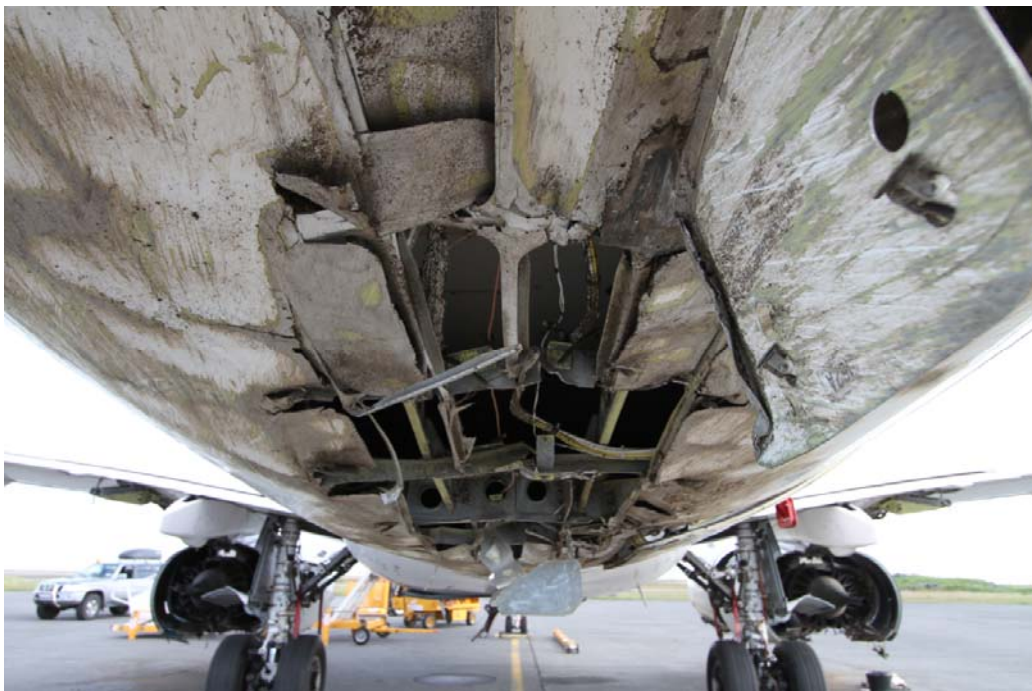
The airplane's aft lower fuselage section was extensively damaged. Other damage, included both engines and cowlings. See Figure 8.

Figure 8: Damage to the aircraft

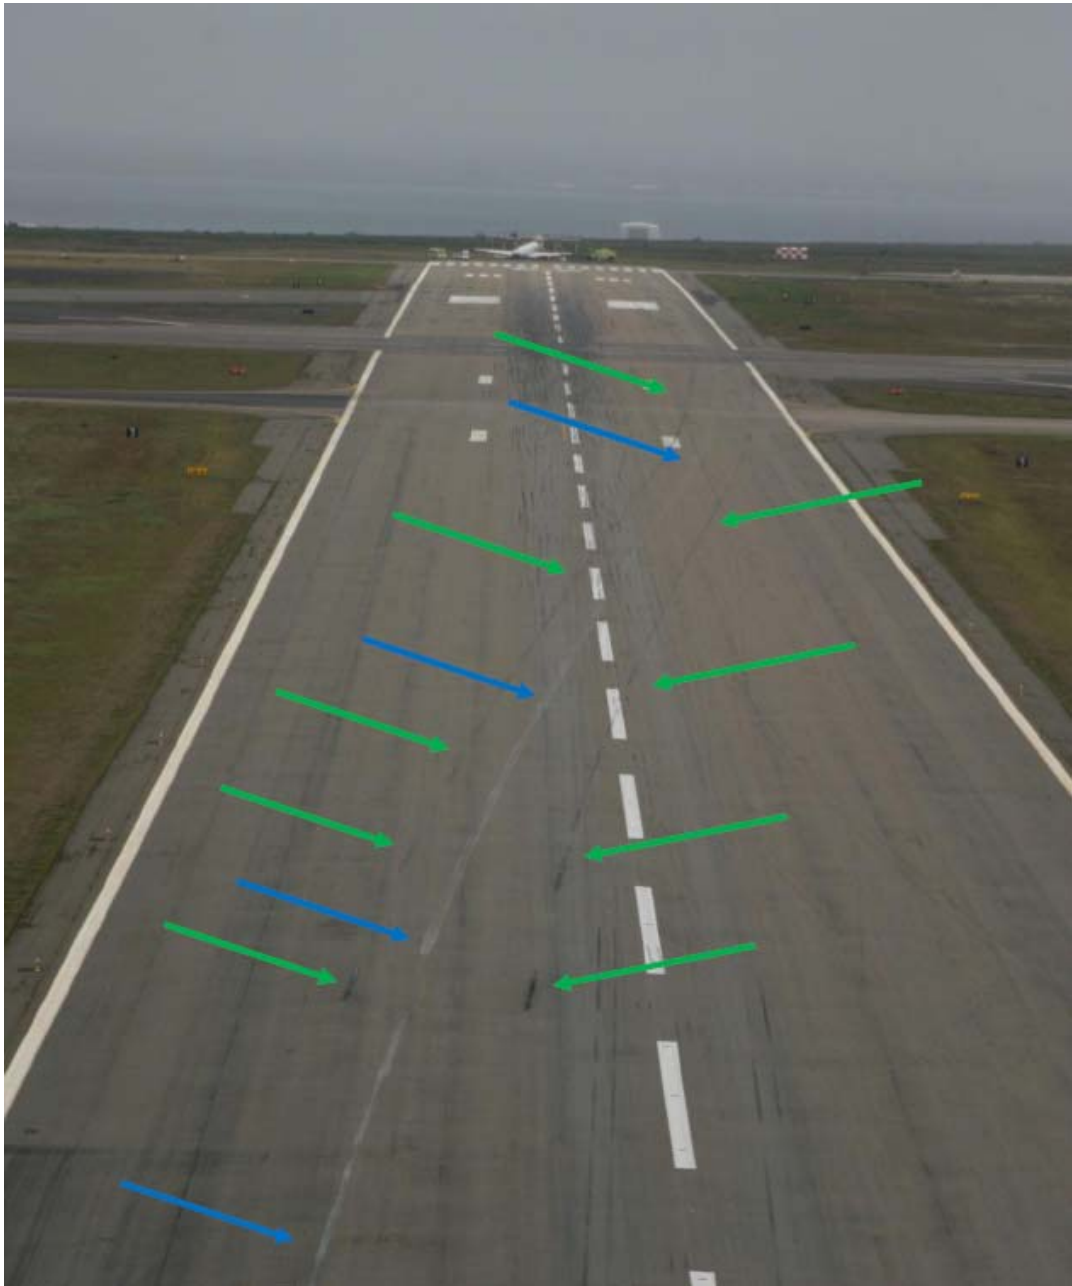
The airplane landed on RWY 11 on its lower aft fuselage belly left of the center line, about 360 meters beyond TWY C1/C2. The airplane then skidded 1.6 km down the runway and came to rest after having passed 163 meters beyond the threshold of RWY 29.

**Figure 11: Airplane skid marks on RWY 11 (blue = fuselage / green = engines)**

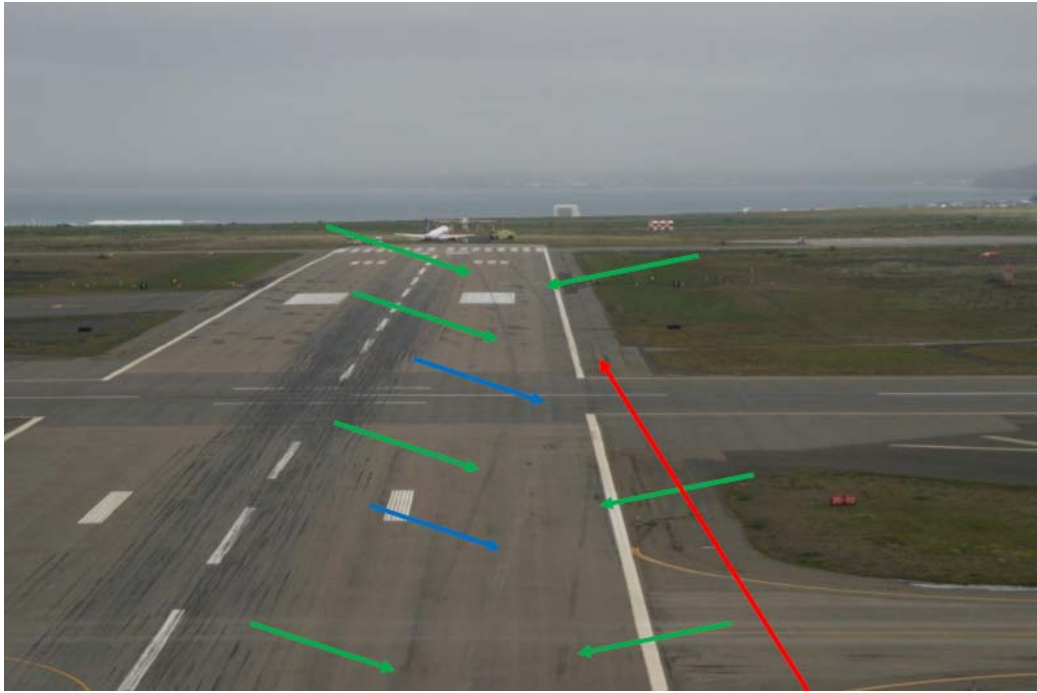
When the airplane skidded off the runway it damaged five rows of runway approach lights, for a total of 25 runway approach lights. One runway light, where RWY 11 and RWY 20 cross, was damaged and minor damage to RWY 11 asphalt was also observed.

**Figure 13: Airplane skid marks on RWY 11**  
(blue = fuselage / green = engines / red = broken RWY light)

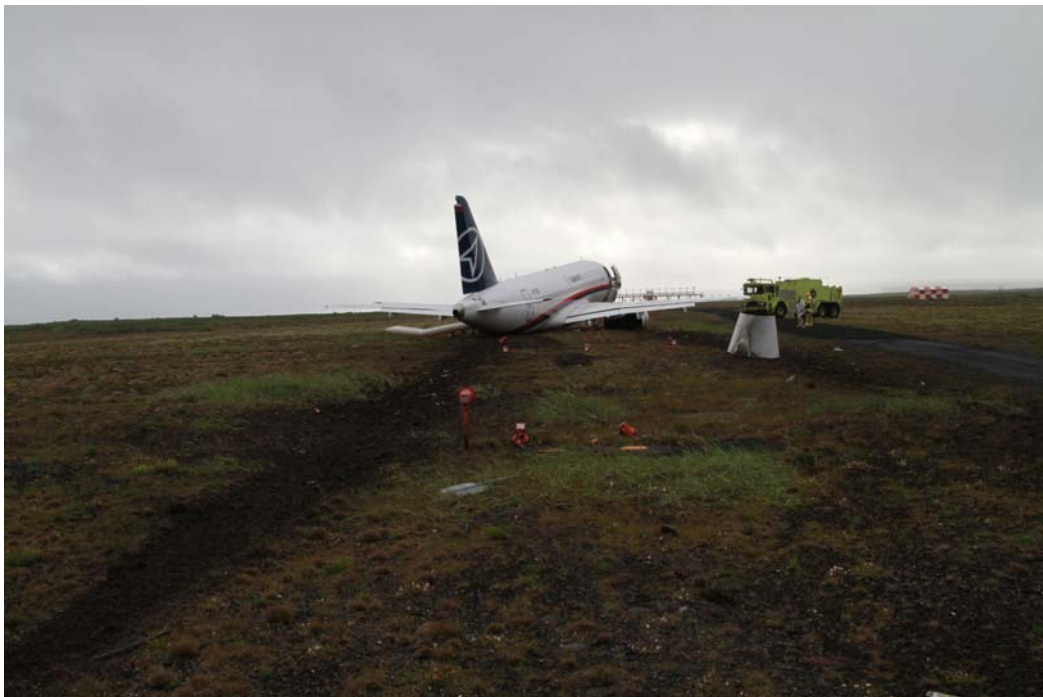
**Figure 14: Airplane skidded off the end of RWY 11**

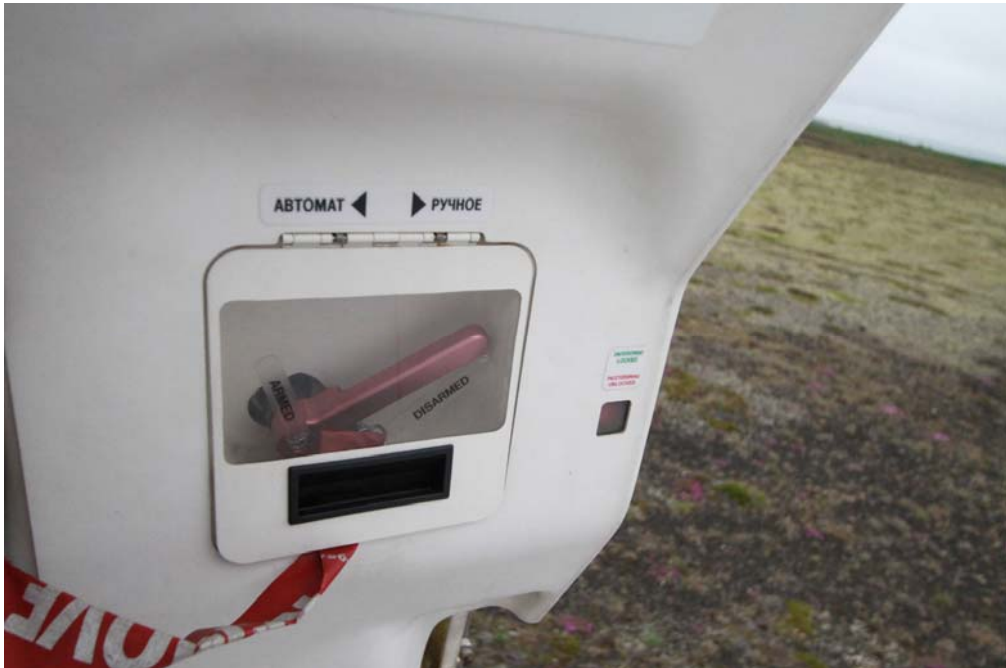
**Figure 15: Forward left cabin door slide was not armed**

- 1) Ensure sufficient resources for flight dispatch operation, independent of the flight crew, during flight tests
- 2) Review the flight test program and take the necessary steps to ensure that arming of door slides is performed prior to flight
- 3) Clarify the AFM procedures to require both TQLs to be operated in cases where a failed engine has not been identified and secured

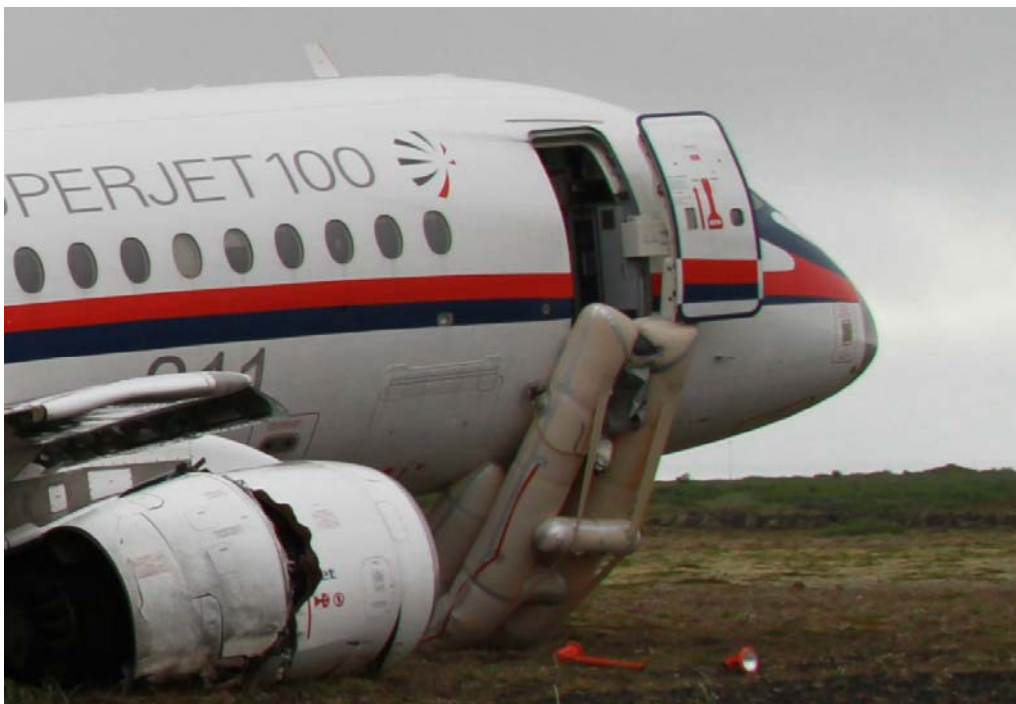
**Figure 16: Forward right cabin door slide unusable**

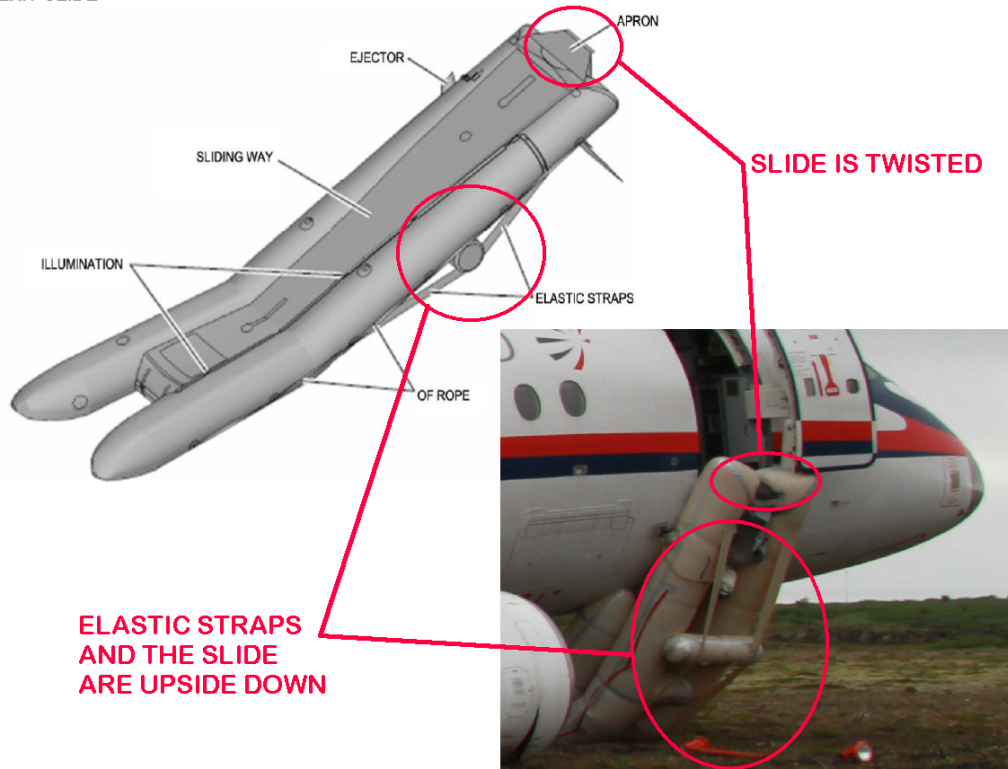
**EXIT SLIDE**

**Figure 19 Right forward door slide twisted upside down and under fuselage belly**
