CAA OCCURRENCE 20/3747
TAYLOR MONOPLANE U/L, ZK-DKQ
DEPARTURE FROM CONTROLLED FLIGHT
4.6 NM SE OF PUKAKI AERODROME, CANTERBURY,
NEW ZEALAND.
25 July 2020

Executive summary

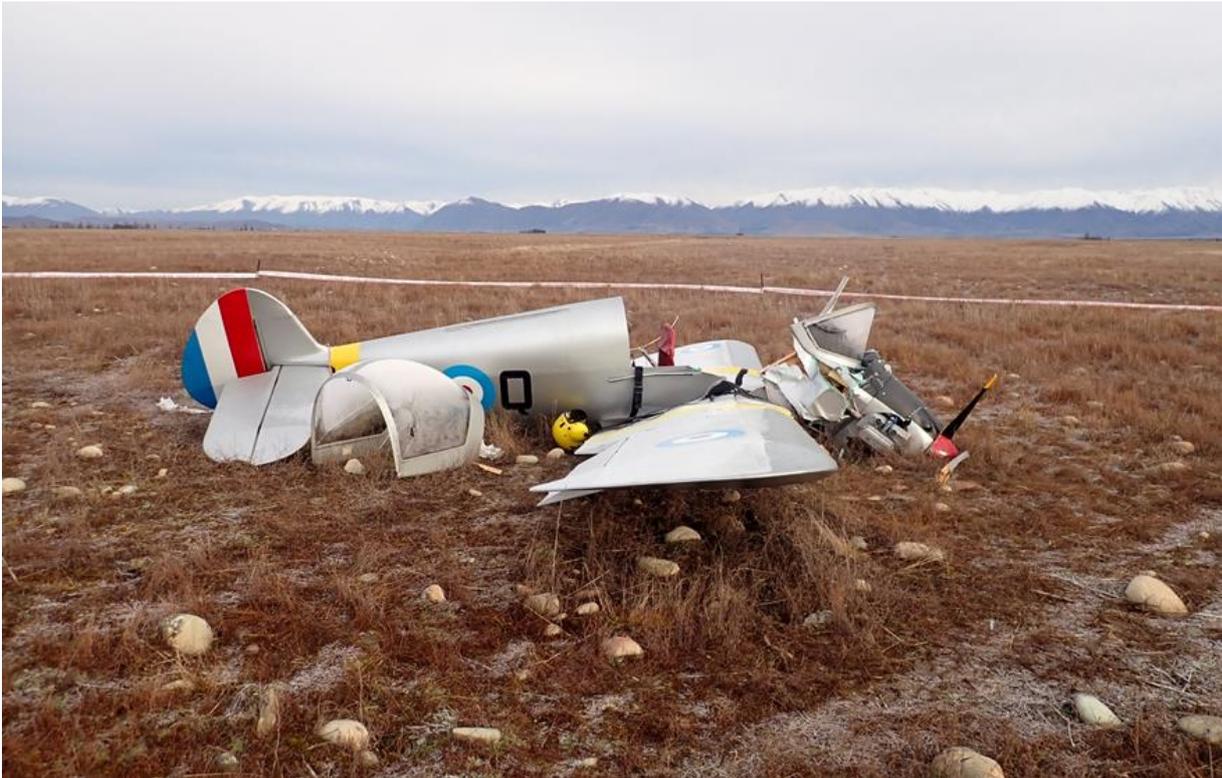
1.12.2 The wreckage signatures indicated high vertical forces with little forward energy with rotation to the left. These signatures were consistent with the aircraft being in a left-hand flat spin just prior to impact. Refer to Figure 3.

Figure 2: Side view of accident. Source: CAA site investigation.

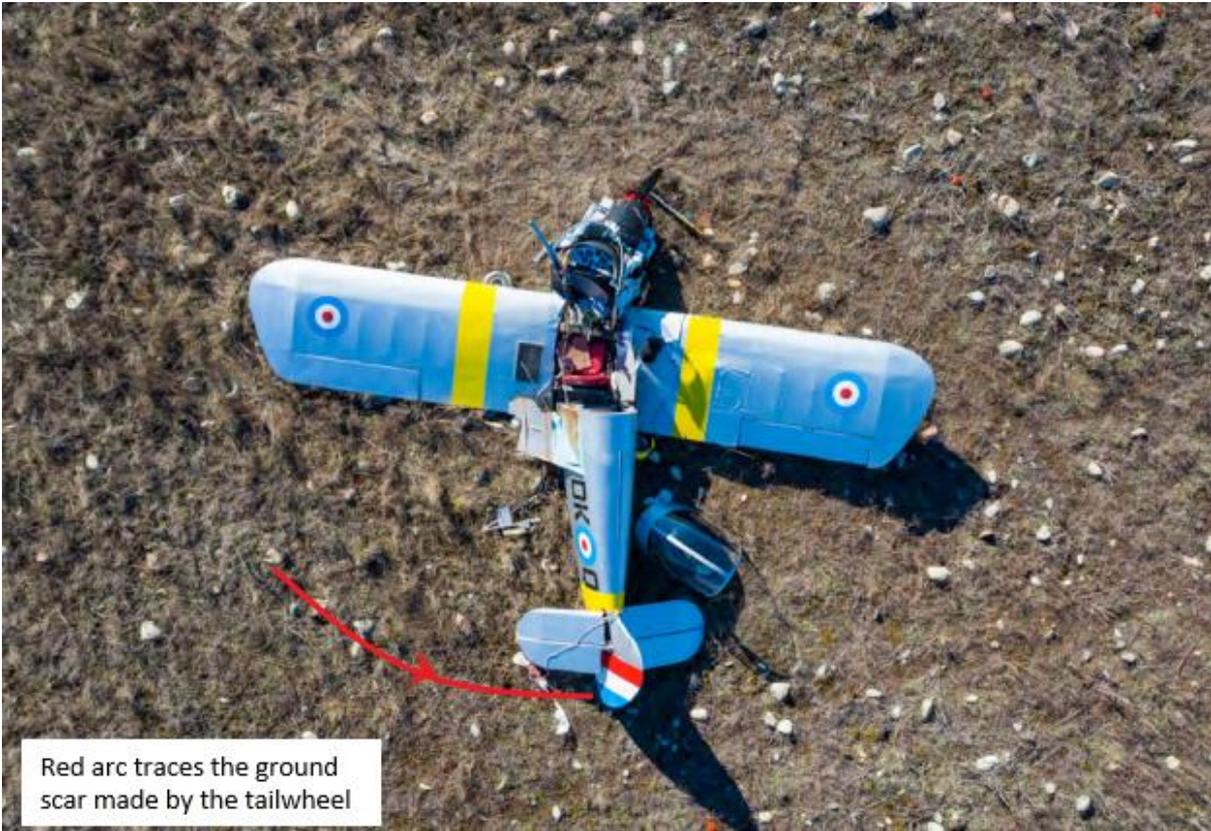
Figure 3. Aerial view of accident. Source: New Zealand Police photo.

2.2 The absence of forward impact ground scars, no wing tip damage and the overall wreckage pattern indicated the aircraft was in a left-hand, flat spin on impact.
