## CAA SAFETY INVESTIGATION REPORT

# Controlled flight into terrain

## ZK-COM Cessna 172G

CAA Final report 21/529

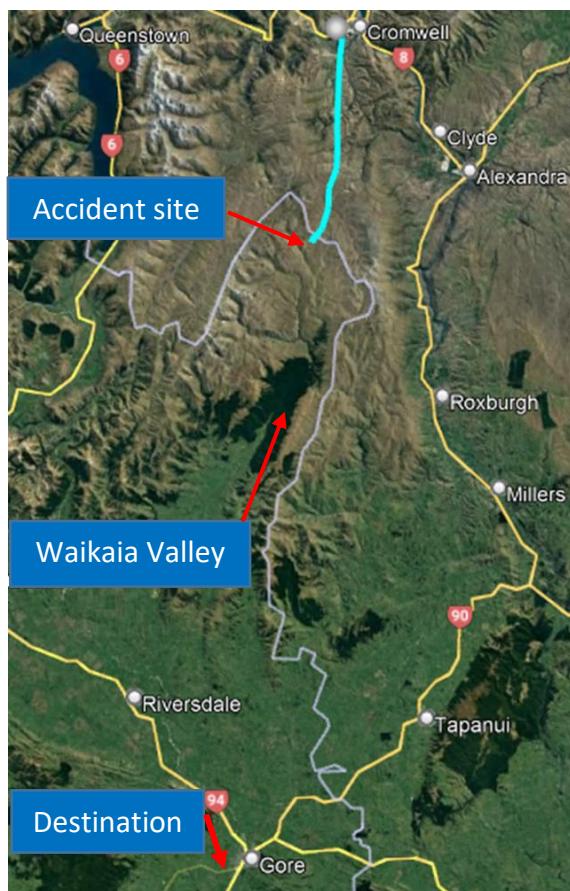
Figure 1 ZK-COM flight overview

On the day of the accident, the pilot departed Cromwell Racecourse aerodrome at 1709 for a private flight to Gore aerodrome (refer Figure 1), which was a flight the pilot had done numerous times and on a regular basis.

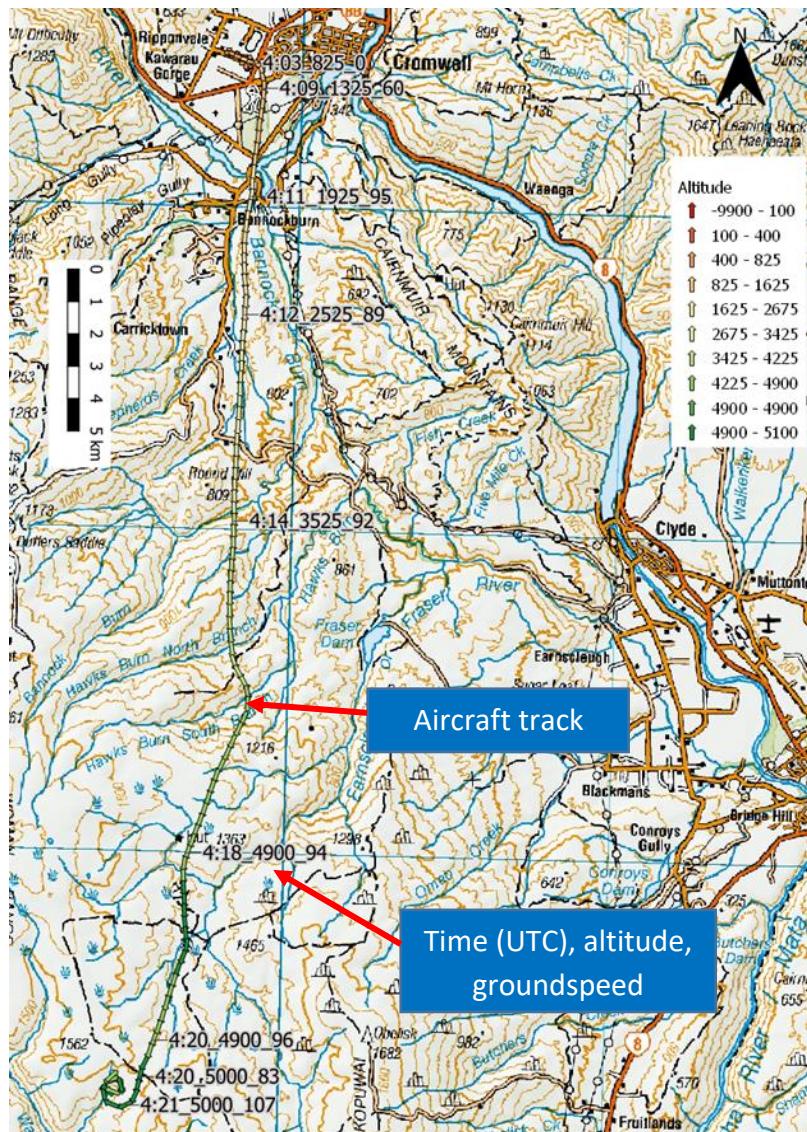
Figure 2 Aircraft ADS-B and MLAT track overlaid on topomap

According to flight track data (refer Figure 2) received from the ADS-B<sup>3</sup> equipment fitted to the aircraft and by an MLAT<sup>4</sup> system operated by Airways, the pilot initially flew in a southerly direction and climbed to 4900 feet above mean sea level (AMSL). After the aircraft passed abeam Clyde it turned to the south-east briefly before turning back towards the south. It tracked towards a saddle between the Old Woman and Old Man Ranges, and after crossing the saddle at 5000 feet AMSL (about 200 feet above terrain) it entered the east branch of the upper Waikaia Valley.

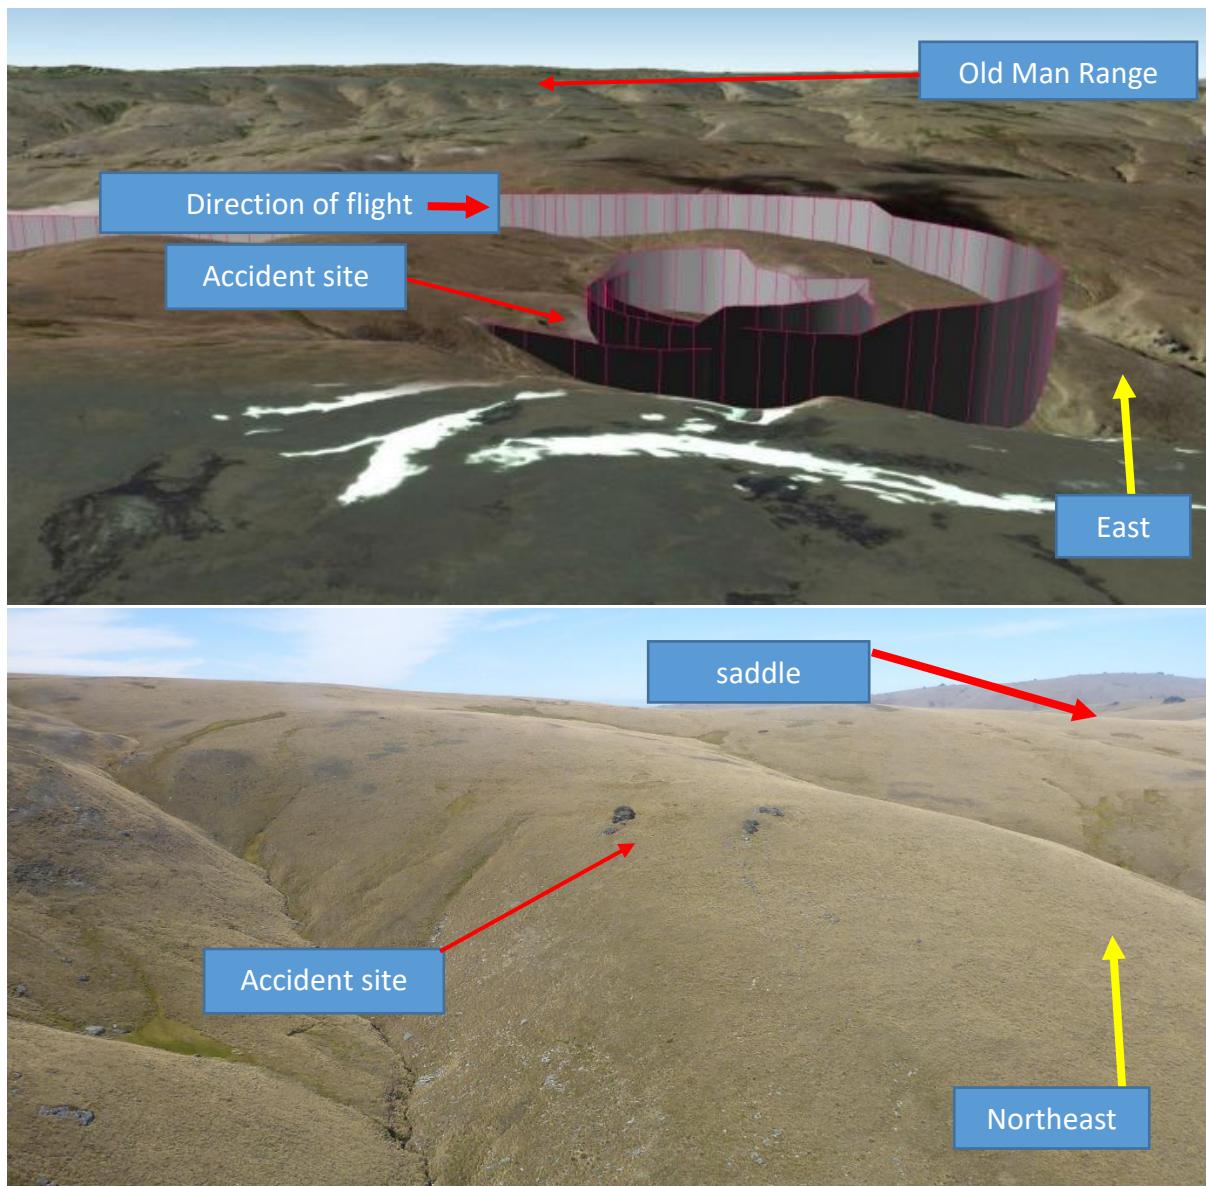
Figure 3 Vertical profile of aircraft orbiting, and location of the accident site (for illustrative purposes)

Shortly after crossing the saddle the aircraft turned to the right, back towards the north and then continued turning in a series of right-hand orbits<sup>5</sup> and descended to 4800 feet AMSL in a valley. After the second orbit and while on an easterly heading, the aircraft struck terrain at high speed in a steep right wing down angle of bank, at an elevation of 4790 feet on the eastern side of the valley (refer Figure 3).

The orbital patterns flown by the pilot progressively moved towards terrain likely due to the southerly wind pushing the aircraft north, and after the second orbit the aircraft struck terrain in a steep angle of bank. This was likely caused by the pilot having reduced visibility due to cloud or rain, and because the pilot could not see the terrain until it was too late to avoid it.

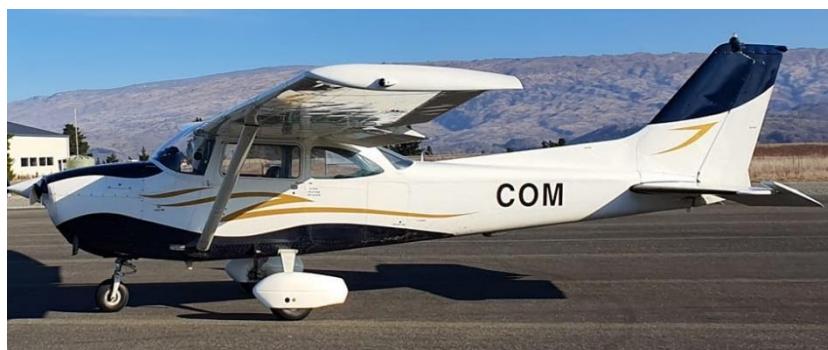
Figure 4 ZK-COM

ZK-COM (refer Figure 4), a Cessna 172G four-seater aircraft, had been owned by the pilot for over twenty years, and since 2019 the aircraft was co-owned by the pilot and a syndicate partner. At the time of the accident the aircraft had accrued about 5757<sup>12</sup> hours total flight time.

The other syndicate partner reported no mechanical issues with the aircraft prior to the accident, and there were no open defects in the aircraft technical log. The engine was inspected at an overhaul facility after the accident, and no pre-existing defects were found that would have prevented normal operation. The propeller displayed typical damage signatures from impacting terrain with significant power being delivered by the engine.

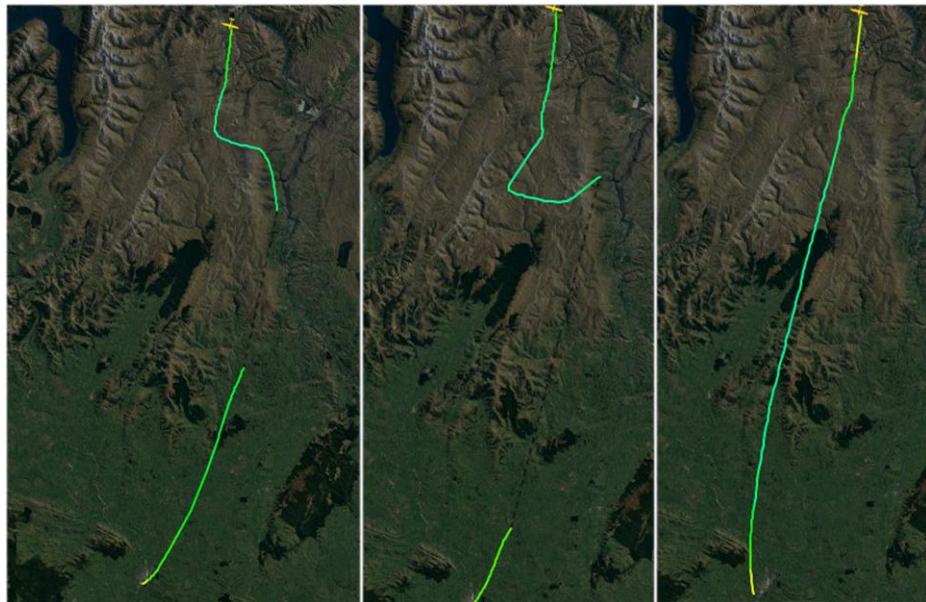
Figure 5 Previous flights

A comparison of three flights in October and November 2020 found that the pilot had carried out two flights from Cromwell to Gore which initially followed the same route towards the Old Man Range, but prior to reaching the upper Waikaia Valley the pilot had turned towards the east and then flown down the Clutha River. A third flight carried out by the pilot followed a direct line between Cromwell and Gore (refer Figure 5).

It is likely that the pilot had encountered adverse weather en route on two of the flights and had diverted around an area of cloud or poor visibility and flown along the Clutha River. The third flight was likely conducted in weather conditions that enabled the pilot to fly directly to the destination.

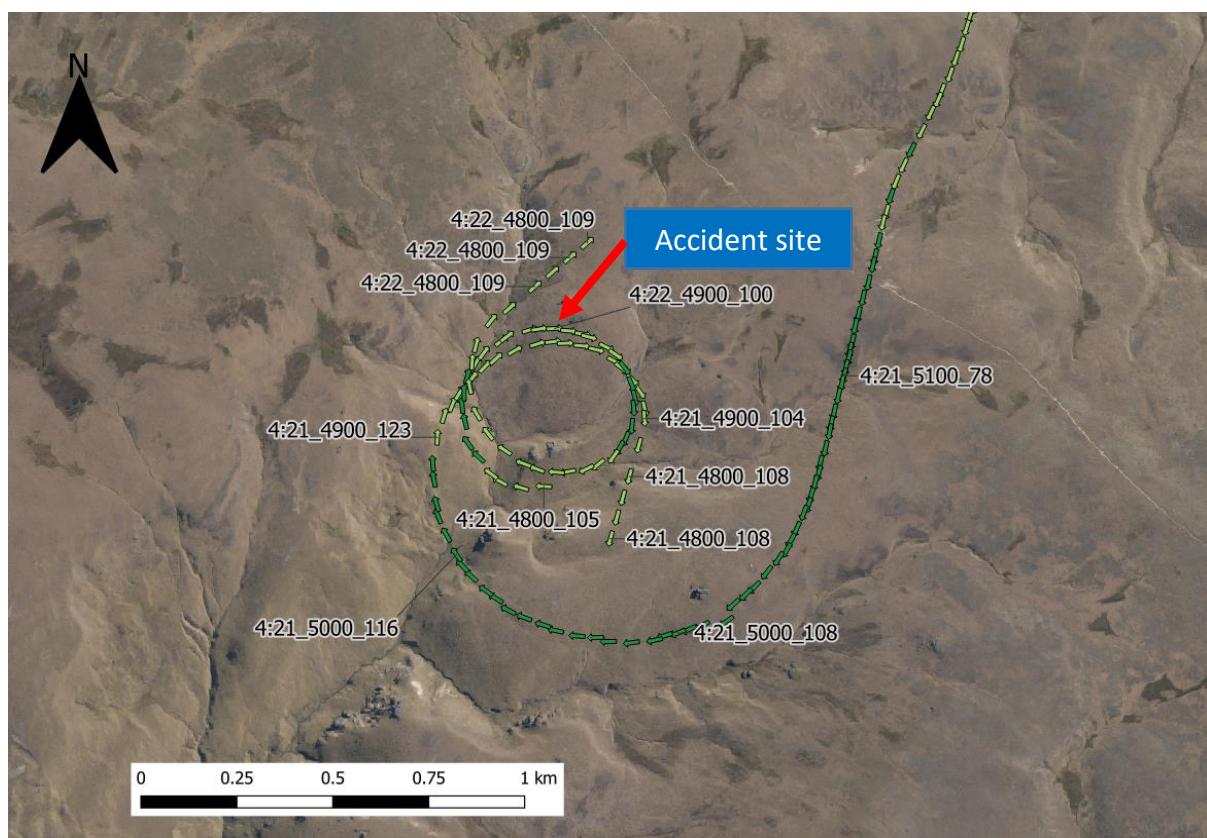
Figure 6 MLAT flight track data; time (UTC) altitude (AMSL) groundspeed (Kts).  
(Straight lines of arrows indicates predicted flight path after a loss of signal)

The last recorded flight tracking datapoint indicated the aircraft was travelling at 109 kts groundspeed just prior to impact with terrain (refer Figure 6). The average<sup>16</sup> airspeed flown during the two orbits carried out immediately before impact was estimated at about 100 kts, and the height varied between 150 to 300 feet above ground. An inspection of the aircraft wreckage established that the aircraft was configured without the flaps extended at the time of the accident.

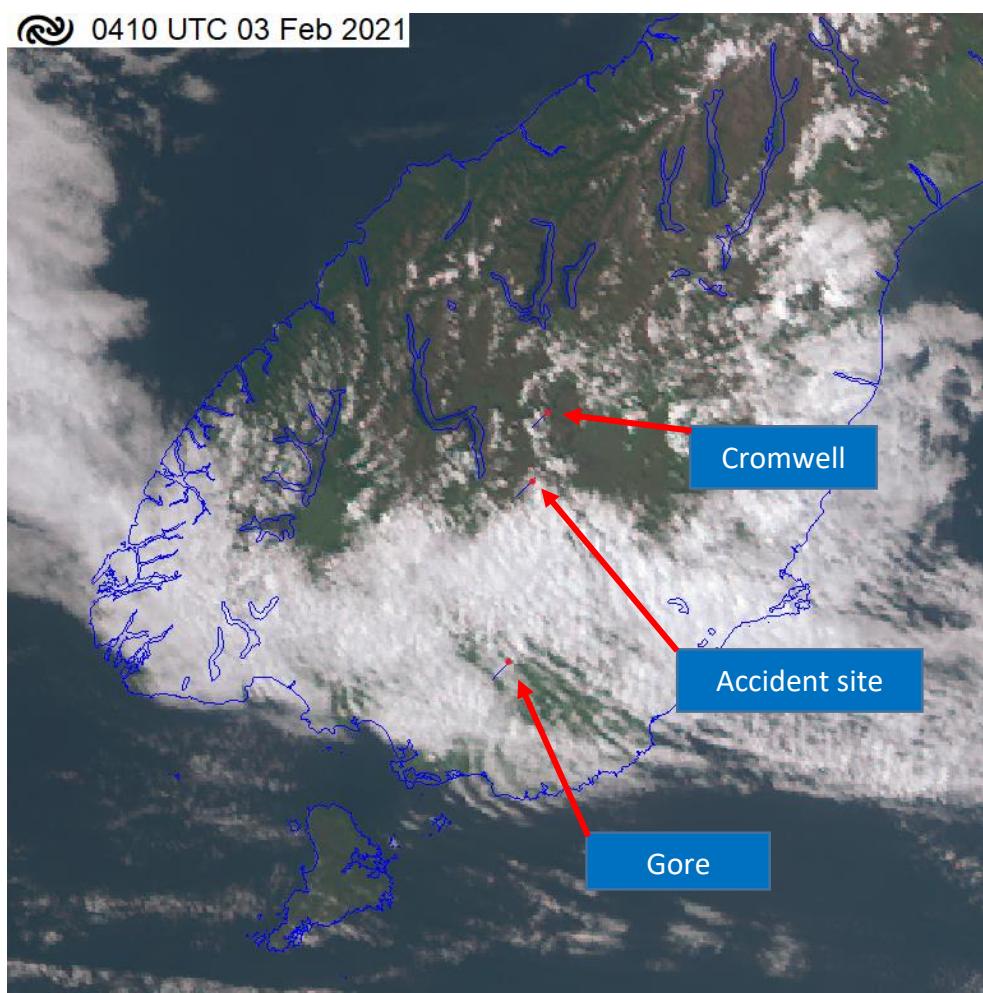
Figure 7 Satellite photo of cloud (image scan captured at 0519 NZDT, four minutes prior to the accident), and locations of the departure, accident site, and destination.

February in the South Island is typically a settled time of year regarding weather patterns, however there are still occasions when frontal systems pass up the lower South Island from the south with associated cloud and rain. The pilot may not have anticipated low cloud along the route on the day of the accident, and the live weather displayed by the farm webcam likely would have showed relatively clear weather near the destination (refer Figure 7), due to a hole in the cloud cover over Gore.

The forecast cloud layer associated with the front situated along the flight route, started at between 1500 and 2500 feet AMSL and the tops were over 10000 feet AMSL. The pilot would not have been able to see past the cloud cover to see what conditions were like behind the front, and the cloud likely extended out to the east and over the lower Clutha River by the time the aircraft reached the Old Man Range.
