CAA OCCURRENCE 22/204

SCHEMPP-HIRTH DISCUS-2b

ZK-GZP

DEPARTURE FROM CONTROLLED FLIGHT

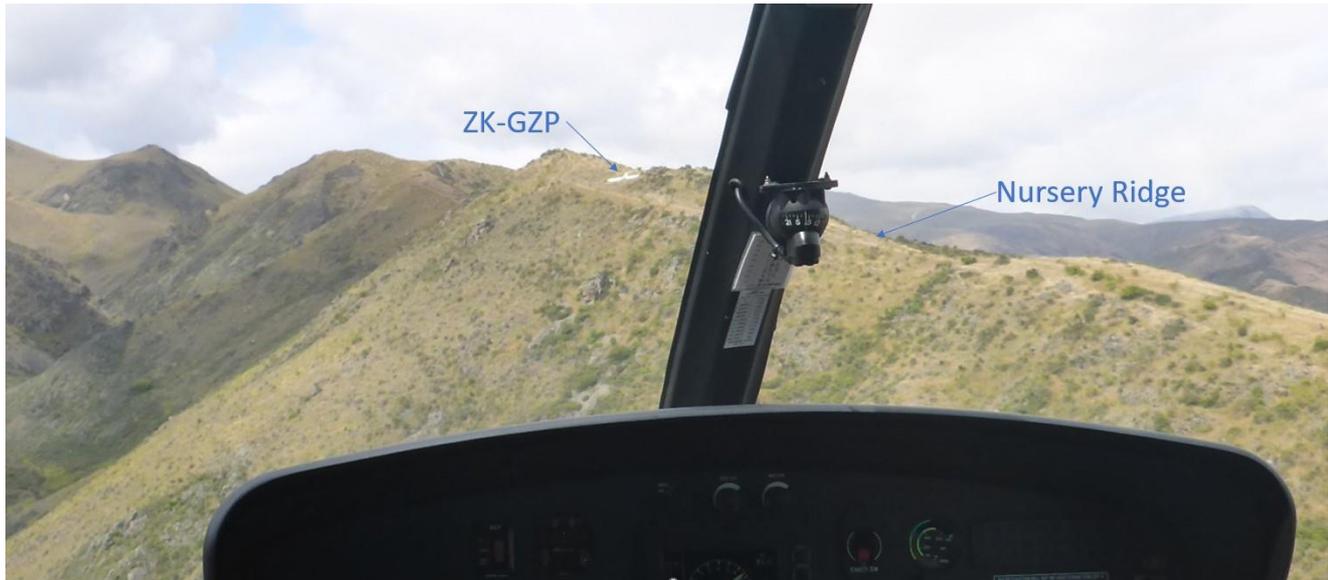
Figure 1: ZK-GZP location on ridge (CAA photo)

- 1.12.1 The accident occurred on the Mount Saint Cuthberts ridgeline which is known by local glider pilots as the 'Nursery Ridge', approximately two nautical miles south-south-west of Omarama aerodrome.

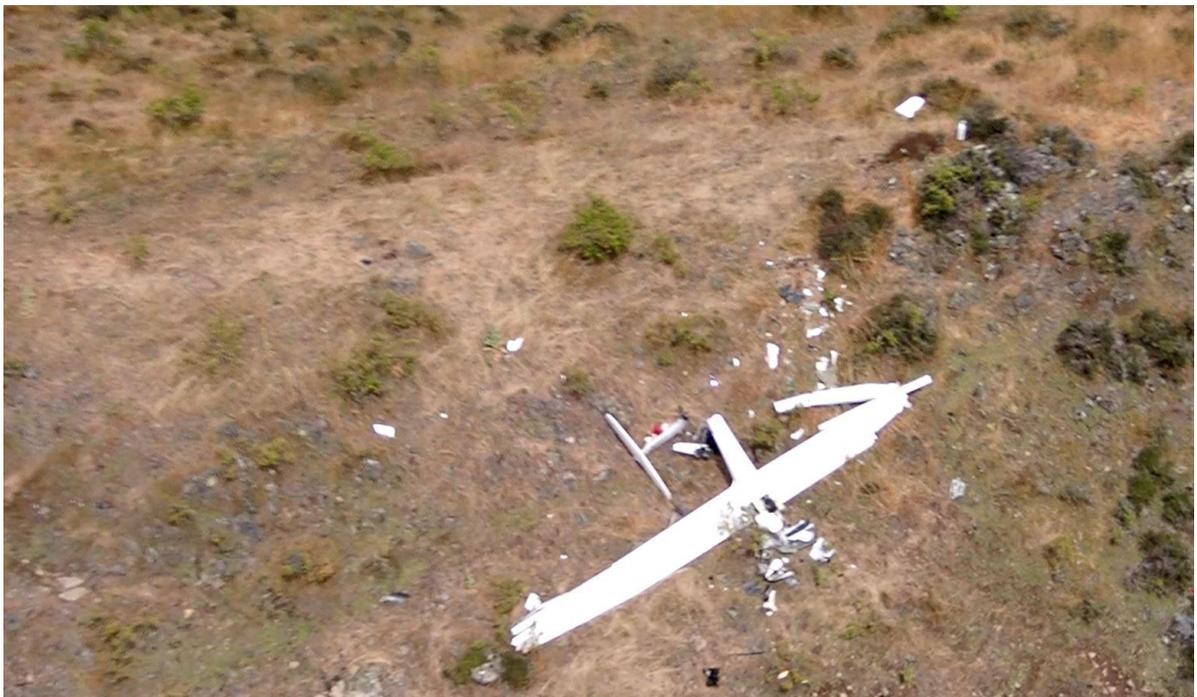
Figure 2: Accident site (CAA photo)

- 1.3.1 The glider fuselage forward of the leading edge of the wings sustained severe damage. The outer sections of the wings also exhibited severe damage from contact with terrain. The aft fuselage fractured immediately forward of the fin, which resulted in a complete separation of the tailplane from the glider.

- 1.12.2 GZP struck the ground in a near vertical attitude, right wing first and slightly inverted. The forward fuselage and cockpit area up to the leading edge of the wings were destroyed. Refer figure 2.
- 1.12.3 Following the initial impact, the glider travelled a further six metres down the slope before coming to rest inverted.

- 1.12.4 All parts of the glider were accounted for at the accident site. Although there was considerable disruption to the control mechanisms and control surfaces due to the impact forces involved in the accident, pre-impact control integrity was established as far as possible. As far as could be determined, all damage was attributed to impact overload failure when the glider struck the ground.

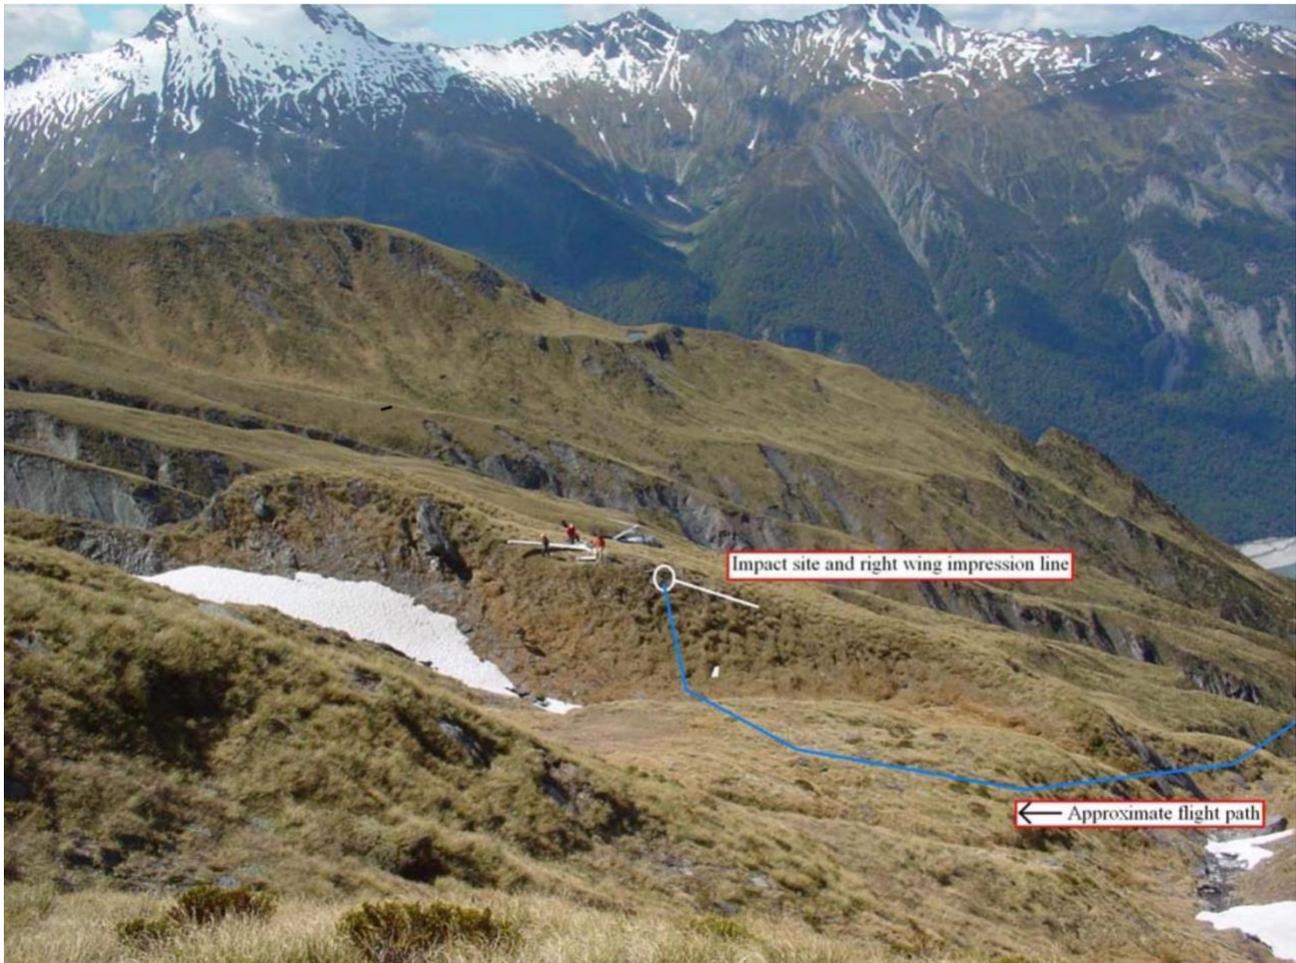
Fig 6: Site of Fatal Crash Near Siberia

Circling above a shallow slope can be particularly dangerous in the mountains. The photo below shows a fatal crash near the Siberia turn point.
