CAA OCCURRENCE 19/8168

CESSNA 172

ZK-SBK

LOSS OF CONTROL - SOLO NIGHT FLIGHT TRAINING

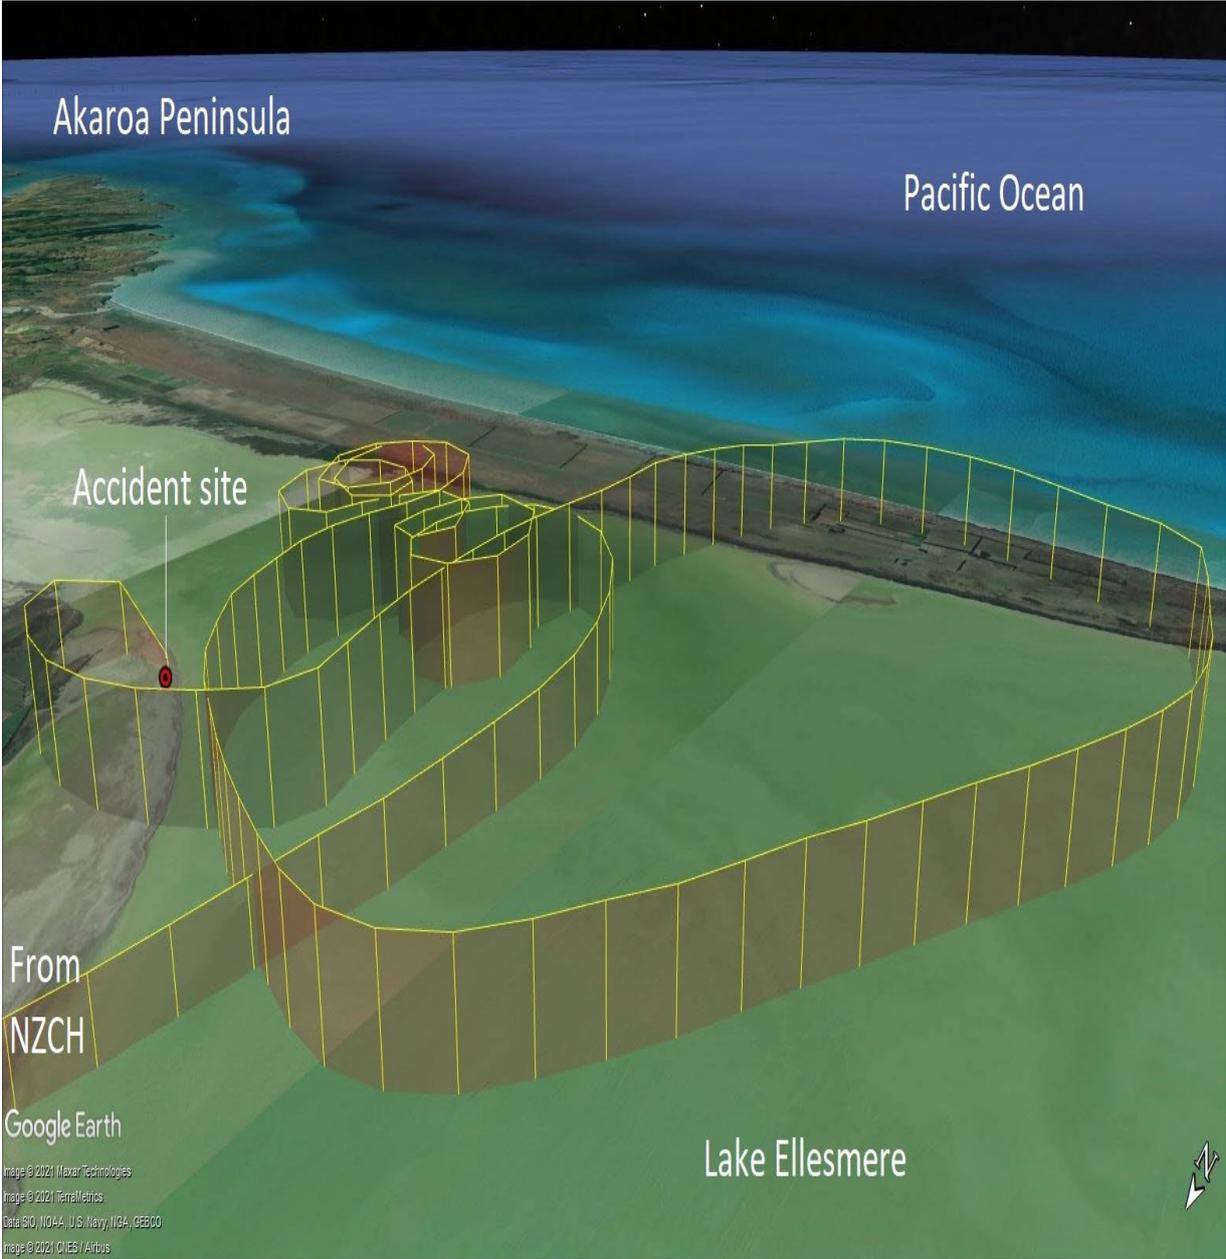
Figure 1. ZK-SBK track while operating over Lake Ellesmere (Google Earth™).

- 1.1.5 The aircraft departed Christchurch aerodrome (NZCH) to the south at 2142 to operate over Lake Ellesmere, where it conducted a series of left and right turns (refer to Figure 1). During the final turn the aircraft departed controlled flight and impacted a sand spit on Lake Ellesmere.
- 1.1.6 The accident occurred at 2216 at 11 feet above mean sea level. Latitude S 43° 46' 9.42", longitude E 172° 32' 24.08".

2.1 After the aircraft was established in the Lake Ellesmere training area it conducted a series of left and right turns. The V2 tracking information showed the first five turns were at angles of bank⁵ (AOB) greater than the training organisation’s night flying procedures recommended. Calculations estimated these AOBs to be between 20 and 30 degrees. The training organisation’s night flying programme teaches, and has pilots demonstrate, their ability to conduct turns up 30⁰ AOB (medium turns). However, students are taught that all night flying turns should be rate one⁶ turns, except in the circuit. A rate one turn generally equates to an AOB of approximately 15 degrees.

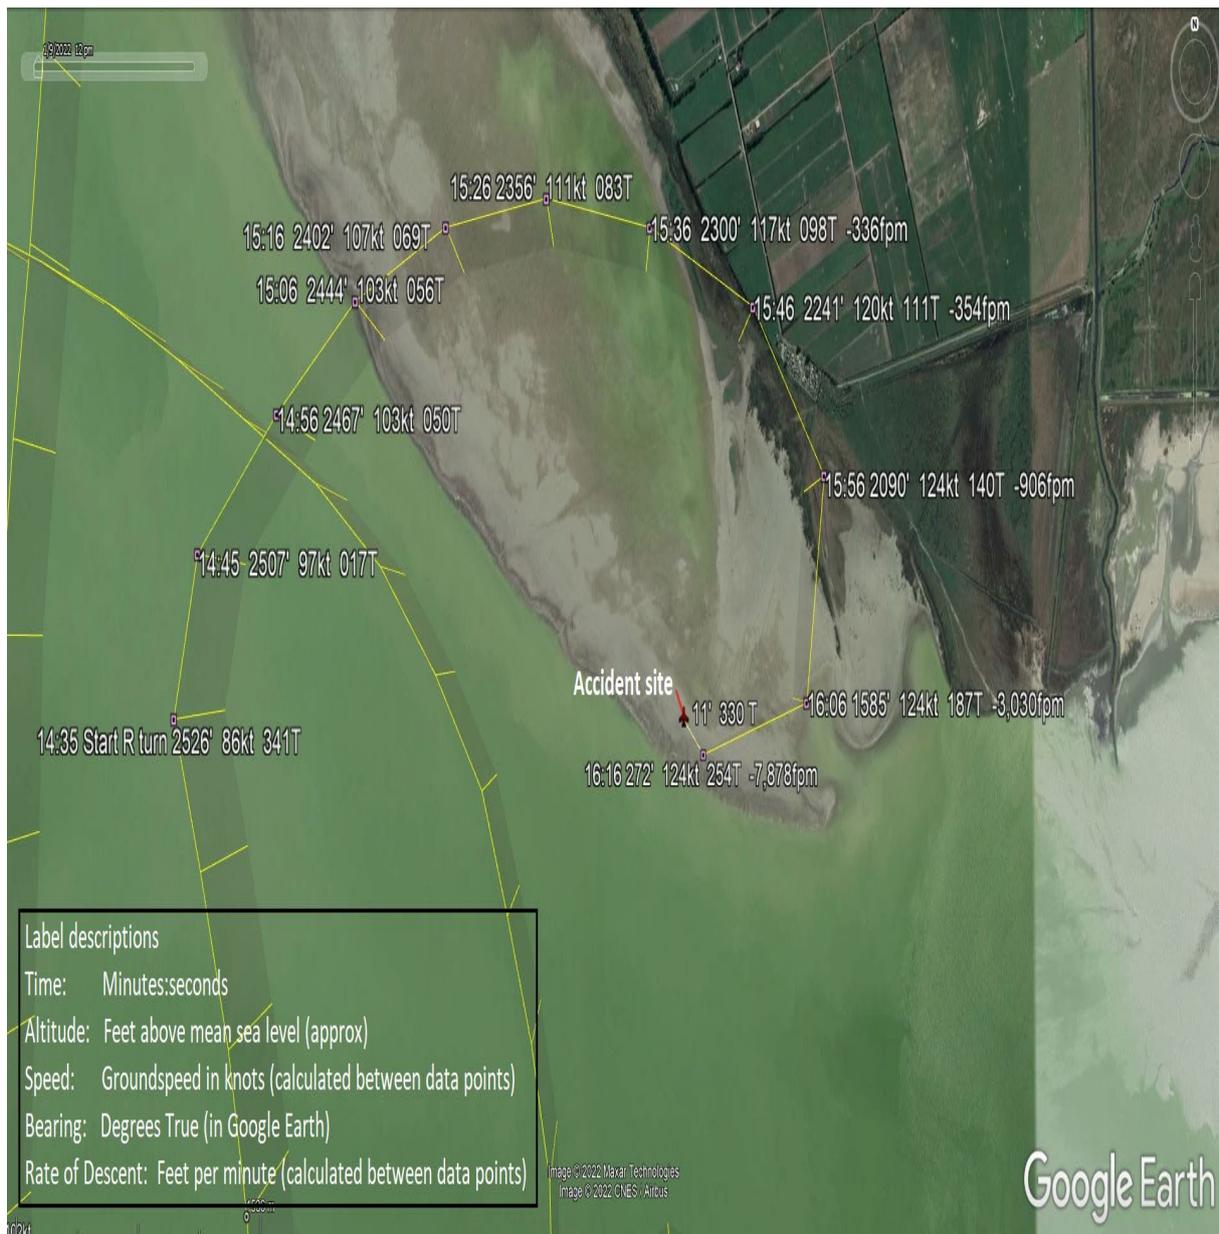
Figure 3. Final turn showing time, altitude, speed, true track and estimated rate of descent (Google Earth™)

- 2.3 The aircraft started losing height as soon as the right turn was begun. During the last 30 seconds, the height loss and change of direction both increased exponentially until the aircraft impacted the sand spit in a steep nose-down spiral turn. The average rate of descent over this time was calculated to be approximately 4500 feet per minute (refer to Figure 3).

- 2.4 The final (right) turn was conducted away from the bright lights of Christchurch city towards the relative darkness of the Akaroa Peninsular and Pacific Ocean in the east. There would be very few significant visual lighting clues for the student to reference during the latter stages of this turn.

2.6 The flight tracking information didn't provide any evidence to suggest the student recognised the situation, or took any action to correct the deteriorating situation.
