**SAFETY INVESTIGATION REPORT**  
**CAA OCCURRENCE NUMBER 13/1524**  
**BEECHCRAFT BARON G58**  
**N254F**  
**DEPARTURE FROM CONTROLLED FLIGHT**  
**31 KM SOUTH-WEST of RAGLAN - TASMAN SEA**  
**30 MARCH 2013**

<b>Aircraft type, serial number and registration:</b>	Beechcraft Baron G58, TH-2169, N254F
<b>Number and type of engines:</b>	Two, Continental IO-550-C
<b>Year of manufacture:</b>	2006
<b>Date and time of accident:</b>	30 March 2013, 12:20 <sup>1</sup> (approximately)
<b>Location:</b>	Tasman Sea, 31 km South-West of Raglan Latitude <sup>2</sup> : S 37° 58.83' Longitude: E 174° 35.07'
<b>Type of flight:</b>	Private, Day IFR
<b>Persons on board:</b>	Crew: 1 Passengers: 1
<b>Injuries:</b>	Crew: 1 (Fatal) Passengers: 1 (Fatal)
<b>Nature of damage:</b>	Aircraft destroyed
<b>Pilot-in-command's licence</b>	Federal Aviation Administration, Private Pilot Certificate.
<b>Pilot-in-command's age</b>	59 Years
<b>Pilot-in-command's total flying experience:</b>	1240.7 Total fixed wing (approximately). 750 Multi-engine fixed wing time (approximately).
<b>Information sources:</b>	Civil Aviation Authority Field Investigation

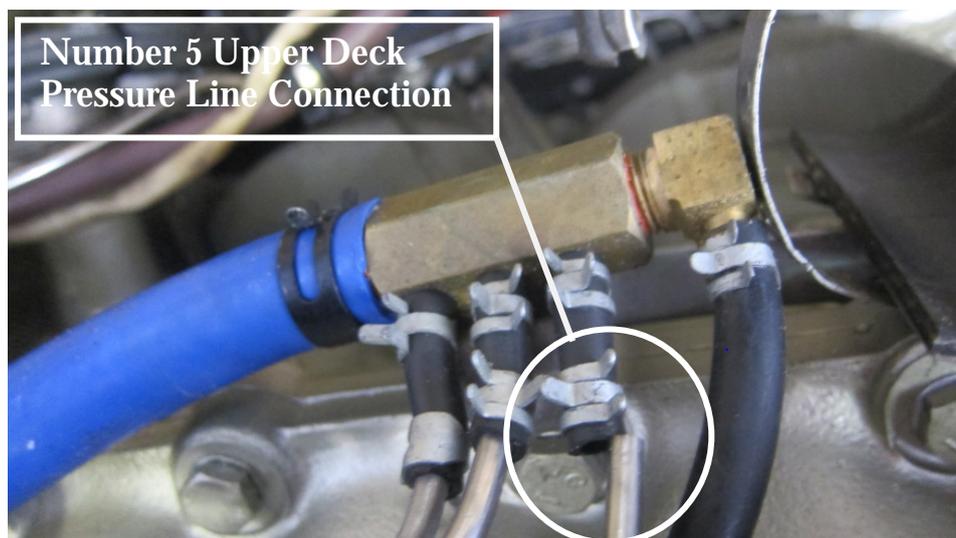
- 1.12.23 During the process of removing the engines from the wreckage, it became evident that the left engine's number 5 upper deck pressure line was dislodged from the upper deck manifold assembly (See Figure 1). When the upper deck pressure line was reinserted into the Viton tubing on the upper deck manifold assembly it could only be inserted a maximum of 4 mm, not sufficient to adequately secure it by the constant tension clamps. Inserting the upper deck pressure line into the Viton tubing until it is past the full width of the constant tension clamps, would achieve the full restraining force available.

- 1.12.24 Further examination revealed an historic impression mark within the Viton tubing, which indicated that the upper deck pressure line had only ever been inserted a maximum of 4 mm.

Figure 1  
Left engine number 5 upper deck pressure line connection.

- 1.12.25 Following this observation the right engine's number 5 upper deck pressure line was checked. It was dislodged. However, following the examination of photographic evidence, it was discovered that the dislodgement occurred during the transfer of the aircraft wreckage from the HMNZS Manawanui to the naval base. This aside, it was noted that the maximum that it could be inserted into the connection on the upper deck manifold assembly was 7 mm; again insufficient to guarantee adequate security.

- 1.16.13 The aircraft engine manufacturer was asked to comment on the effects on the engine’s ability to produce power with a disconnected number 5 upper deck pressure line, despite the fact that these components were an independently manufactured after-market kit installed on the engine. The engine manufacturer communicated that its analytical department had conducted tests on a similar engine where the upper deck pressure line had been intentionally loosened and, at 32 inches of manifold pressure, a noticeable fuel leak was visible at the loosened fitting. They went on to say that ‘at 18,000 [ft] it is very probable that a significant fuel leak might be expected if the reference line is loose or disconnected’.

- 1.16.14 The turbocharger manufacturer also commented on the effects on the engine’s ability to produce power with a disconnected number 5 upper deck pressure line. They stipulated that ‘one cylinder might become too lean to run, but the other 5 would not be effected [sic]. This would cause a slight reduction of power (about 17%), but not a complete loss.’

- The anomaly noted with the number 5 upper deck pressure line connection, on the left engine; and
  - The anomaly noted with the induction inlet ducting, on the left engine.
