AIRCRAFT ACCIDENT REPORT
CAA OCCURRENCE NUMBER 11/829
SCHUTTE SAILS KEA 146 HANG GLIDER
DEPARTURE FROM CONTROLLED FLIGHT
PAEKAKARIKI HILL, WELLINGTON
27 FEBRUARY 2011

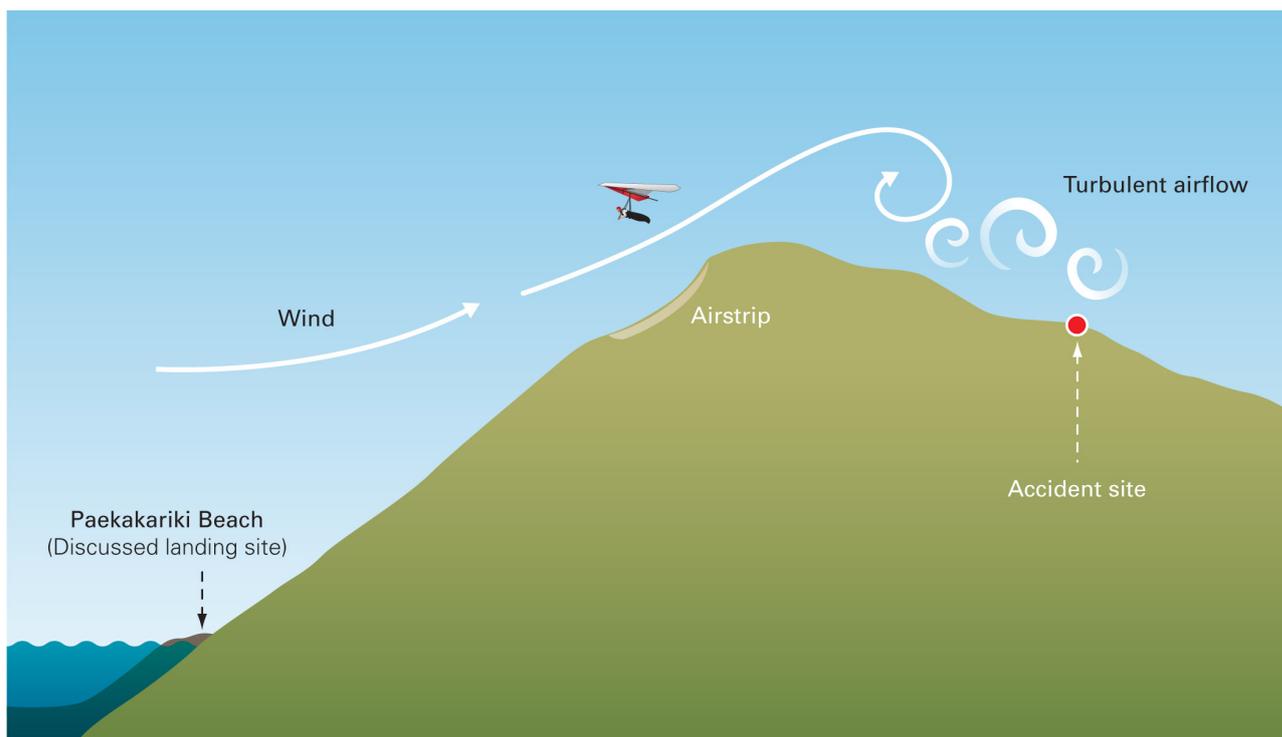
- 1.1.5 On the way up the Paekakariki Hill Road, the pilots stopped at the summit car park, where flying conditions and the location of the landing site (Paekakariki Beach) were discussed. This was the first time the Novice Pilot had flown from this location. They then drove and parked at the end of the airstrip located on the north-western ridge on the Paekakariki Hill. See Figure 1.

Figure 1
 Cross section representation of the Paekakariki Hill area.
 (For illustrative purposes only)

⁵ Rotor wind is a closed eddy that forms in the lee of an obstacle in the airflow, and can be an area of severe turbulence. See Figure 1.

- 2.7 The report commissioned from the MetService of New Zealand indicated that rotor and downwash conditions east of the ridge were probably severe and unpredictable making this area unflyable. For the hang glider to arrive at the accident scene, it would have flown through this area and likely encountered rotor wind and downwash.
