**AIRCRAFT ACCIDENT REPORT**  
**OCCURRENCE NUMBER 02/1167**  
**NZ AEROSPACE FU24-950**  
**ZK-EGO**  
**12 KM SOUTH-SOUTH-EAST OF MASTERTON**  
**19 APRIL 2002**

### OCCURRENCE No 02/1167

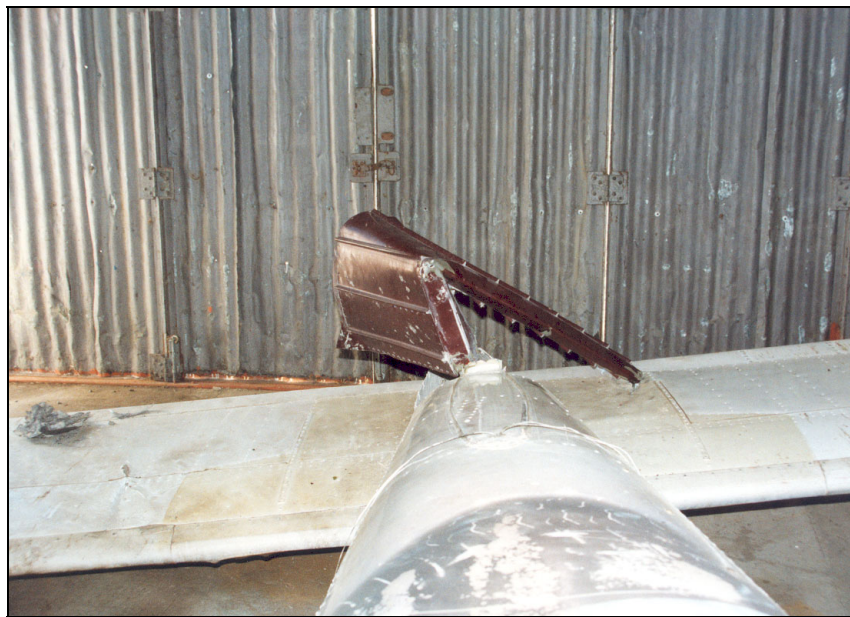
**Figure 3: rudder tip embedded in tailplane**

1.12.7 The rudder, although badly bent, remained attached to its torque tube, the top hinge on the fin having failed as the latter departed. A gash on the upper surface

of the tailplane was found to have been made by the rudder tip, and further experimentation found that the rudder tip had been at some point actually lodged in the tailplane (see Figure 3). This would have restricted elevator travel, but it could not be determined whether this was a momentary phenomenon or it had persisted from the time of the fin failure until ground impact.

- 2.2 The pilot probably found that he had restricted elevator control, with the tip of the rudder jammed into the upper surface of the tailplane, but it is not possible to say whether this persisted until ground impact or the pilot managed to free the restriction. He may have been able to achieve this by a vigorous application of rudder or by a brief, sharp application of down elevator.

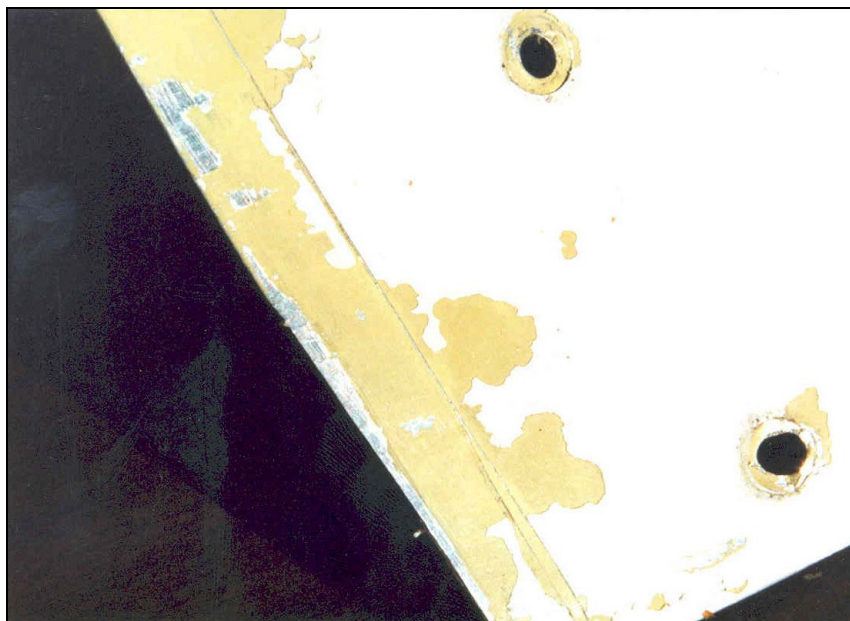
**Figure 4: cut mark on discarded leading edge section**

- 1.16.3 Microscopic examination found that the cracking was due to fatigue, and had originated from an apparent cut or score mark in the outer surface of the skin. The score mark corresponded to the edge of a rubberised protective strip that had been applied to the fin leading edge, and trimmed to accommodate the fairing. The score mark was present along at least 80% of the failure surface, and there was evidence of fretting on the crack surfaces on the left side. This indicated that the crack had been developing over a considerable period of time.

- 1.16.4 It was evident that when the protective leading-edge strip was being applied, it had been trimmed in situ, and the cutting tool used had cut into the metal skin beneath the rubberised strip. The cut had then acted as a stress riser from which the fatigue crack had initiated. The skin was originally 0.020 inches (0.5 mm) in thickness; the cut had penetrated to a depth that ranged from 25 to 30% of the skin thickness.

- 2.8 It was clear that the failure resulted from the propagation of one or more fatigue cracks, which had in turn been initiated by knife cuts in a critical area of the leading edge skin. As the skin in this area is load-bearing and subject to cyclic stresses, the development of fatigue cracks from what could be described as classic examples of stress risers was only a matter of time.

- 1.16.6 As a result of the site investigation, an emergency Airworthiness Directive (AD) was issued on 23 April 2002, effective 26 April 2002, requiring all FU24 aircraft to be inspected within seven days for cracking in the forward area of the base of the fin.
- 1.16.7 In complying with the AD, the operator (of ZK-EGO) discovered similar score marks, without cracks, on the fin leading-edge skins on three other FU24 aircraft (see Figure 4). The aircraft were immediately removed from service and the leading edge sections replaced.

- 4.1 An emergency AD (DCA/FU24/173) was issued by CAA on 23 April 2002, effective 26 April 2002, requiring all FU24 aircraft to be inspected within seven days for cracking in the forward area of the base of the fin. The Civil Aviation Safety Authority (Australia) followed suit with a similar AD effective 1 May 2002.
- 4.2 “Hands-on” education of aircraft engineers and related trades by the CAA Field Safety Advisers was still in progress at the time of publication of this report.
- 4.3 An educational article is to be published in the November/ December 2002 of *Vector* (the CAA’s bi-monthly safety magazine).
