AIRCRAFT ACCIDENT REPORT
OCCURRENCE NUMBER 06/1135
NZ AEROSPACE FU24-950
ZK-EGP
9 KM SOUTH-WEST OF KAITAIA
31 MARCH 2006

AIRCRAFT ACCIDENT REPORT

OCCURRENCE No 06/1135

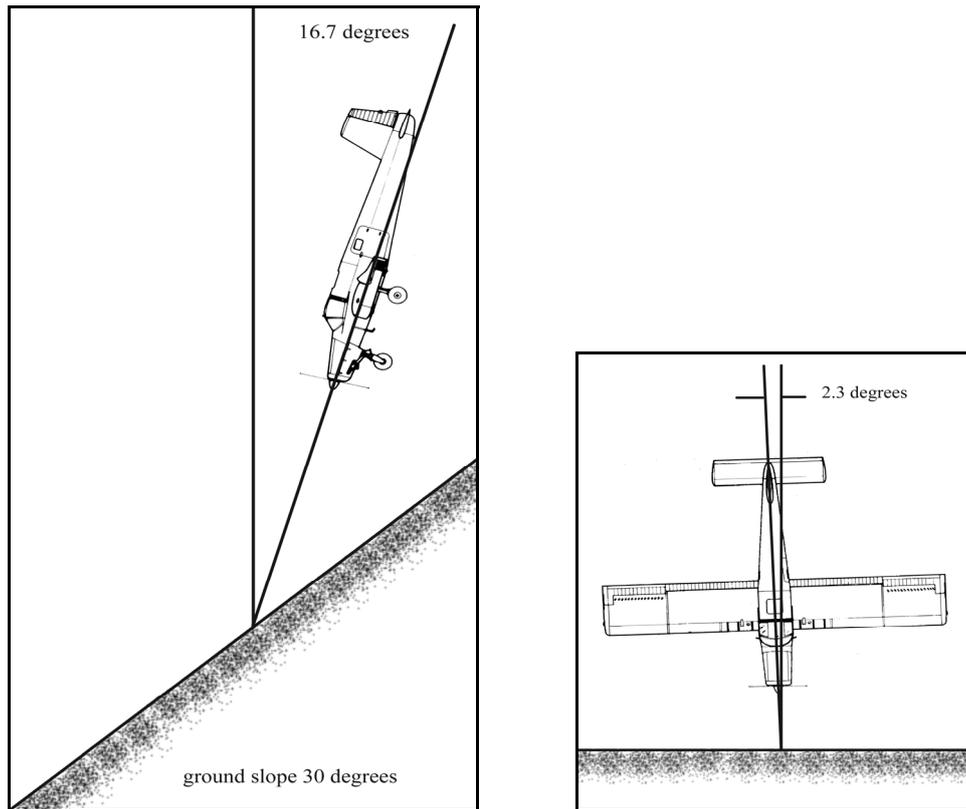
Figure 1. Calculated impact angle

1.12.1 The aircraft had struck downward sloping ground (approximately 30 degree slope) in thick bush, in a steep nose-down attitude facing directly down the slope. The engine was partly embedded in the ground. From the engine position it was determined that the aircraft had struck the ground at an angle of approximately 17 degrees to the vertical and 2 degrees to the right of the centre line (see figure 1). The cockpit had suffered significant longitudinal deformation leaving no occupiable space.
