AIRCRAFT ACCIDENT REPORT
OCCURRENCE NUMBER 04/940
POTEZ AIR FOUGA CM 170 MAGISTER
ZK-FGA
IN THE FIRTH OF THAMES, NEAR KAIAUA TOWNSHIP
19 MARCH 2004

AIRCRAFT ACCIDENT REPORT

OCCURRENCE No 04/940

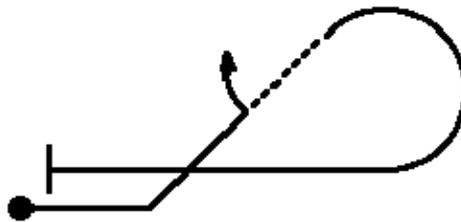
Fig 2

Reverse Half Cuban Eight (illustrative purposes only)

*This figure starts with a pull to a 45 degree up-line. Centred on this line is a half roll from upright to inverted. Five-eighths of a loop completes the figure to horizontal flight.
This is one manoeuvre that can be used to reverse direction while preserving altitude and airspeed.*

- 1.18.3 The witness thought the pilot was a little low to be performing the manoeuvre because the pilot is required to “pull” toward the ground after rolling inverted in the climb, and this would call for careful height management.
- 1.18.4 The information on the low altitude was confirmed when radar return recordings for that flight were viewed and it was found the aircraft had been flown as low as approximately 100-200 feet at speeds greater than 300 knots around Great Barrier Island and the Firth of Thames area.
- 1.18.5 New Zealand Warbirds Association personnel involved in preparing for the Taupo Airshow were not aware that the pilot had conducted any aerobatic manoeuvres that day.
