SAFETY INVESTIGATION REPORT
CAA OCCURRENCE 17/7177
PIPISTREL TAURUS ELECTRO G2
ZK-GEL
BATTERY FIRE AND SUBSEQUENT IN-FLIGHT BREAK-UP
KAIKOHE, NORTHLAND
16 NOVEMBER 2017

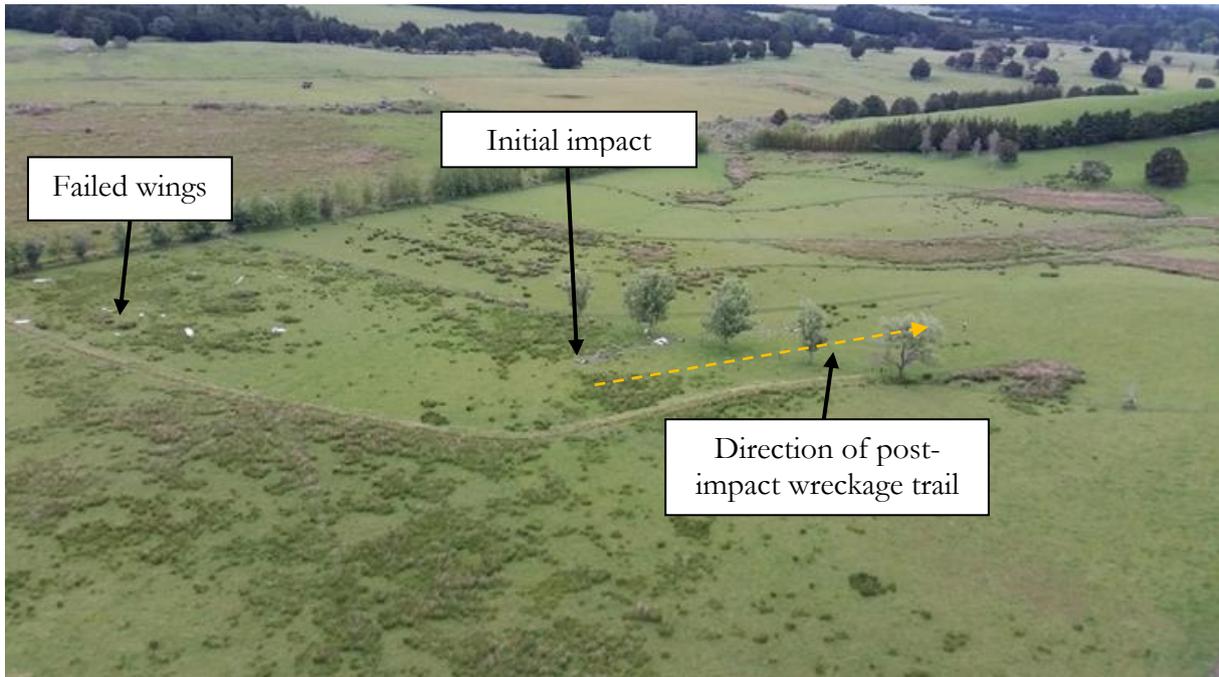
Figure 2: Accident site

1.12.2 The wings and wing spars were located 80 m before the initial impact site indicating an in-flight break up had occurred (see Figure 2).

1.12.3 The glider's fuselage struck the ground on its left side at high speed, with the cockpit area experiencing significant disruption. The debris field extended from the initial impact site approximately 95 m in the direction of travel.

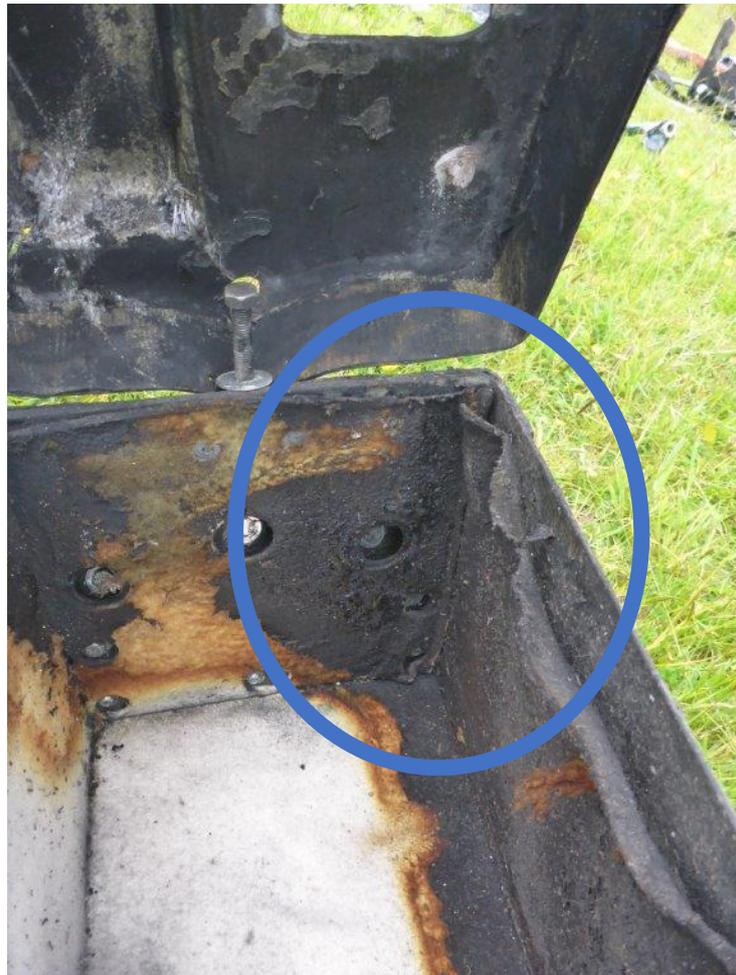
Figure 3: Origin point of the battery fire

1.14.1 During the wreckage examination, evidence of an in-flight fire was identified. The fire appeared to have originated from, and was isolated to, the battery pack located behind the pilot's seat (see Figure 3).

1.14.2 Soot was evident on the leading edge of the wing roots and a section of the plexy canopy. These components were located 80 m before the initial impact site.

1.14.3 The pilot's seat and rudder control cables showed evidence of in-flight heat damage and sooting. These components were separated from the heat source during the impact sequence.

- 2.6 It was not possible to definitively conclude why the batteries experienced a thermal event, which led to the in-flight break-up. However, three possible scenarios are:

- during charging and discharging cycles the pilot did not follow the manufacturer's battery management instructions
 - the batteries were damaged at some stage, possibly during the wheels-up landing

- arcing occurred between battery cells, possibly caused by penetration of one or more of the cells by debris.
- 2.7 It is known that the glider experienced a wheels-up landing in 2017: however, no documentation was provided to the CAA, maintenance provider, or appropriate Part 149 ARO. Consequently, the effect, if any, of the wheels-up landing on the battery packs is unknown. Furthermore, the *Flight manual and Maintenance manual* provides no guidance on what to do if battery damage is suspected. As such CAA Safety Action CAA 21A291 has been raised recommending the glider manufacturer amend the *Flight manual and Maintenance manual* to include guidance on suspected battery damage.

- 4.4 CAA Safety Action CAA 21A292 has been raised for the CAA to recommend that the glider manufacturer amend the *Flight manual and Maintenance manual* to emphasise the possibility and severity of an in-flight battery fire.

- 4.5 CAA Safety Action CAA 21A291 has been raised for the CAA to recommend that the glider manufacturer amend the *Flight manual and Maintenance manual* to include guidance on suspected damaged batteries and the process for having these checked.
