**CAA Safety Investigation Report
Loss of Control During Approach to Land
PZL-Swidnik PW-5 ZK-GPE
Tauranga Aerodrome
01 May 2016**

Executive summary

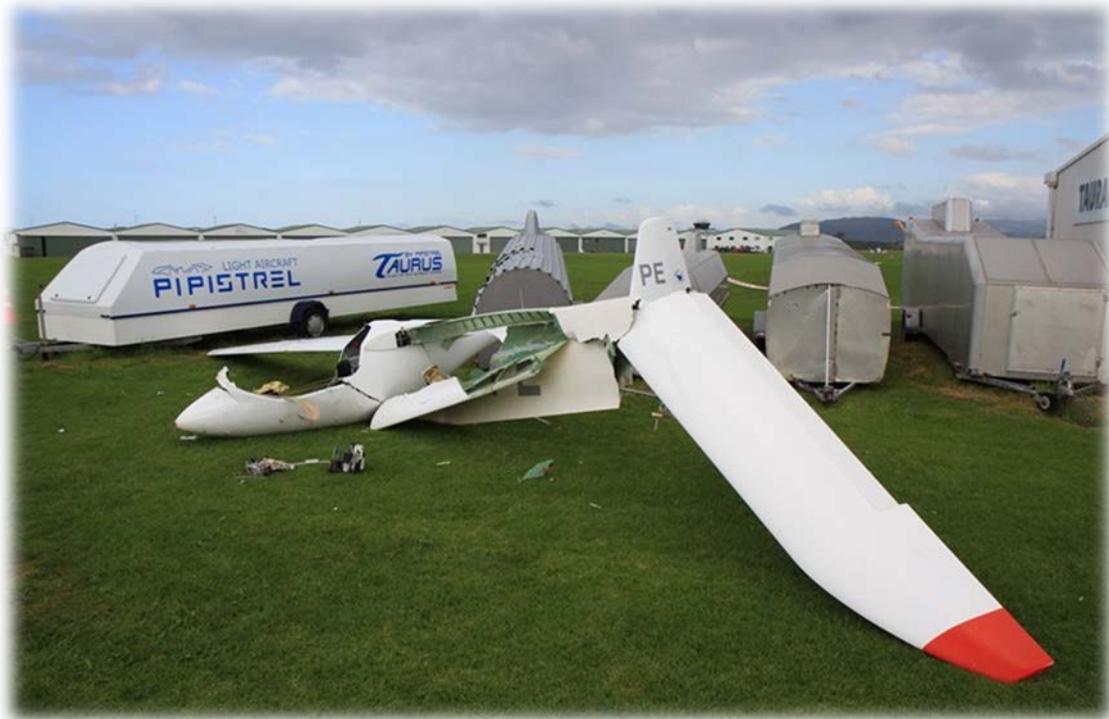
Figure 1: Accident site (CAA photo)

Witness marks and damage to the glider and glider trailers at the accident site, indicate that the glider was in a nose low, left wing down attitude with rotation to the left when it struck the ground.

The glider struck the ground in a steep nose low and left wing down attitude while rotating to the left. The glider also struck two glider trailers which were parked at the end of the gliding club hangar.

Witness marks on one of the glider trailers and the glider itself, indicate that the cockpit area of the glider came into contact with the chassis of one of the glider trailers which caused major disruption to the right side of the glider's cockpit.
