# Wing separation during winch launch

## 18 February 2024

### ZK-GRR LAK-12 glider

### Lake Station Aerodrome

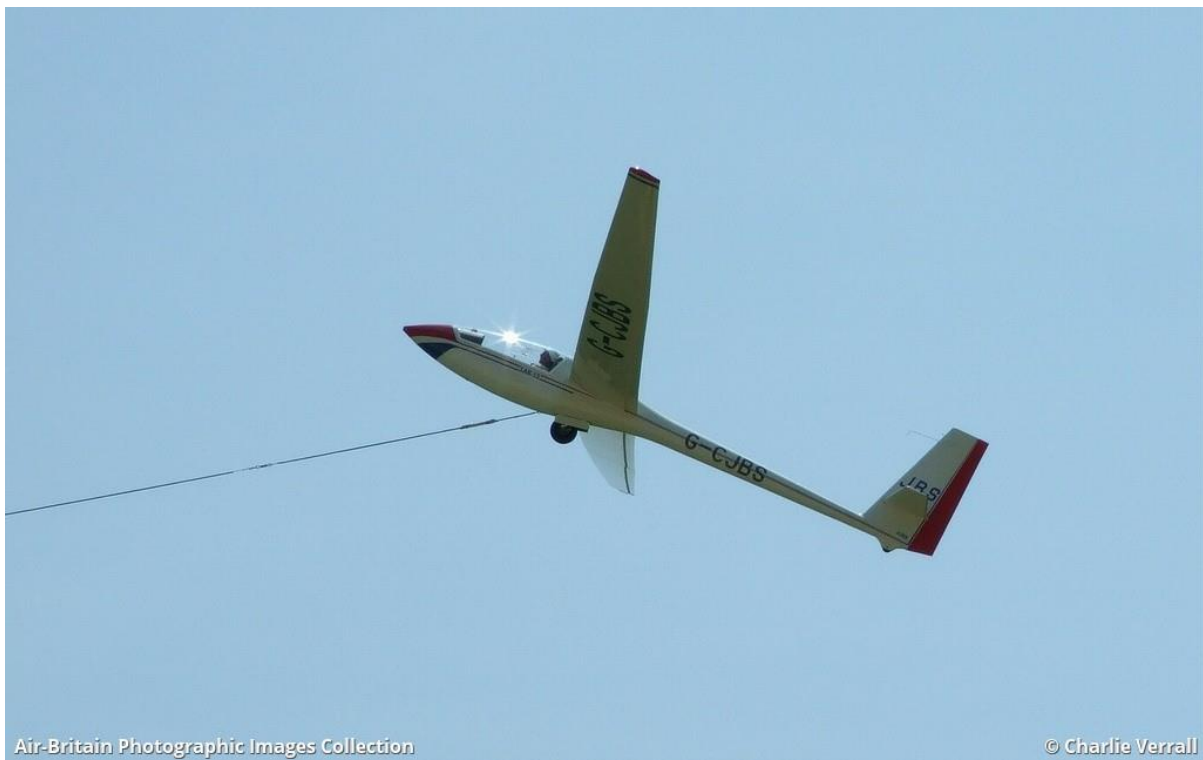
General photo of a LAK-12 under winch launch showing cable weak link - photo with permission of Mr Charlie Verrall

A winch launch will increase the G load on a glider's wings rapidly. The G load will rise slowly at first but increase rapidly as the glider gains height and the angle of the tow line steepens (see figure 6). To safeguard against the towing operation from exceeding a glider's wing G load limit, all winch cables have a 'weak link' connected between the end of the winch cable and the glider. The weak link is designed to deliberately fail well before a glider's G limits are reached (refer to cover picture).

In this accident, the weak link did not break or even deform during the winch-tow sequence, thereby indicating the right wing failed at a much lower G loading value than that of the weak link.

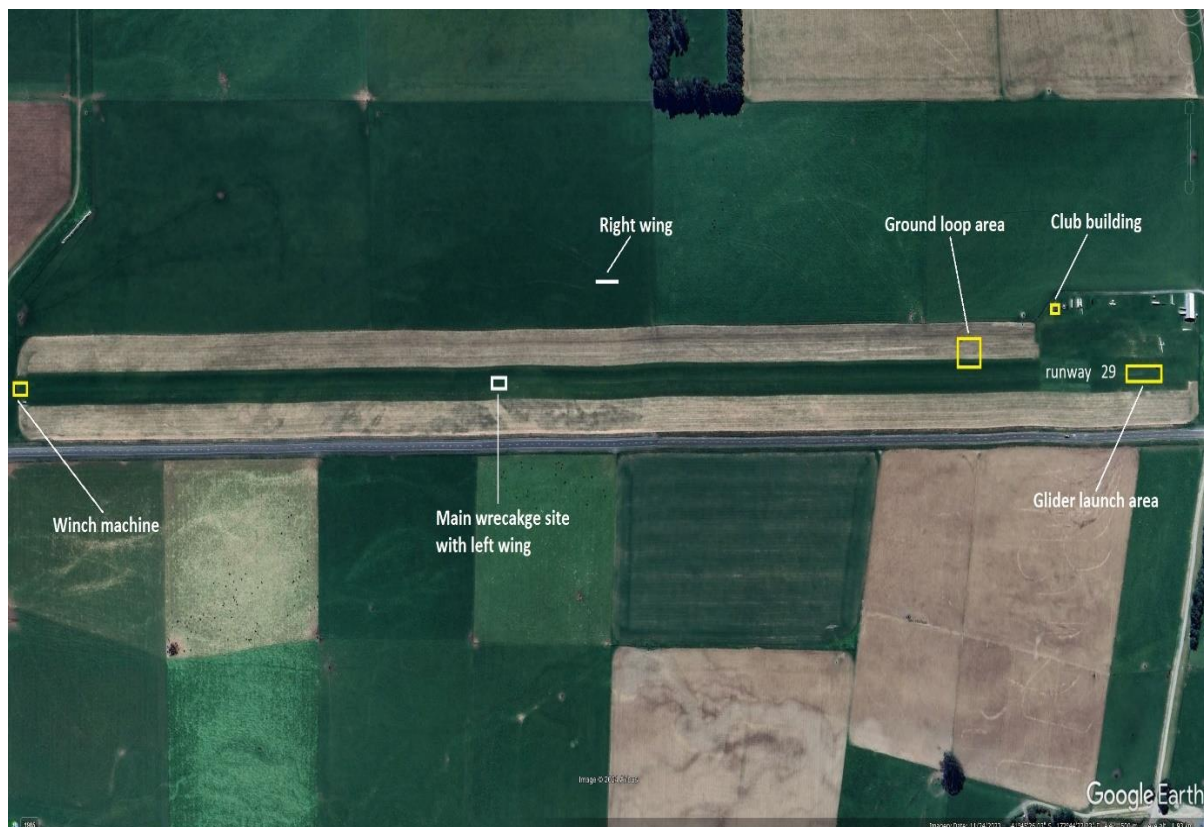
The glider then rapidly descended and struck the ground in a steep nose-down attitude. It was destroyed on impact and the pilot did not survive. The right wing landed separately in an adjoining farm paddock (see figure one).

Figure 1. Runway 29, with winch, launch start and accident site positions, and previous days ground loop area

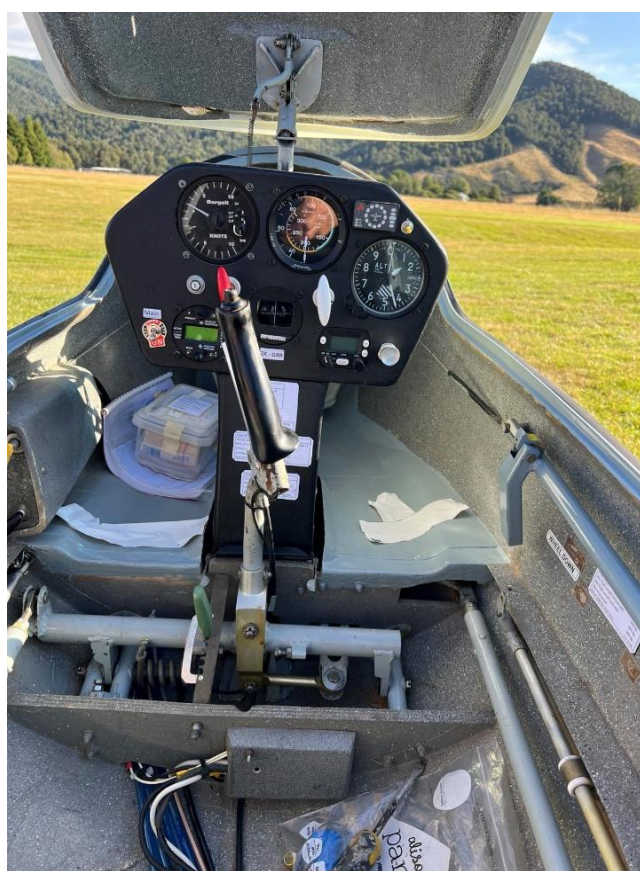
Figure 2. Photo showing GRR left offset control column hand grip.

This means if the hand grip is held vertically, an unwary pilot will inadvertently be applying right turn aileron inputs.

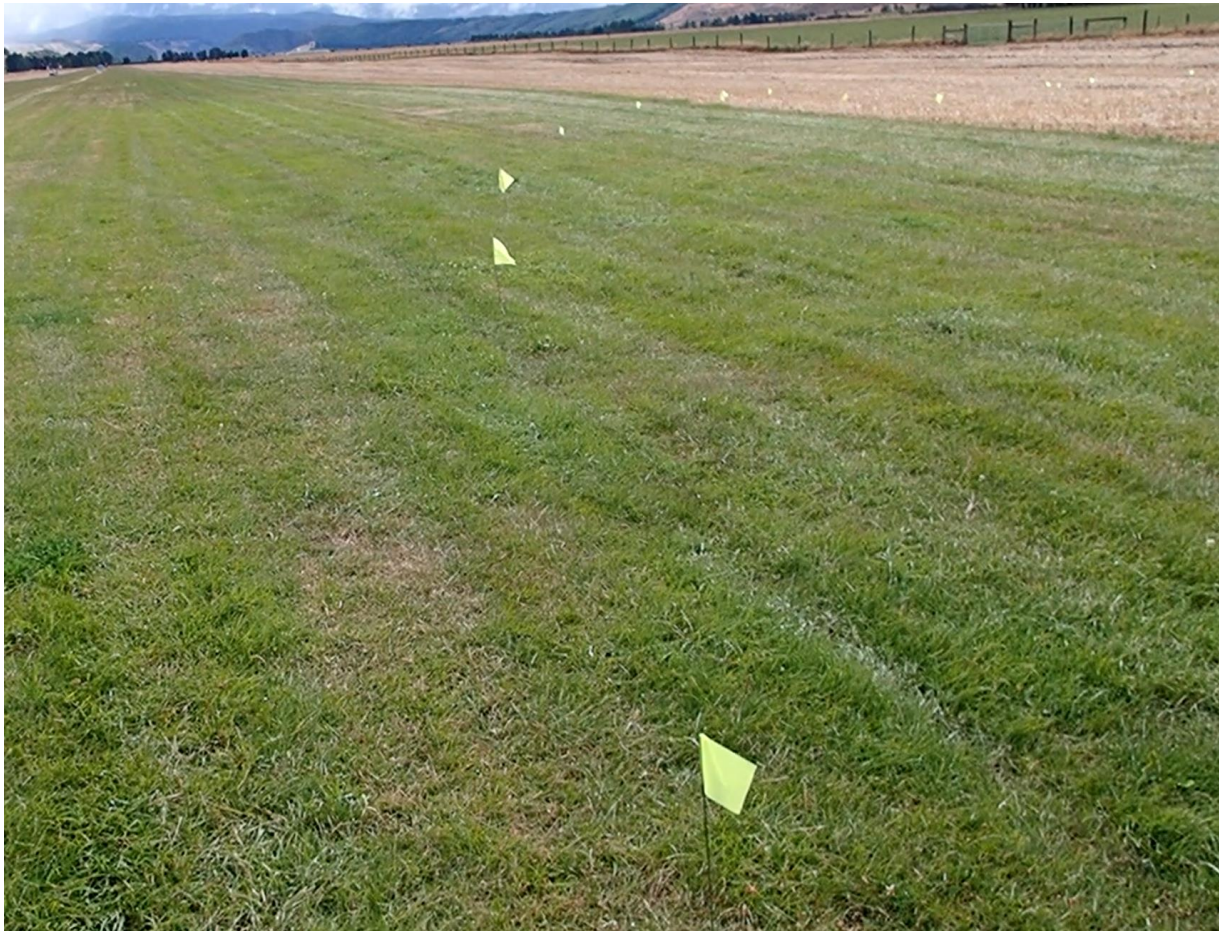
The witness recalled seeing the glider land and bounce then do a rapid right turn, coming to rest in rough ground, facing the opposite direction. The witness added that the time from landing to stopping was approximately five seconds.

The witness showed the police the landing area and they marked and mapped the site as relevant evidence on the day of the accident (see figure 3).

*Figure 3. The ground loop markings from the grass runway on to adjoining rough area*

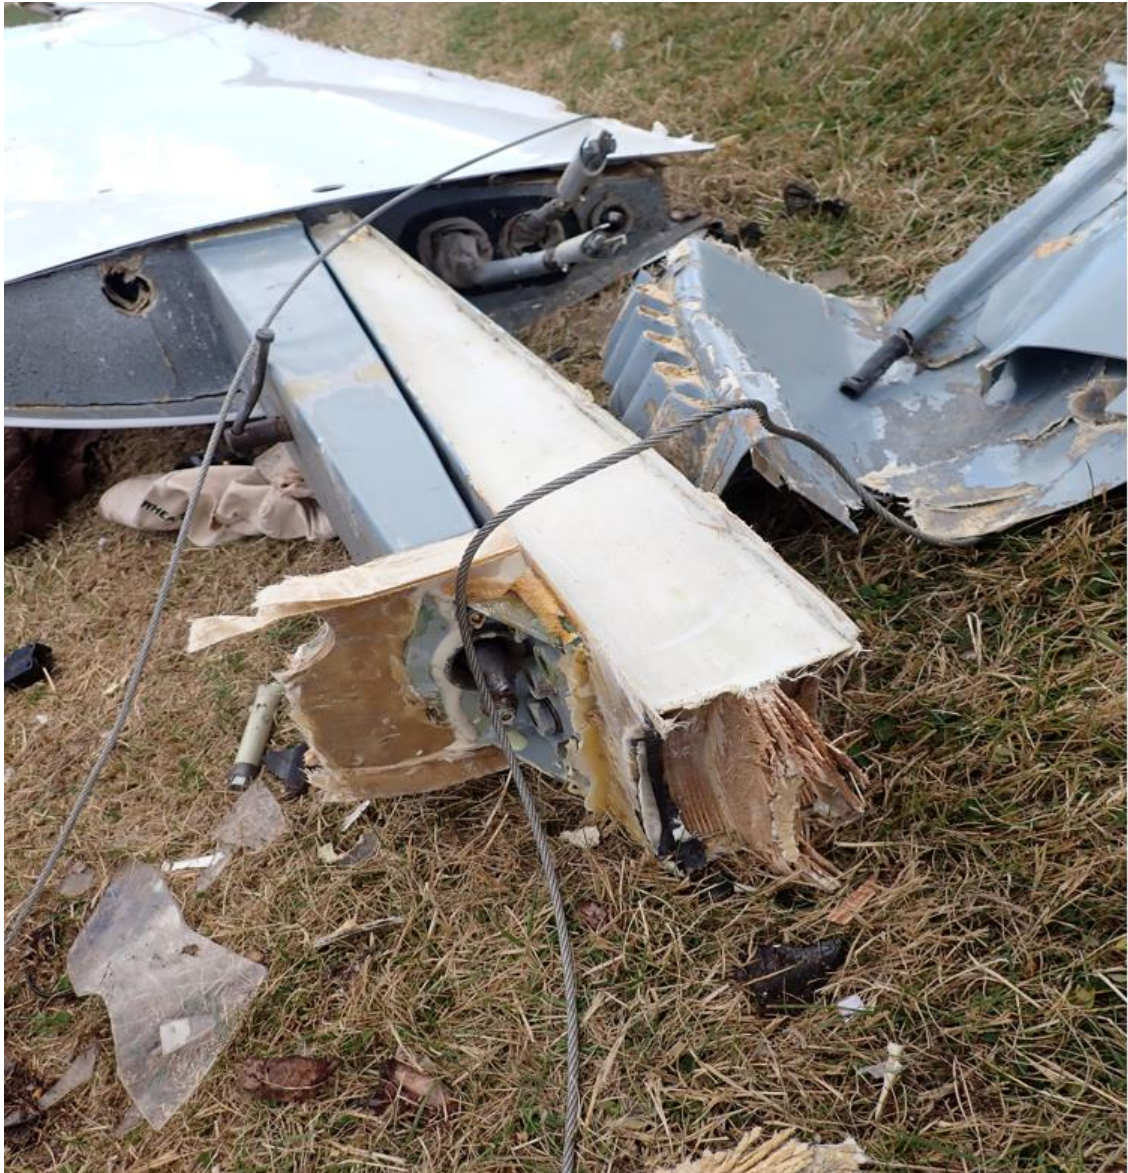
The area of the wing where the separation occurred was carefully examined at the accident site. It was noted that the wing locking mechanisms were still correctly in position (see figure 4), thus eliminating incorrect assembly of the glider as a contributing factor.

An independent engineering consultant was later engaged to examine the wing failure area. The inspection concluded that unseen internal damage and delamination probably initiated or contributed to the sudden catastrophic failure of the right wing. This information reinforced the probable link to the heavy landing and ground loop events the evening before, as described by the only available witness.

The glider manufacturer was also contacted, and they confirmed that this type of failure could happen after a heavy landing scenario (refer figures 4 and 5).

*Figure 4. Right wing failure area and wing spar connections pins still in position (fuselage was in the middle section)*

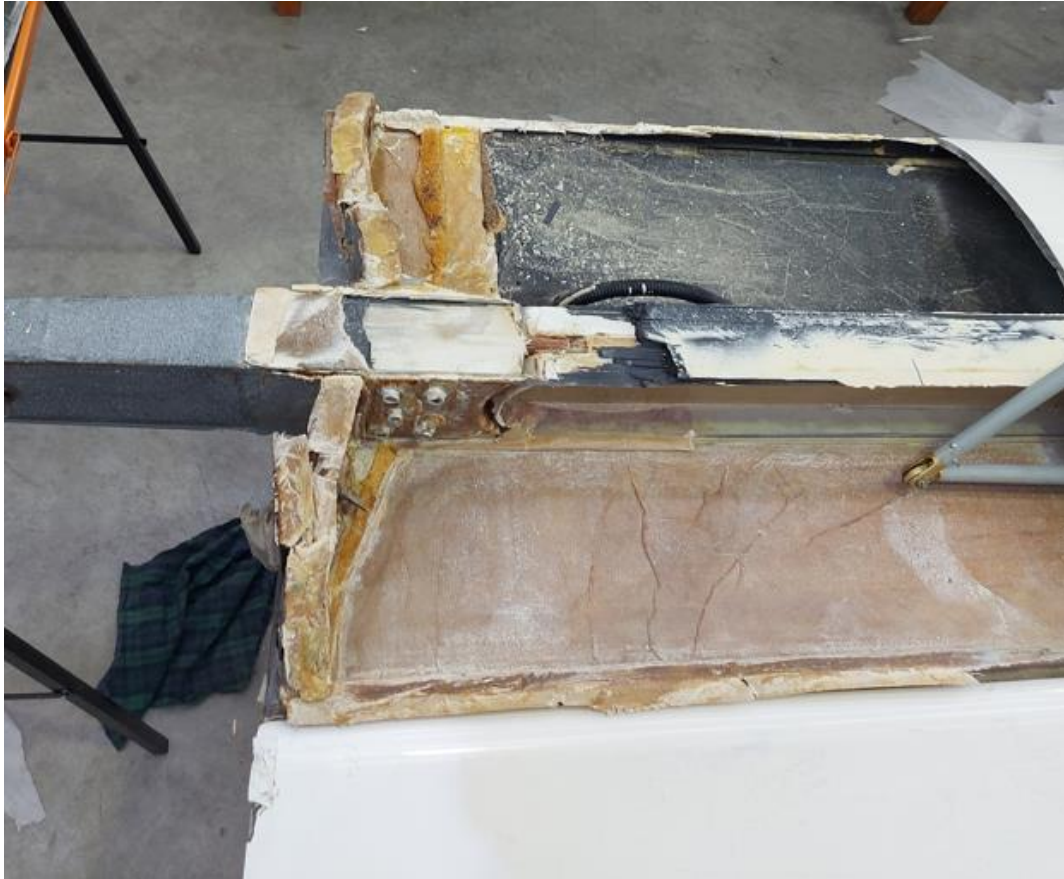
*Figure 5. Right-wing failure area (right of four bolts) with spar and wing repositioned for this photo.*

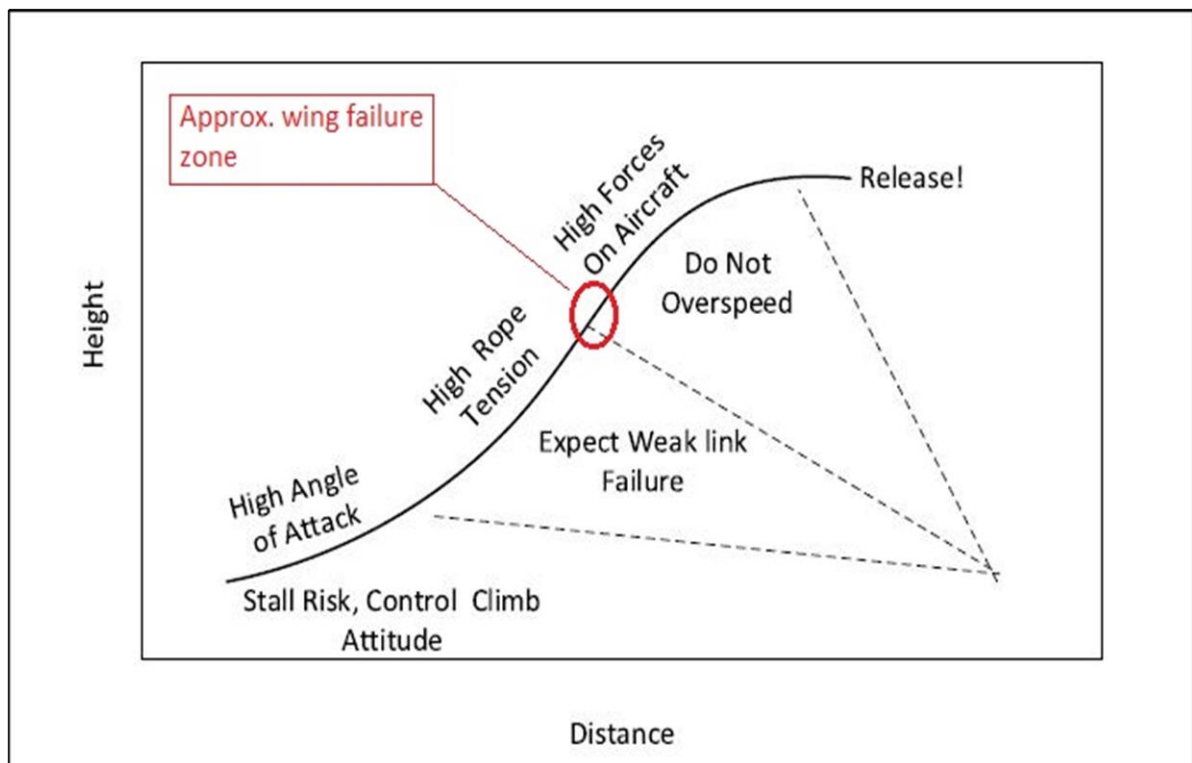
Figure 6. Winch launch loading graph with approximate indication where wing separated.
