AIRCRAFT ACCIDENT REPORT
OCCURRENCE NUMBER 00/315
AEROSPATIALE AS 350 D HELICOPTER
ZK-HKV
TAPORA, NORTHLAND
10 FEBRUARY 2000

AIRCRAFT ACCIDENT REPORT

OCCURRENCE No. 00/315

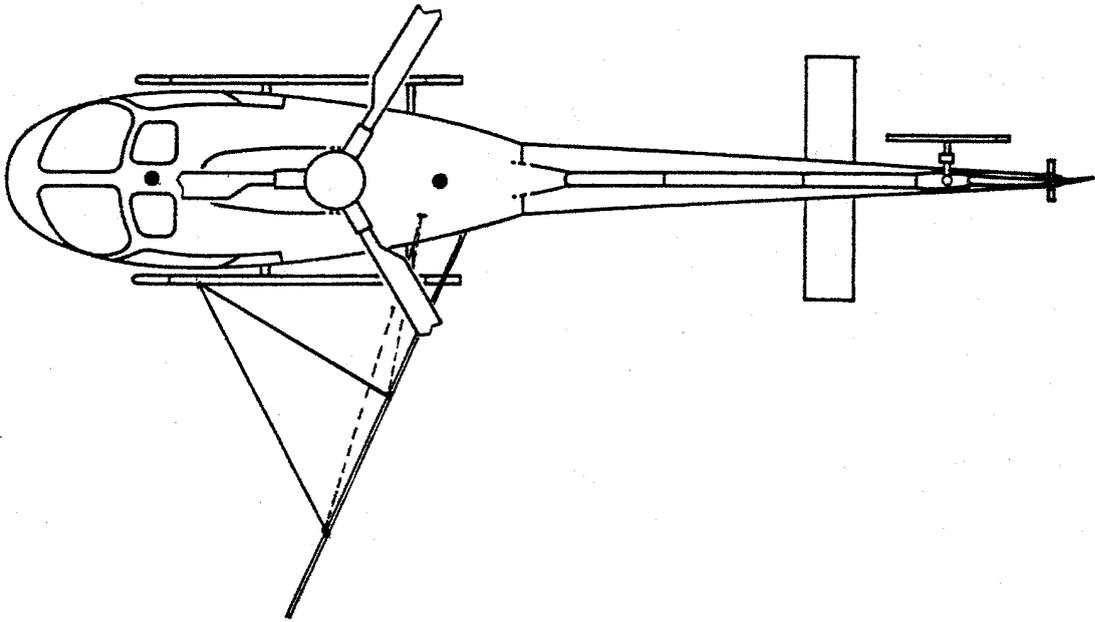
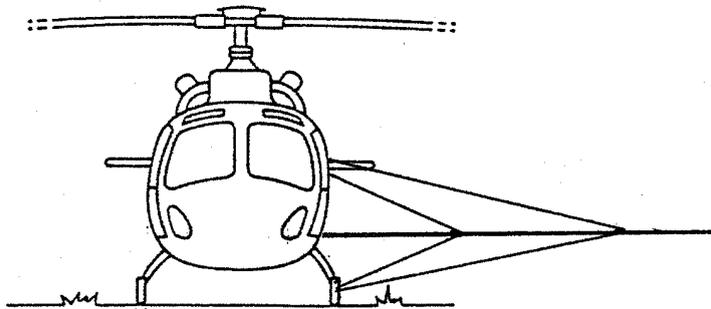
**Diagram 1: Spray equipment configuration as approved
(Only one side shown for clarity)**

- 1.6.4 When the modification drawings were examined, it was found that the boom and support strut configuration at the time of the accident differed from that depicted. The drawings called for two support struts and two drag braces on each boom, but as described in paragraph 1.1.2, there was only one of each fitted. See Diagrams 1 and 2.

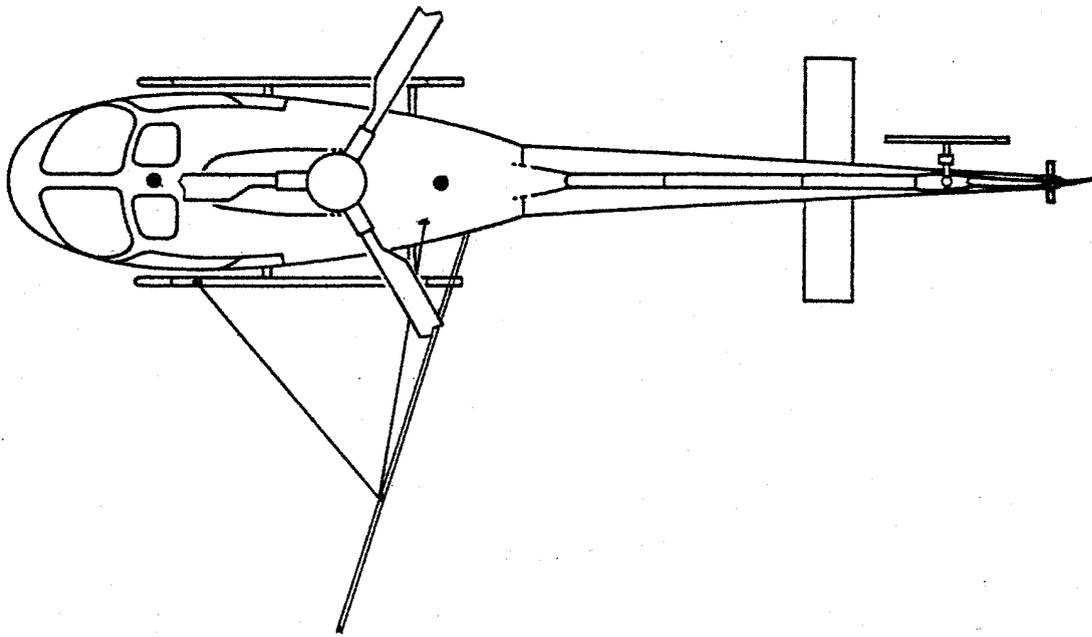
Diagram 2: Changed spray equipment configuration

- 1.6.5 The spray booms had been supplied new in 1999, complete with the two pairs of struts per side. These replaced the original set, which was of lighter construction, the braces being of aluminium alloy rather than the stainless steel of the replacement set. It was found that, with the new equipment installed, the loader’s access to the spray tanks was severely impeded, so the booms were reconfigured to one pair of braces per side. This occurred about the end of September 1999 and was done without the knowledge of the company’s chief pilot or the engineering staff.

- 2.2 The reconfiguring of the spray equipment undoubtedly made the loader's task easier, but the relocation of the support points on the booms meant that either boom would have been more susceptible to fatigue failure. The longer unsupported outboard section would be more prone to flexure and possibly subject to loadings outside the design criteria. Although this was not a factor that contributed to this accident, it serves to illustrate the possible consequences of departure from design specifications.

- 3.3 The spray equipment configuration had been modified from the original design without the knowledge of the operator, but this was not a factor contributing to the accident..
