AIRCRAFT ACCIDENT REPORT
OCCURRENCE NUMBER 06/633
ROBINSON HELICOPTER R22 BETA II
ZK-HLC
22 NM North-West of WANAKA
5 MARCH 2006

AIRCRAFT ACCIDENT REPORT

CAA OCCURRENCE No. 06/633

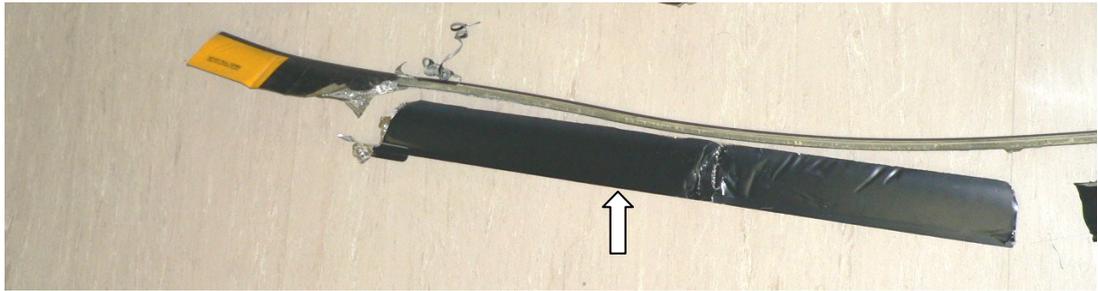
1.12.5 The mid-section of one of the two main rotor blades was located on steep terrain 1000 feet below and half a nautical mile from the accident site (see Figure 1). The left cabin door was located in close proximity to the mid section of the rotor blade. Approximately a quarter of the distance between the location of the mid section of main rotor blade and the impact site were small sections of Perspex.

Figure 1
Recovered main rotor blade mid-section (arrowed).

- 2.3 The discovery of the missing main rotor blade mid-section, the left cabin door and pieces of Perspex some distance from the main wreckage area, indicates that an in-flight break up occurred at least half a nautical mile before the impact point.

- 2.4 As the left cabin door and main rotor blade mid-section were located 1000 feet below the ground impact point on a steep ridge face, they are likely to have fallen at least 1500 feet given the probable descent rate and angle of the helicopter after the door separation.

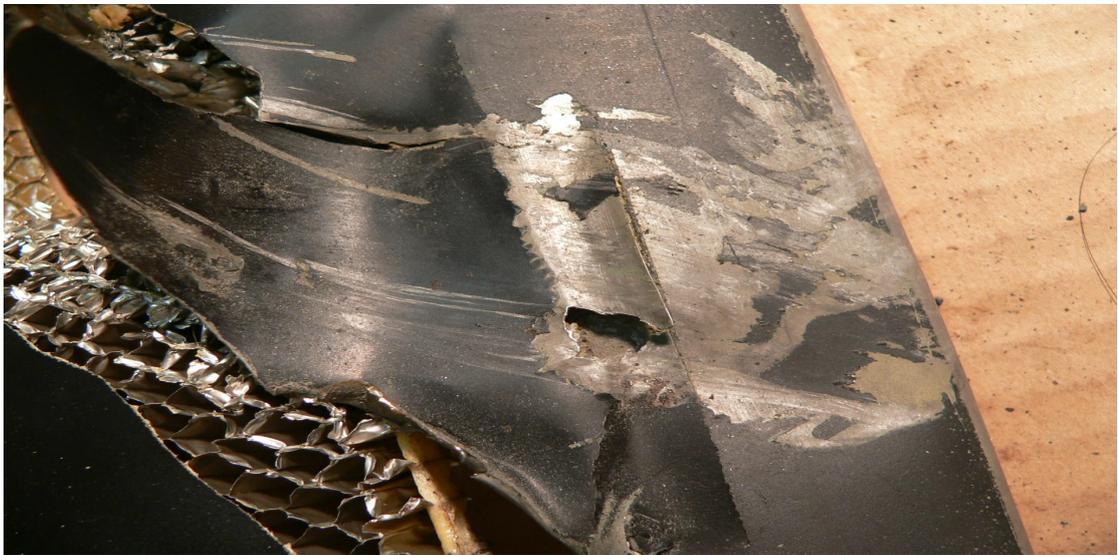
1.12.6 The left cabin door suffered impact damage to its window frame consistent with being struck by a main rotor blade. The main rotor blade mid-section had strike marks matching the impact damage on the left cabin door (see Figure 2). Similar strike marks were also evident on the other main rotor blade.

Figure 2
Marks on the main rotor blade caused by contact with the left cabin door.

- 2.5 Both main rotor blades exhibited witness markings consistent with being struck by the departing left cabin door. The large mid-section of one main rotor blade (approximately 33% of the blade surface area) most likely separated from the main rotor blade when it was struck by the door.

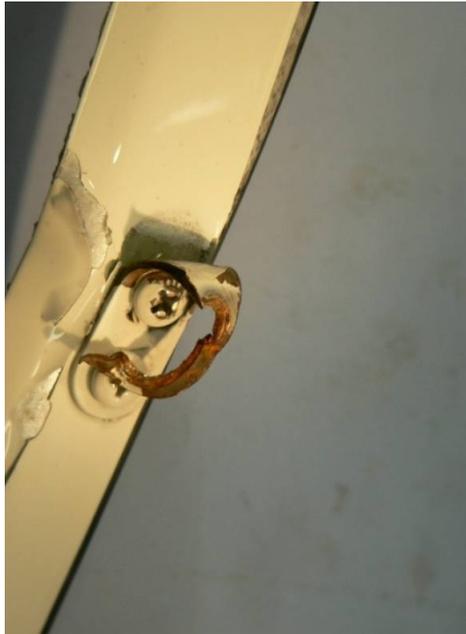
- 1.12.7 The upper airframe hinge bracket for the left cabin door was found twisted and broken (see Figure 3).
- 1.12.8 The lower airframe hinge bracket showed no signs of deformation. The left cabin door fitted neatly into the hinge when reassembled (see Figure 4).

Figure 3
Twisted upper hinge bracket.

- 2.9 The cabin door upper hinge was severely twisted indicating that the upper hinge clevis pin was most likely secured correctly by a cotter pin. This cotter pin would have retained the door on the hinge long enough for the door to twist about the hinge before the hinge failed in overload (see Figure 3).

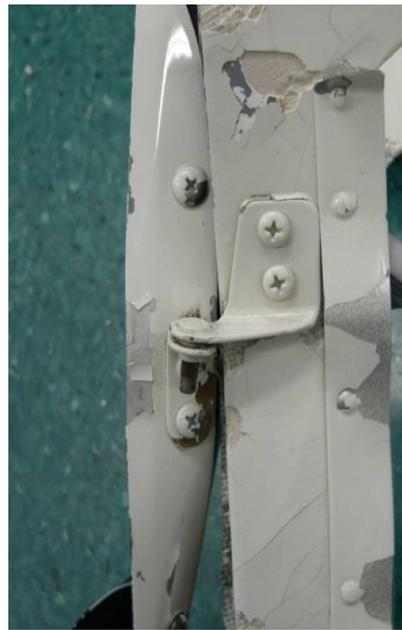
Figure 4
Undamaged lower hinge (reassembled).

- 2.10 The lower hinge, by comparison, showed no signs of distortion. This indicates that the cabin door had most likely freely detached from the lower hinge as it wasn't secured with a cotter pin, even though there was provision for one (see Figure 4).

- 4.1 The CAA issued Airworthiness Directive DCA/R22/45 as a result of this accident (effective from 27 March 2008) to ensure that R22 helicopter cabin doors are secured using cotter pins in the upper and lower hinges of each cabin door.
- 4.2 Robinson Helicopter Company issued R22 Service Bulletin SB-101 on 30 April 2010 requiring both hinges to be secured by cotter pins and hinge hardware to be replaced. This Service Bulletin is to be embodied within the next 150 flight hours or by 31 July 2010 whichever occurs first.
- 4.3 The CAA issued Airworthiness Directive DCA/R22/45C, effective on 27 May 2010, to introduce and mandate the requirements of R22 Service Bulletin SB-101 for NZ registered Robinson R22 helicopters.

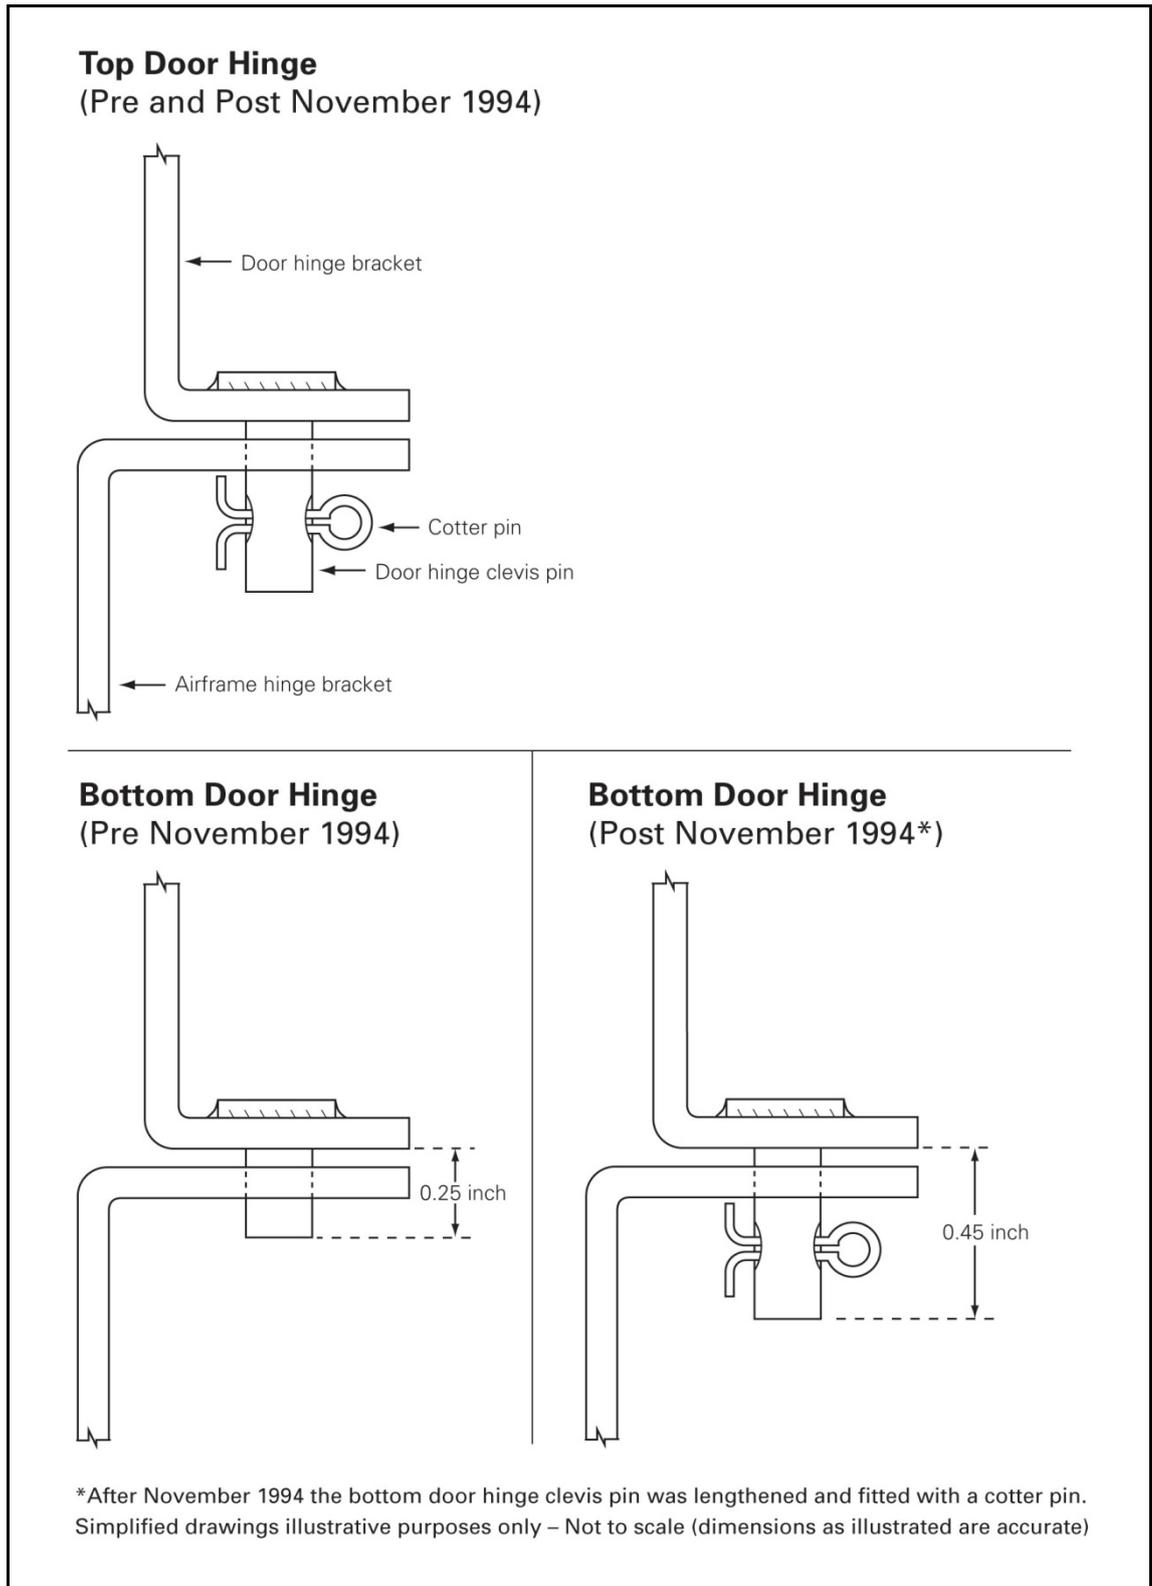
Figure 5

- 1.18.2 A design change to the lower door hinge, known as Revision H, was introduced by the helicopter manufacturer in November 1994. All new helicopters, and those which underwent an overhaul after this date, were fitted with a more secure lower door hinge. This was accomplished by lengthening the lower hinge clevis pin from 0.25 inches to 0.45 inches, and adding a hole to enable the insertion of a cotter pin (see Figure 5).

Illustration of upper and lower Robinson R22 cabin door hinge design change.
