AIRCRAFT ACCIDENT REPORT
CAA OCCURRENCE NUMBER 11/4430

Robinson R44 Raven

ZK-HLL

Forced landing into the sea

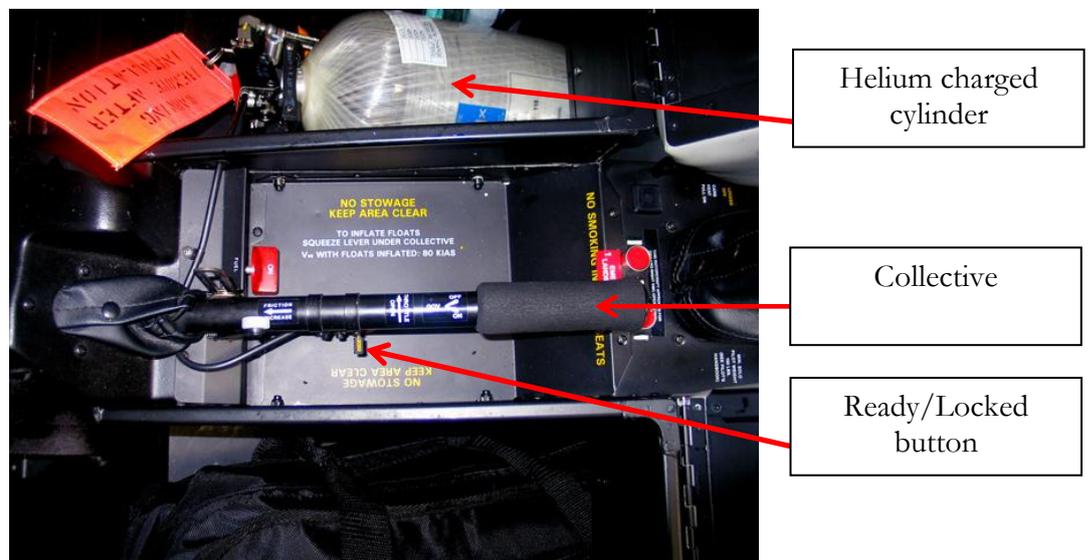
Figure 1. Locked/Ready button and helium cylinder

1.6.3 The floats on the helicopter are required to be 'armed' by a pilot prior to operation, which is recommended to be carried out daily or on a pre-flight check.¹¹ To arm the floats the pilot must set the safety on the activation lever from 'Locked' to 'Ready'. (Figure 1)

1.6.5 Due to ZK-HLL being unrecoverable, it is not possible to establish whether the pilot had armed or attempted to activate the floats. It is possible that if the floats had been deployed as designed, the pilot may have had additional time to egress safely from the helicopter before it sunk.

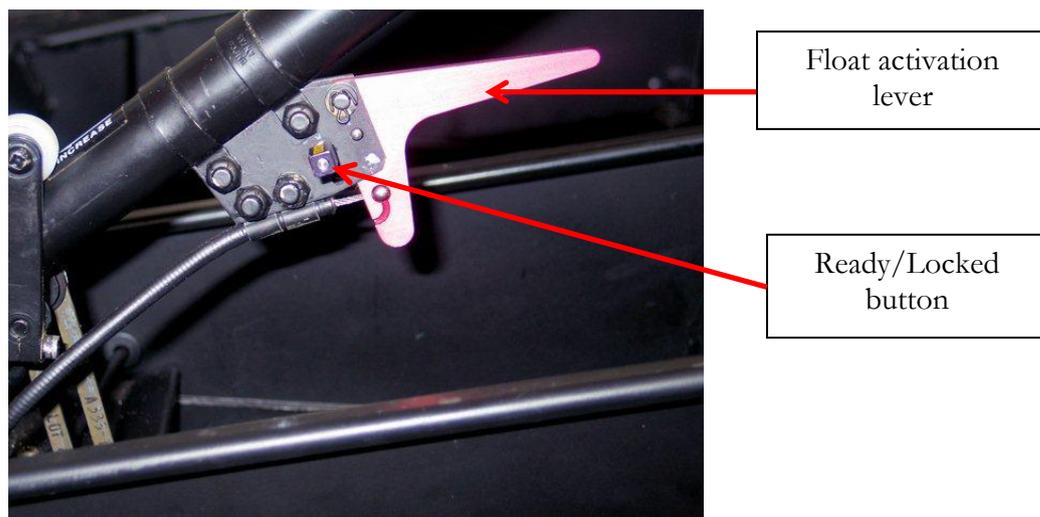
Figure 2. Activation lever on collective

1.6.4 The floats are activated by the pilot squeezing a handle connected under the collective triggering the release of compressed helium from a cylinder located under the front passenger seat. The floats take approximately four seconds to fully deploy and can be activated at indicated air speeds below 80 knots. (Figure 2)

1.15.4 The helicopter was fitted with pilot activated emergency pop-out floats. The evidence available suggests that these were not activated by the pilot or did not deploy as designed.

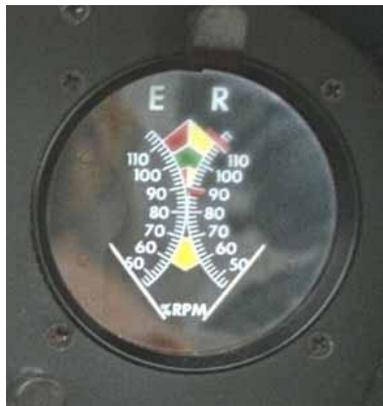
Figure 3: Dual needle Engine/RRPM tachometer

2.1.1 The pilot reported to the passenger that there was a fault with the governor, requiring them to return to the fishing vessel. The governor system senses engine RPM and applies corrective input forces to the [on the collective] throttle. When RPM is low, the governor increases throttle and vice versa¹². A number of faults can give rise to a suspected governor fault, which tend to be indicated to the pilot through the dual engine/RRPM tachometer positioned at the top right of the instrument panel as fluctuating or abnormal needle movements.

2.1.2 Faults in this system, which include the right hand magneto, can occur. However, adherence to the Robinson R44 Pilot Operating Handbook (POH), Section 3 Emergency Procedures¹³ should allow the pilot to maintain control of the engine and RRPM and make a controlled landing if required. The POH states:
