**AIRCRAFT ACCIDENT REPORT**  
**OCCURRENCE NUMBER 04/39**  
**ROBINSON R22 BETA**  
**ZK-HXT**  
**10km NORTH EAST OF TAUPO**  
**10 JANUARY 2004**

### OCCURRENCE No 04/39

<b>Aircraft type, serial number and registration:</b>	Robinson R22 Beta ZK-HXT
<b>Number and type of engines:</b>	1 Lycoming O-360-J2A
<b>Year of manufacture:</b>	2000
<b>Date and time:</b>	10 January 2004, 1130 hours <sup>1</sup> (approx)
<b>Location:</b>	Near Lake Rotokawa , 12 km NE of Taupo Latitude <sup>2</sup> : S 37° 14.4' Longitude: E 175° 14.1'
<b>Type of flight:</b>	Private
<b>Persons on board:</b>	Crew: 1 Passengers: 1
<b>Injuries:</b>	Crew: 1 fatal Passengers: 1 fatal
<b>Nature of damage:</b>	Aircraft destroyed
<b>Pilot's licence:</b>	Private Pilot Licence (Helicopter)
<b>Pilot's age:</b>	50 years
<b>Pilot's total flying experience:</b>	200.45 hours, 22 on type
<b>Information sources:</b>	Civil Aviation Authority field investigation
<b>Investigator in Charge:</b>	Mr T.P. McCready

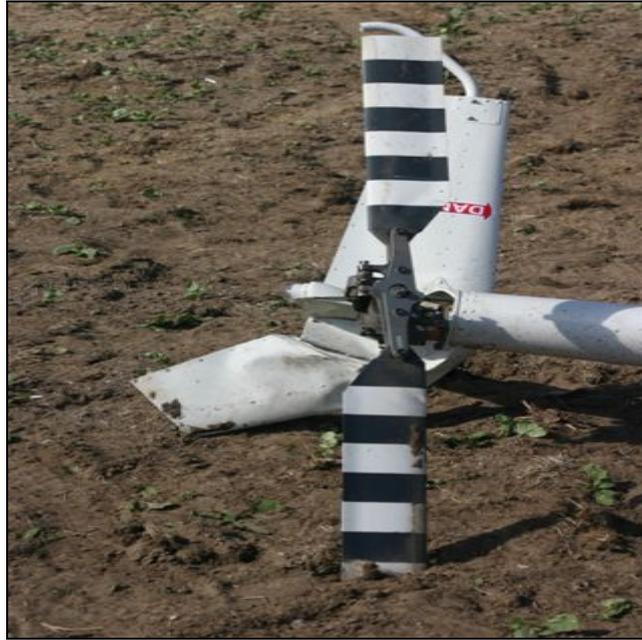
- 1.12.3 Examination of the aft section of the helicopter indicated that the tail rotor blades struck the ground with little or no rotation, indicated by the slight static bending of one blade. The other blade appeared undamaged. Static witness marks on the tail rotor driveshaft upper half also indicated an inverted impact with little or no driveshaft rotation. The lack of rotation remained consistent with examination of the upper pulley and flexible couplings. The engine cooling fan indicated no rotation of the engine at impact.

**Figure 2 Tail section showing crushed vertical upper fin from inverted impact and no evidence of tail rotor rotation.**

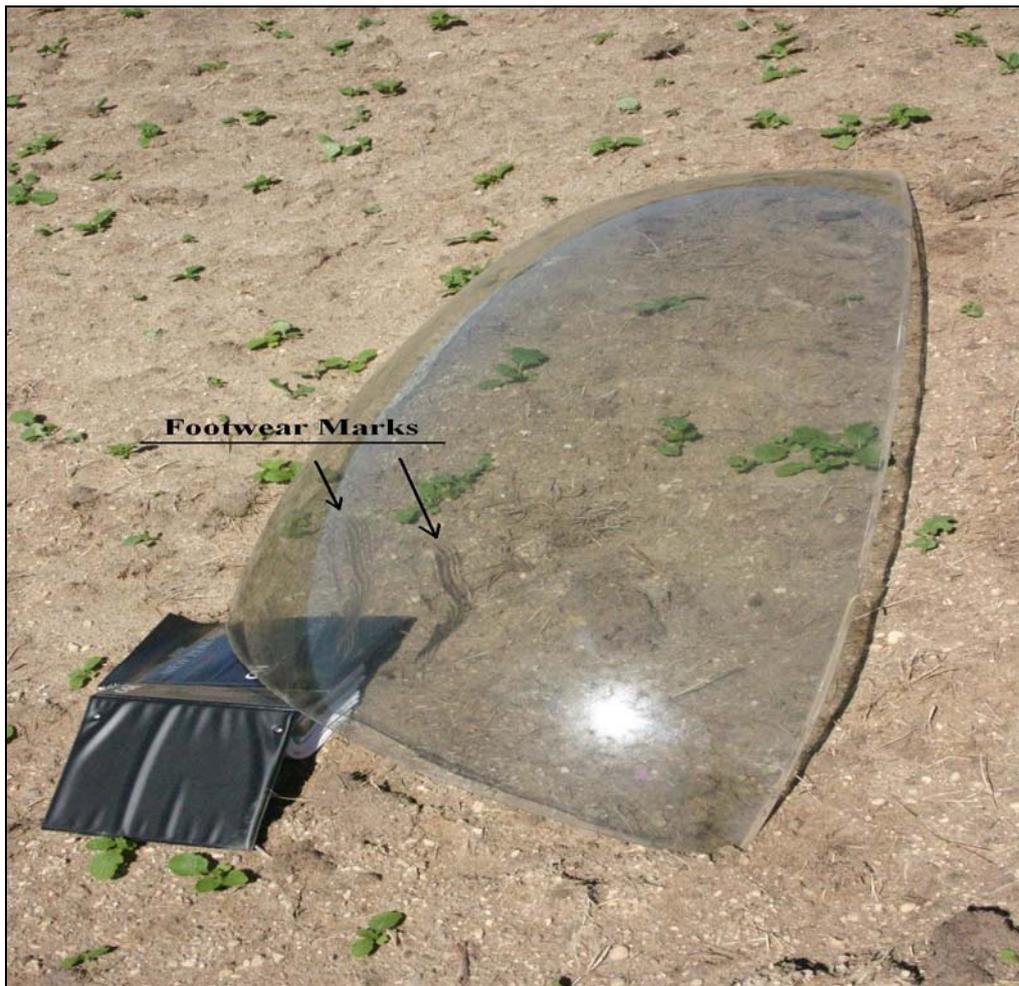
- 1.12.6 The fuel selector was in the OFF position.
- 1.12.7 The pilot's windscreen assembly was examined and rubber marks, similar to tyre marks, ran up the inside of the screen and then abruptly changed direction.

- 2.4 The injuries to the occupants indicate that they were thrown to the left of the cabin. The black 'tyre' marks on the inside of the pilot's windscreen from the soles of his footwear, suggest that his feet left the tail rotor pedals, contacted the windscreen, and abruptly changed direction. This is consistent with experiencing a very low 'g' situation, followed by the helicopter rapidly rolling right and the occupants being flung to the left. The severity of such a roll is dependent on the amount of power being applied at the time. Low 'g' is characterised by a light feeling in the stomach, similar to driving a car over the crest of a hill at high speed.

**Figure 3: Pilot's windscreen with footwear marks. Note abrupt change in direction.**

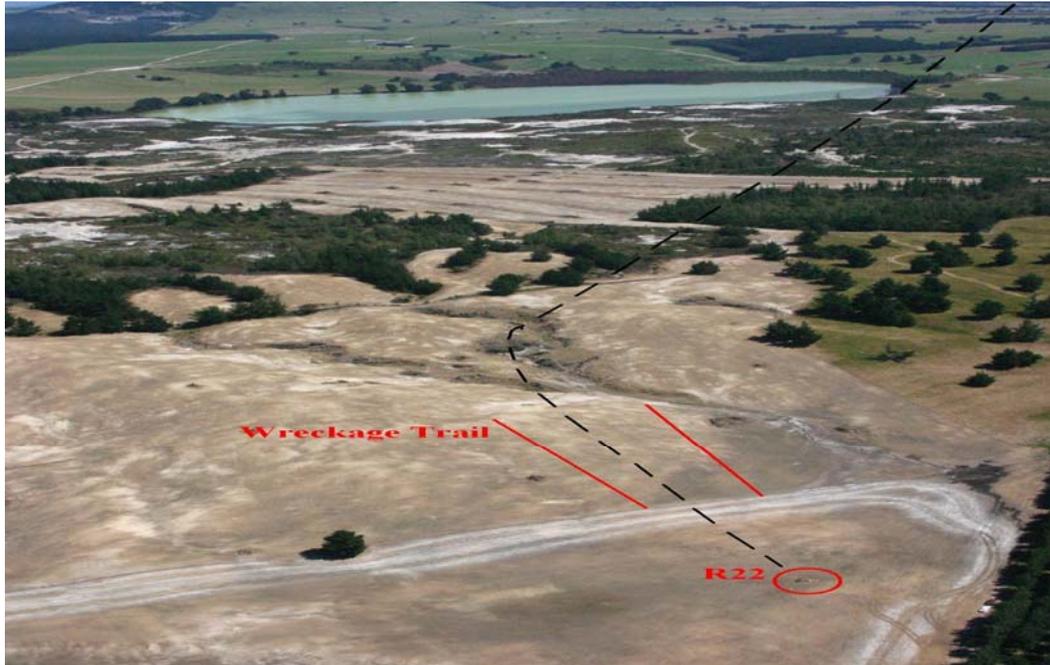
- 2.9 Assuming the helicopter had descended towards Lake Rotokawa the pilot would have noted a group of high voltage transmission power line pylons in his vicinity. If he opted to climb rather than to turn away, the low 'g' push over could have been a reaction to decreasing airspeed at the top of a cyclic climb. That would be consistent with the high vertical descent to the impact as little forward speed was evident. If normal speed was present some bouncing and rolling could be expected over the flat open farmland after impact.

**Figure 4: The flight path from the race course required a turn to align with the wreckage trail. Note the small “foot print” of the wreckage trail and two circuits of the paddock by the fertiliser truck.**

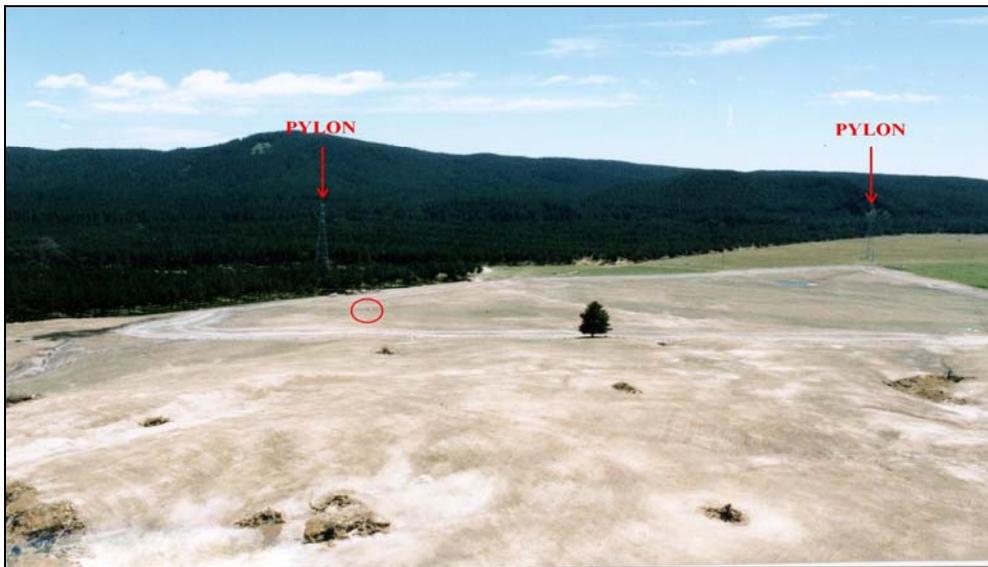
**Figure 5: View along the approximate flight path of the helicopter. Note the transmission power lines. R22 accident site is circled in red.**
