**ADDENDUM TO AIRCRAFT ACCIDENT REPORT**

**CAA OCCURRENCE NUMBER 12/2242**

**HUGHES 369D**

**ZK-HXZ**

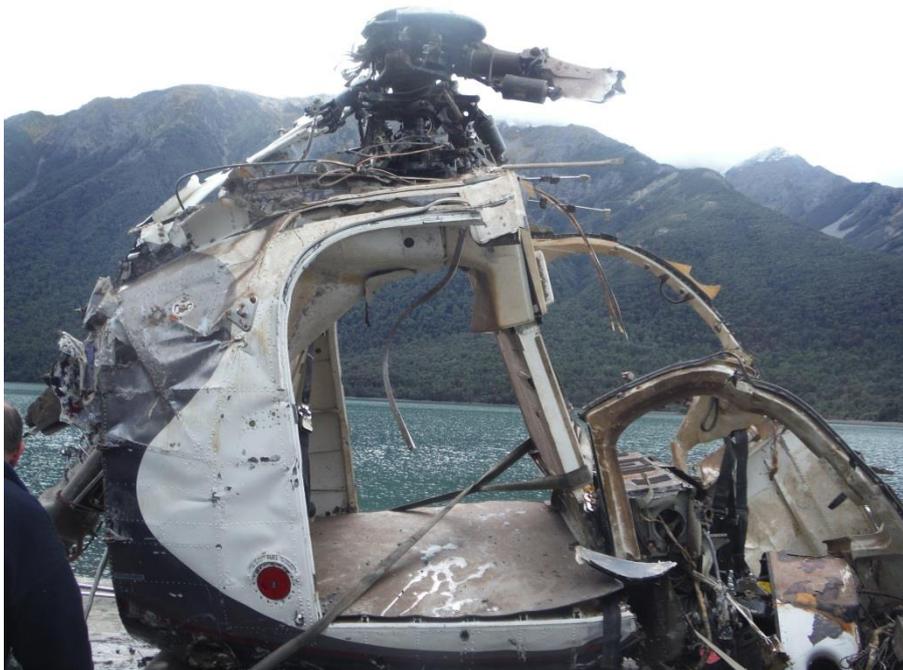
Figure 1. Damaged fuselage, after recovery

The damage to the fuselage was considered to be consistent with a shallow angle high speed entry into the water. The front right forward corner of the helicopter was severely disrupted. This was as a consequence of the main rotor blades striking the water causing the helicopter to roll to the right on impact.
