CAA Safety Investigation Report

Collision with terrain

ZK-ING, Hughes Tool Company H269B

CAA Final Report 13/5710

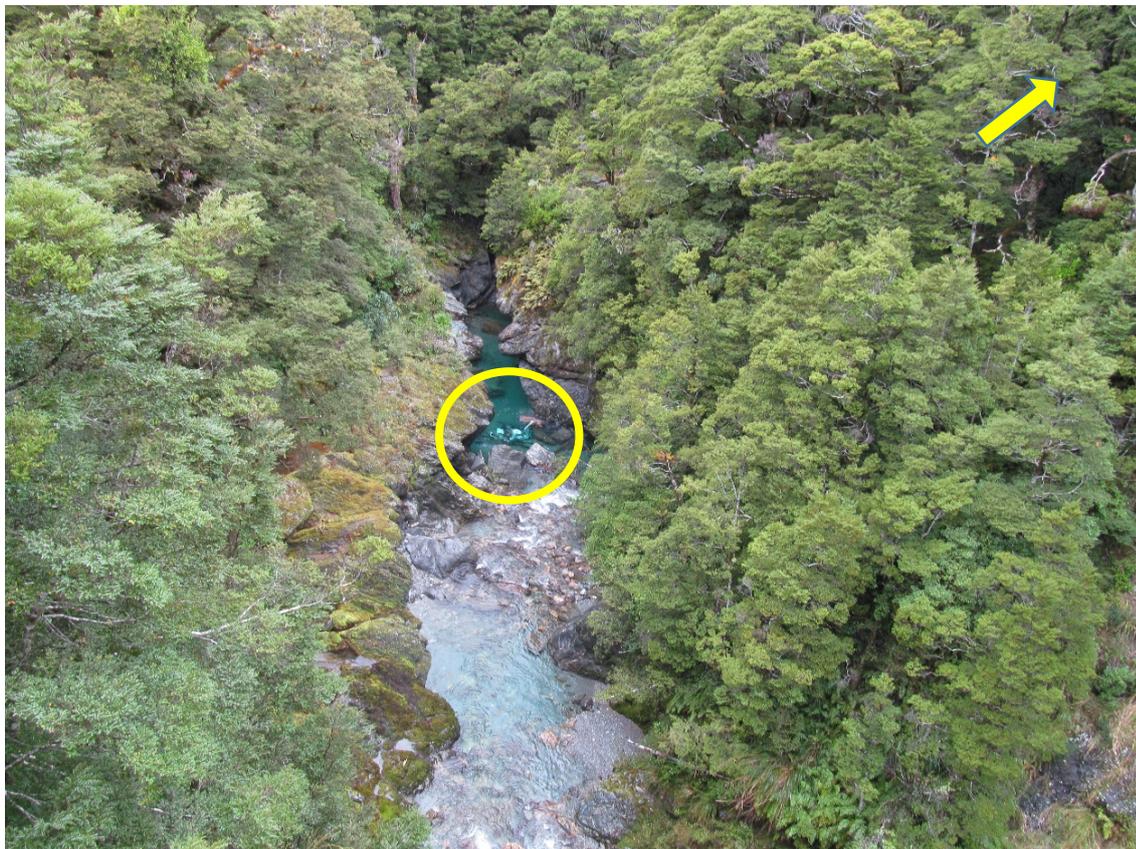
Figure 2. Wreckage of ZK-ING located in Fish River (arrow indicates North) (source New Zealand Police)

The helicopter initially struck the tree tops, approximately 10 meters above the Fish River, adjacent to an old bridge foundation. The helicopter then hit the ground heavily splaying the skid undercarriage to the point of structural failure, allowing the engine to impact the ground sufficiently to break open the oil sump. The helicopter then fell approximately 10 feet into the river, coming to rest fully submerged on the river bed. (Figure 2 and 3.)

Subsequent examination of the airframe and engine noted no anomalies which may have contributed to the accident. All damage was considered consistent with extreme impact forces and components being overstressed during the collision with the terrain. It was noticeable that the tail-rotor drive shaft displayed a characteristic torsional twist indicating that it was being driven by the engine. It was also found that the collective control on the pilot side was deformed upward, probably as a result of forces applied by the pilot.

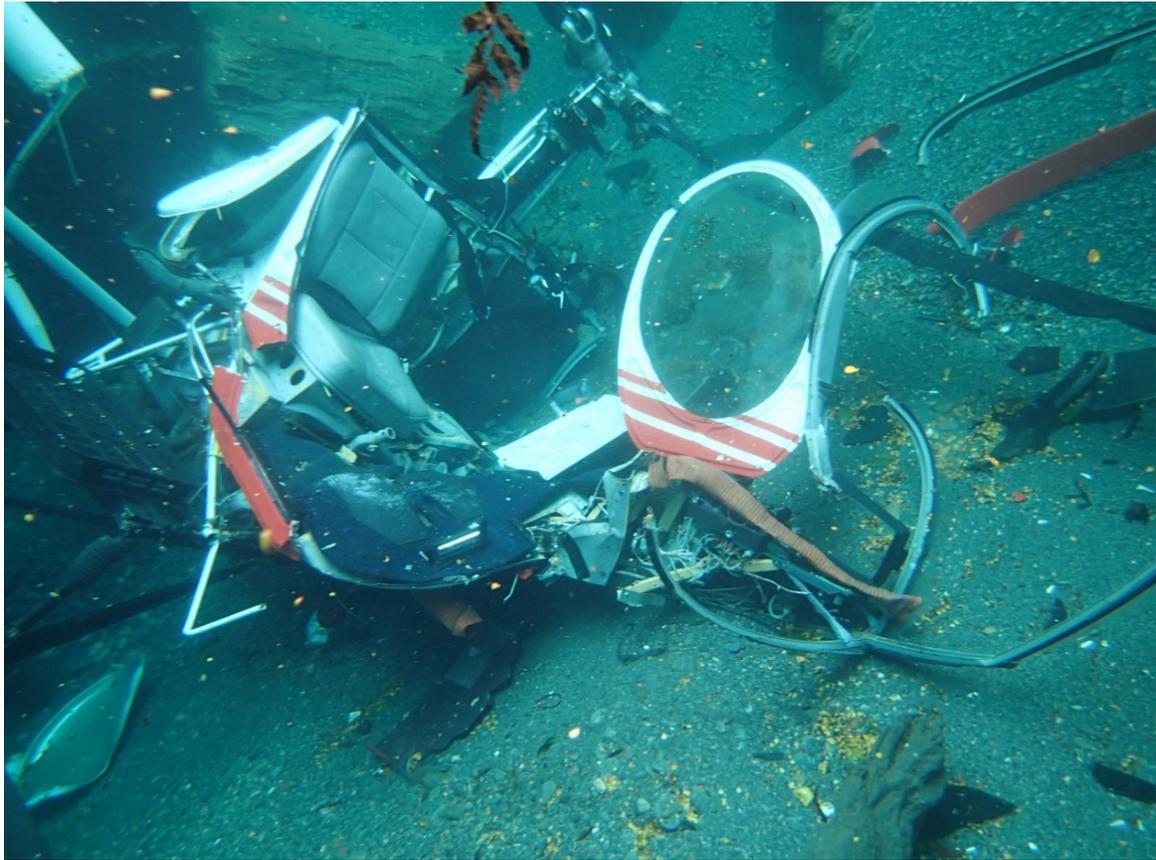
Figure 3. Picture of ZK-ING submerged in Fish River (source New Zealand Police)

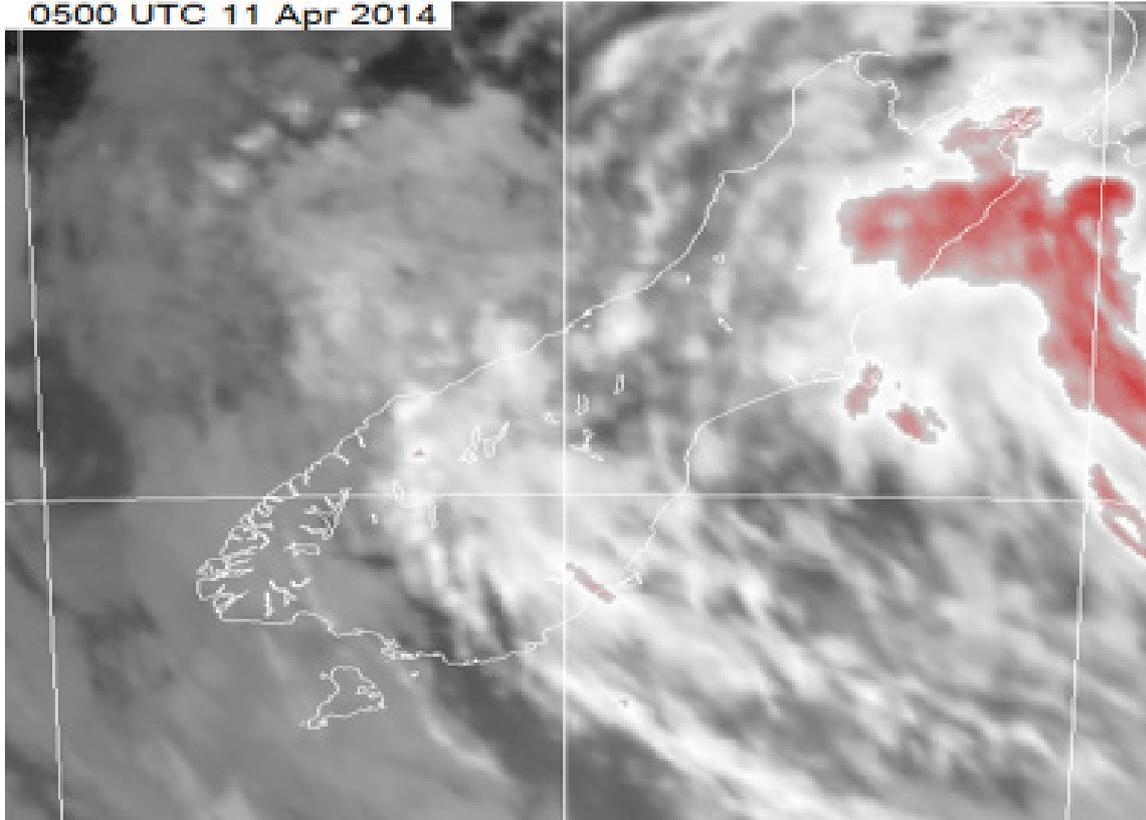
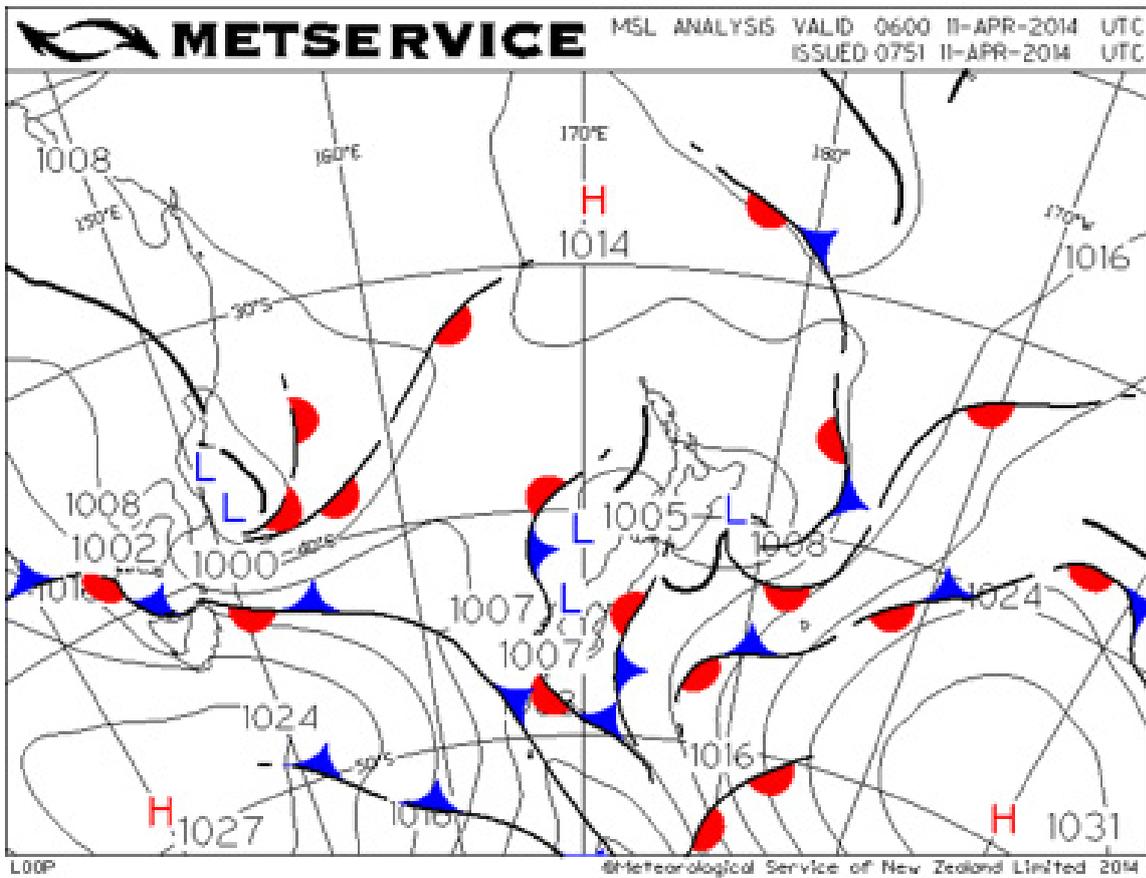
Figure 4. Infrared cloud imagery and synoptic chart (source New Zealand Met Service)

Meteorological information provided by the New Zealand Meteorological Service supported the recollections of the Makarora pilot. A moist south-westerly airflow was conducive to the formation of cloud in valley systems. (Figure 4.)
