AIRCRAFT ACCIDENT REPORT
OCCURRENCE NUMBER 02/3747
ZENAIR ZENITH CH-200
ZK-JLP
IN THE SEA, OFF MATAKANA ISLAND
28 DECEMBER 2002

AIRCRAFT ACCIDENT REPORT

OCCURRENCE No 02/3747

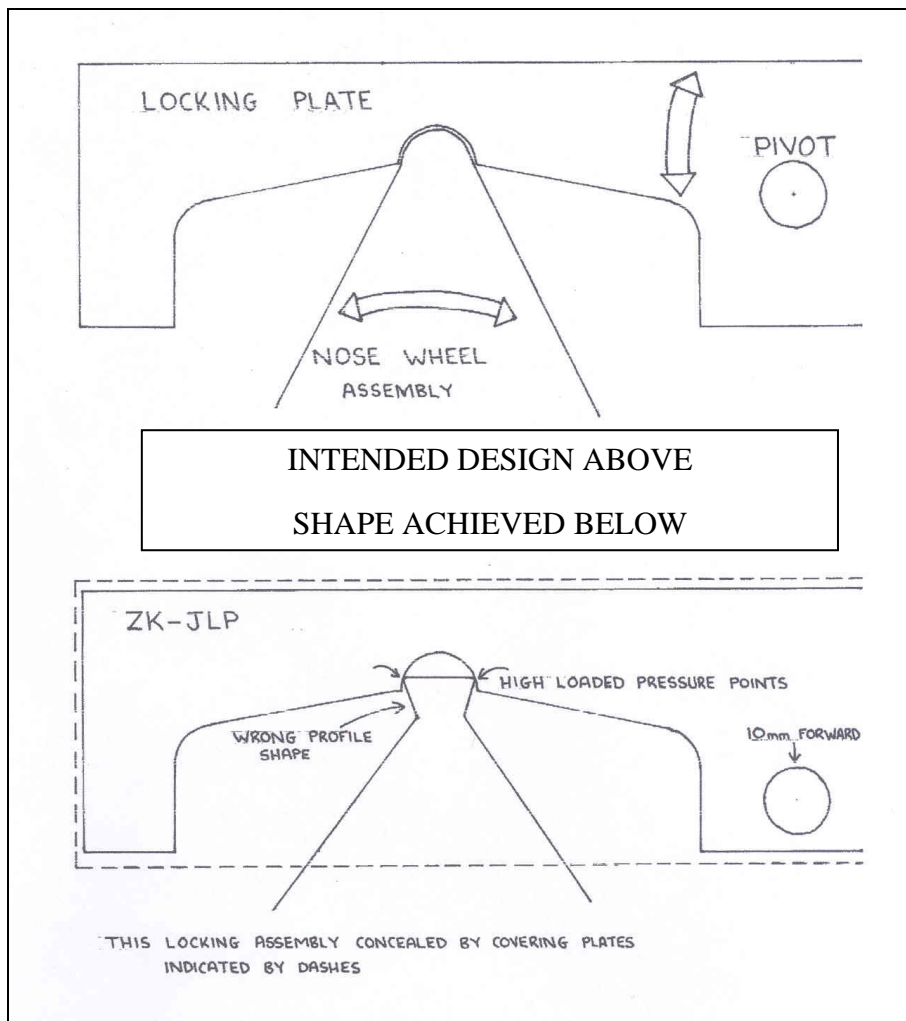
Figure 1: locking mechanism

1.16.1 Because of the damage to the nose wheel locking plate, the design history of this part was researched, and close comparisons made with the actual plate and the construction drawing requirements. This found that the plate was dimensionally correct, but the high wear rate exhibited after only 31 hours of flying (which included an estimated 110-120 landings) was due to the dimensions and shape of the nose wheel steering key, which slots into the locking plate, being incorrect.

1.16.2 The locking plate detent is semicircular in shape; therefore the nose wheel steering key should have been of a similar shape and dimension. Instead, an irregular triangular shape was found, and this had given rise to highly-loaded pressure points, which accelerated the wear rate. The location of the pivot point of the plate was also in error by about 10 mm. The key of the nose wheel assembly was set too far forward of the detent, so that most of the surface locking area of the detent was never used. The area that was used carried a large load for a small contact area, and had worn very quickly. Although the correct materials were used as specified in the construction drawings, the aircraft designer's specifications called for a steel steering key to be matched to the locking plate made of aluminium, which is a softer material. This also promoted an accelerated wear rate, when combined with the poor fit.

1.16.3 Inspection of a set of CH-200 drawings applicable to the construction of another CH-200 aircraft, and physical comparisons with that aircraft, revealed that this wear would normally have been detectable through normal inspection techniques. However, a later factory modification that had been incorporated only in ZK-JLP consisted of two plates, being fitted one over and one under the nose wheel steering key and locking plate detent, thus concealing both the wear indication, and the poor fit and assembly. See Figure 1.

- 2.1 The sequence of events, together with the indications of wear to the locking plate, suggests that the nose wheel locking did not engage, and the pilot lost control in a subsequent attempt to rectify the problem. The wear was significant and was enough to ensure that it was never going to re-engage.

- 3.8 The design of the nose wheel steering lock has proven to be unreliable in service, even when constructed correctly.
- 3.9 A construction error relating to the fit in the locking mechanism had resulted in accelerated wear and worsening of the problem.

- 3.10 The damage could not be seen on a daily inspection, because of the modification requiring the addition of two covering plates.
- 3.11 The previously-required stage inspection process probably would have discovered the problem before the cover plates were fitted.
- 3.12 Timely reporting of previous similar incidents on this type of aircraft could have resulted in measures that would have prevented this accident.

- (a) the aircraft control system, and
 - (b) any other vital point, the failure of which would lead to an accident.
- 4.2 The CAA has issued [Airworthiness Directive](#) DCA/ABUILT/8 for this aircraft type, to address the unsafe conditions concerning the construction, locking and operation of the nose wheel assembly. The effective date of the AD was 22 April 2004.

- 4.7 The CAA intends to advise the aircraft designer of the unintended consequences of his modification requiring the addition of the two covering plates, referred to in 3.10.
