AIRCRAFT ACCIDENT REPORT
CAA OCCURRENCE NUMBER 11/1148
G PEREIRA GP4
ZK-JPE
DEPARTURE FROM CONTROLLED FLIGHT
OREWA BEACH
20 MARCH 2011

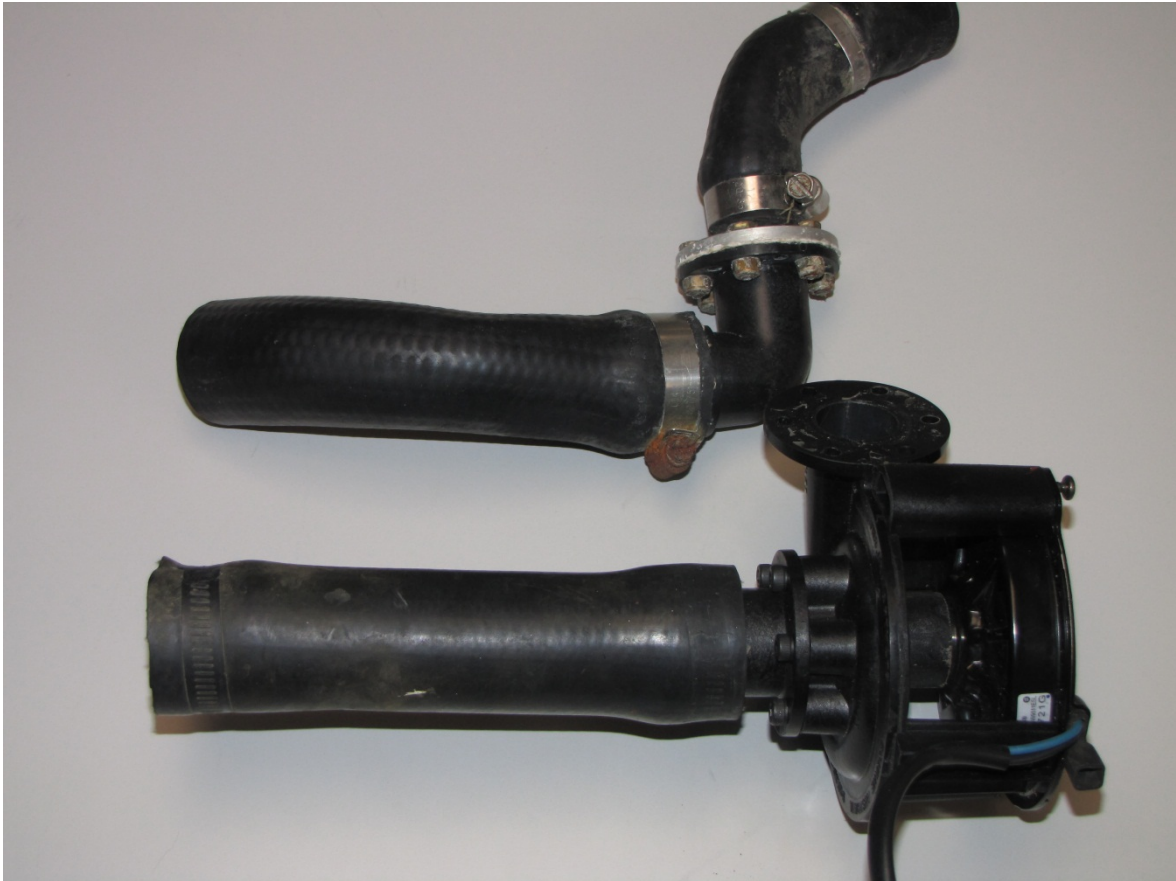
- 1.1.2 During this maintenance the pilot explained to his friend that a seal in the auxiliary coolant pump installed in the engine compartment was leaking, and said that he was going to replace the pump with an elbow tube arrangement in its place (see Figure 1). After the elbow tube was installed the pilot and his friend performed a ten minute engine ground run, during which no leaks were detected.

Figure 1, Elbow Tube Arrangement (Top) and Original Auxiliary Coolant Pump (Bottom).

- 1.12.4 The elbow tube arrangement fitted to the coolant system by the pilot, just prior to the accident was found within the confines of the engine compartment.

- 2.2 It is likely that, prior to the flight, the pilot had replenished the coolant system with the conventional ethylene glycol coolant mixed with water, indicated by the red coloured coolant seen by the pilot's friend to be pooling on the hangar floor under the aircraft, and the empty coolant container. An effect of replenishing the engine cooling system with water based coolant instead of Evans NPG coolant was that, once at operating temperature, the cooling system would be pressurised. Although no corresponding evidence was discovered, it is possible that a problem relating to the disturbance of the engine cooling system or the resulting pressurisation may have occurred, such as coolant ejection from a radiator or hose leak, accompanied by steam and odour. If this was the case, it may not have been possible to cool the engine effectively, particularly as the engine inherently exhibited a tendency to overheat.

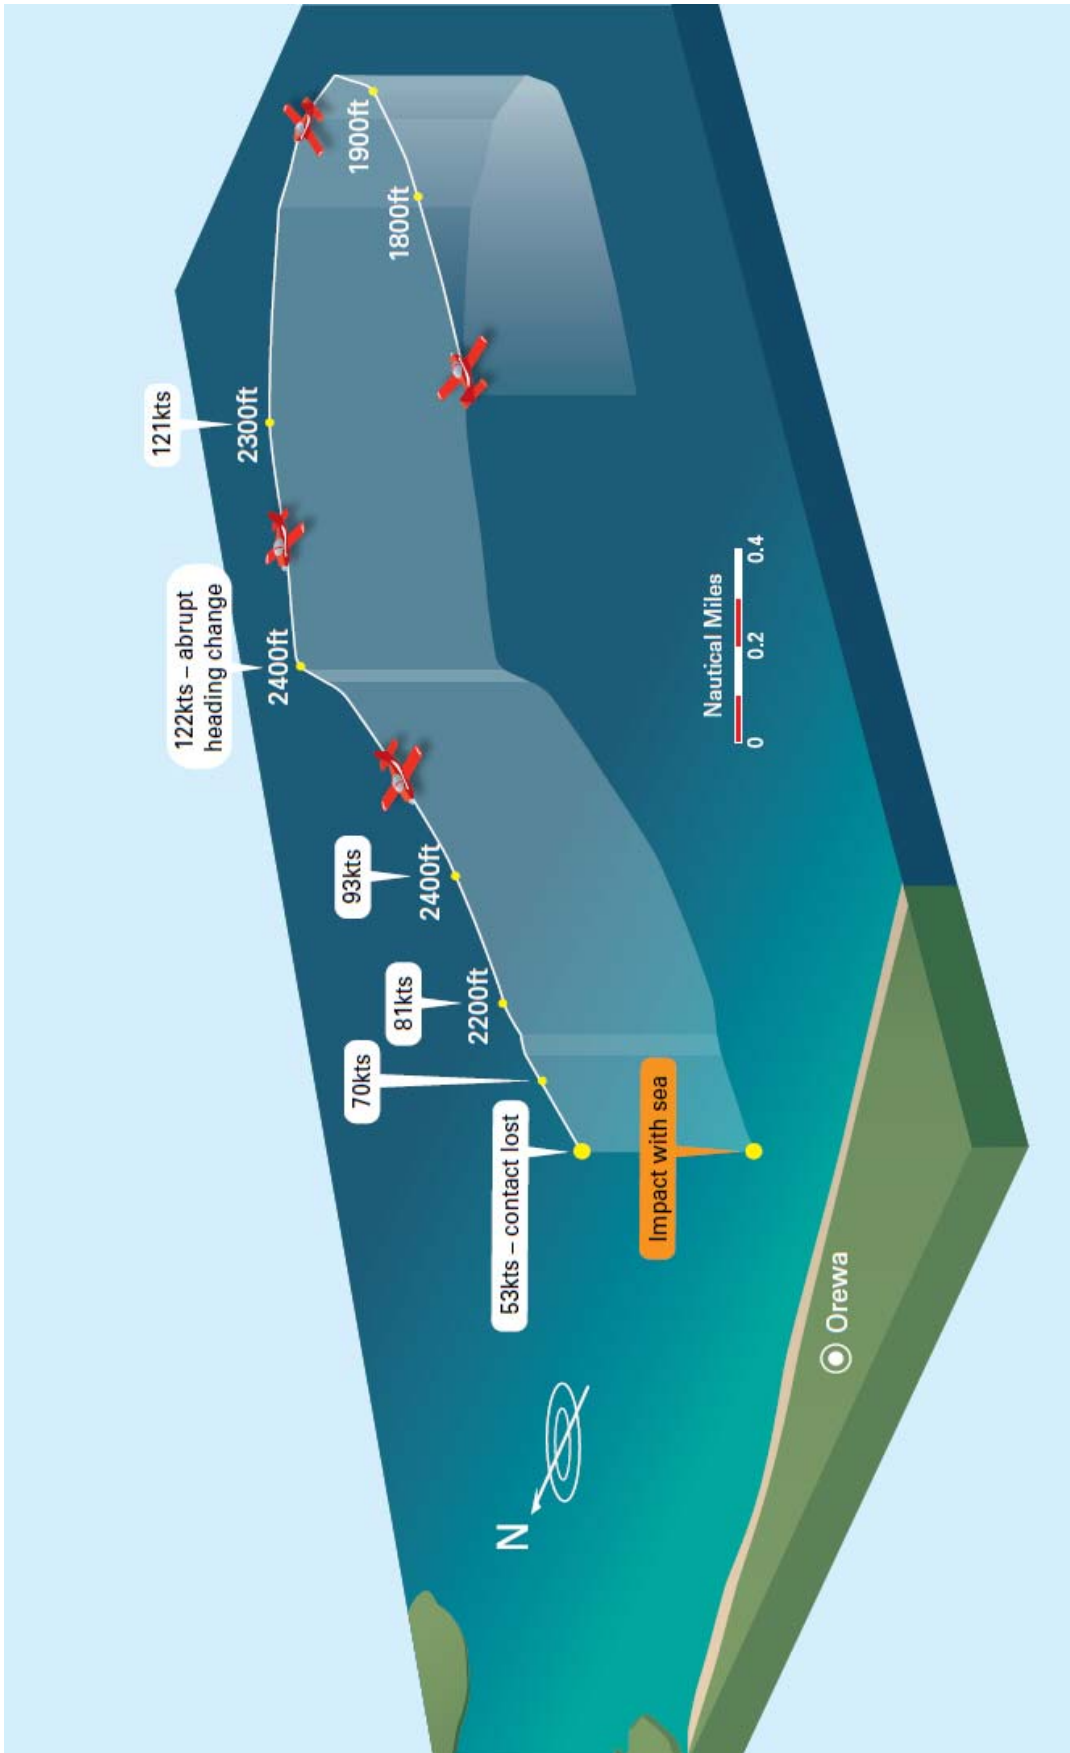
Figure 2. Diagram of Flight Path Derived from Airways Radar Data

- 1.1.13 Airways radar data was examined which revealed information about the final portion of the flight, (see Figure 2): At 1452.12 hours the aircraft was at 1800 ft, climbing toward the east followed 5 seconds later by a climbing turn to the north. The turn was completed in 30 seconds, by which time the altitude had increased to 2300 ft. The aircraft continued to climb on a north-westerly heading, during which the groundspeed remained constant at 121 knots.

- 1.1.14 At 1452.55 hours, while at 2400 ft altitude and 122 knots groundspeed, the heading changed abruptly towards the south-southwest. This heading change resulted in the aircraft heading toward North Shore Aerodrome. Over the following 49 seconds the altitude gradually decreased by 200 ft and the groundspeed reduced to 70 knots. The final data point at 1453.53 hours recorded 53 knots of groundspeed, but altitude data was not recorded.
