Loss of control during approach to land

ZK-JRX Van's Aircraft Incorporated RV-4

17 December 2018

CAA final report 18/8850

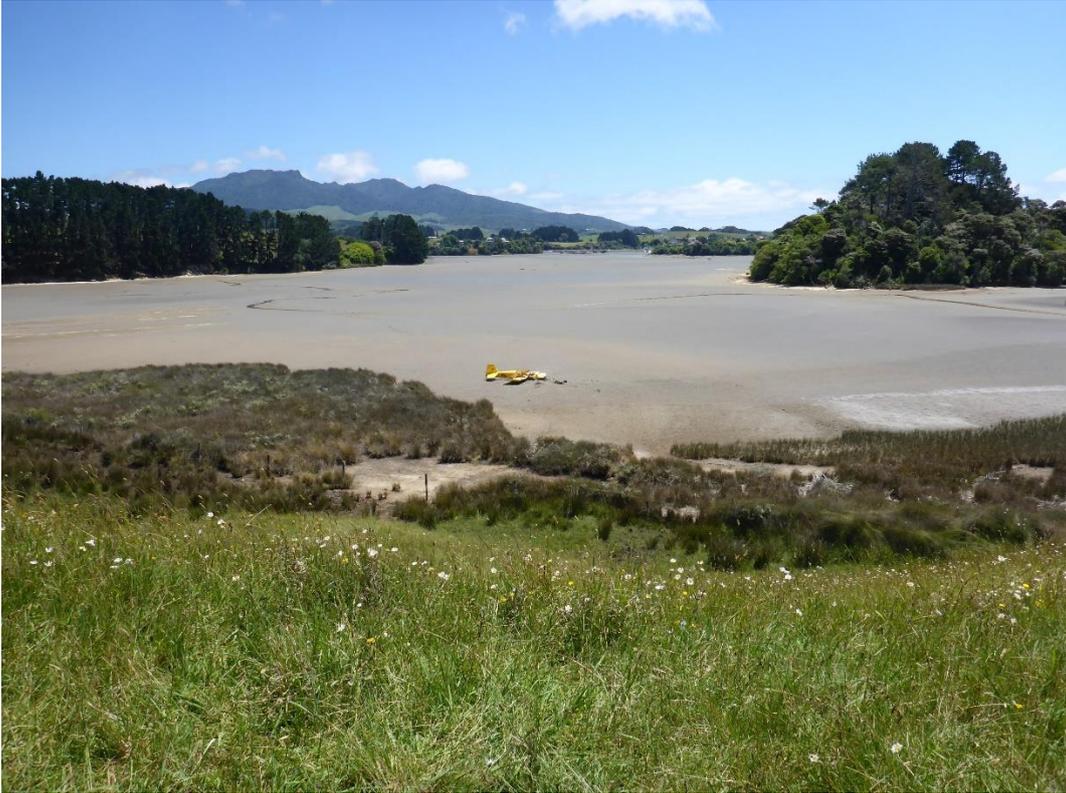
Figure 3: Accident site (CAA photograph)

The aircraft was observed by several witnesses, including another pilot, approaching and turning towards Raglan aerodrome when it rapidly rolled to the left and descended at a high rate. The aircraft then struck the mud flats in an approximate 40 degree nose down attitude, with rotation to the left. The impact signatures are consistent with the aircraft being in a spin to the left when it struck the mud flats.

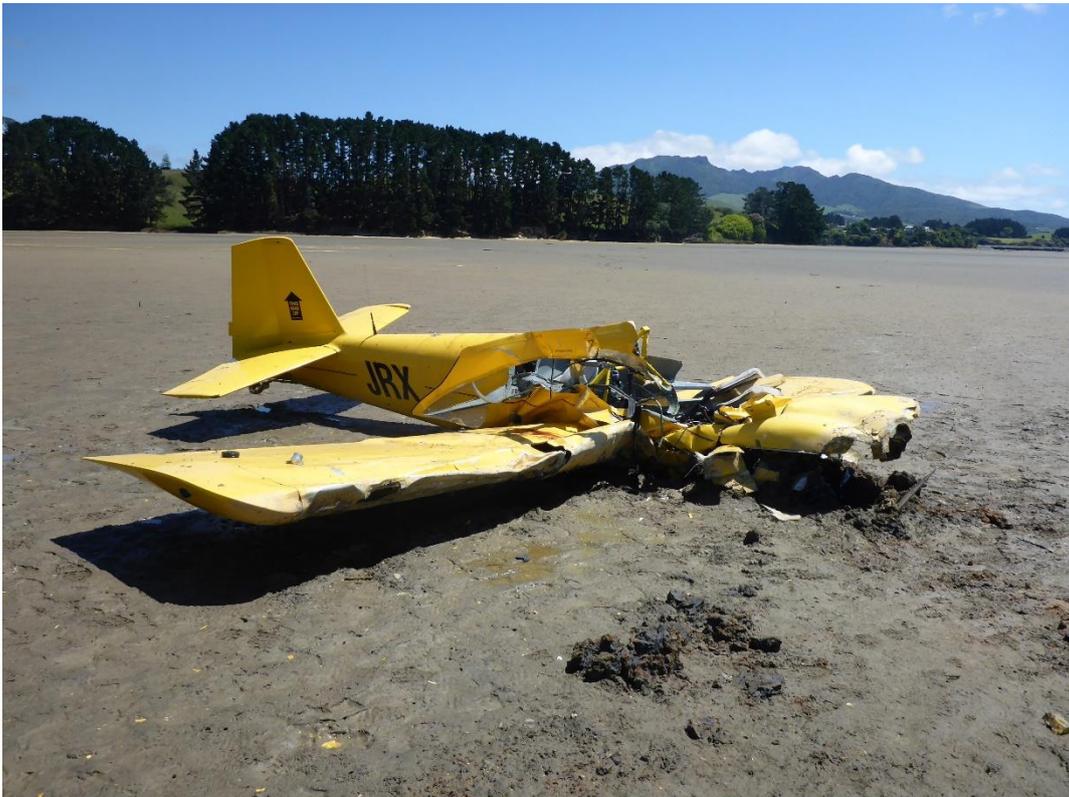
Figure 4: Aircraft wreckage (CAA photograph)

Examination of the aircraft during the safety investigation did not find any defects which may have contributed to the accident. The aircraft was maintained to the required standards and there were no outstanding defects which may have affected the safety of the flight.
