CAA Safety Investigation Report

Collision with terrain following a loss of control at low level

ZK-LAT, Cessna C172R

CAA Final Report 18/64

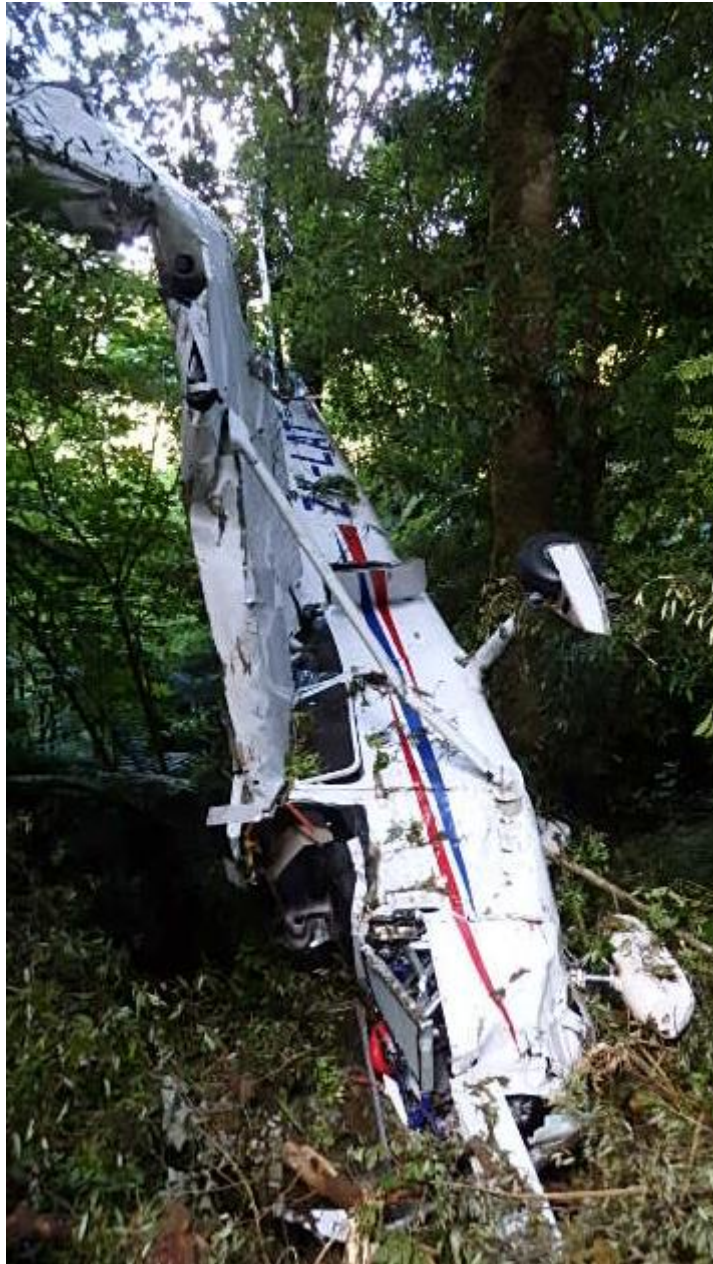
Figure 1: ZK-LAT after it had been lowered from the trees. (Supplied by the recovery company)

Before vacating the aircraft, the instructor selected the ELT switch to ON. The Rescue Coordination Centre was however unable to locate the aircraft using the ELT signal. This was probably caused by the ELT aerial being snapped off during the accident sequence, along with possible signal shielding caused by the tree canopy and surrounding terrain.

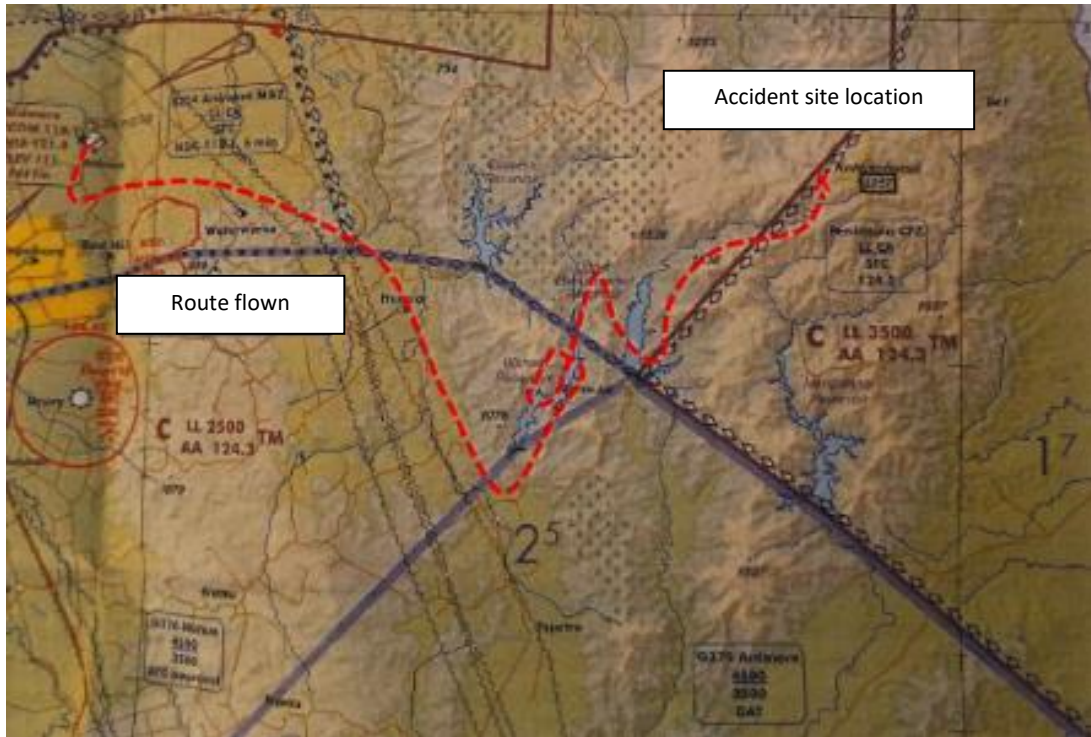
Figure 2: Approximate route flown and the position of the accident site (Supplied by the operator).

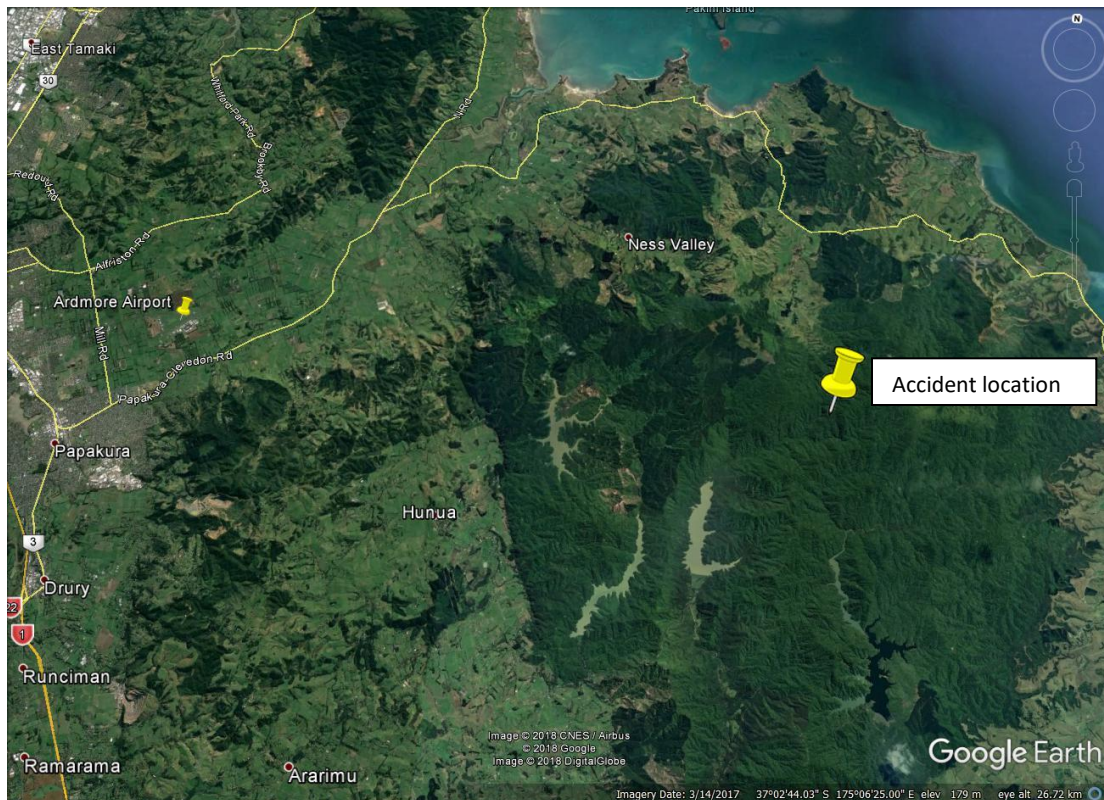
Figure 3: Aerial view of the Hunua Ranges and accident location (Google Earth).

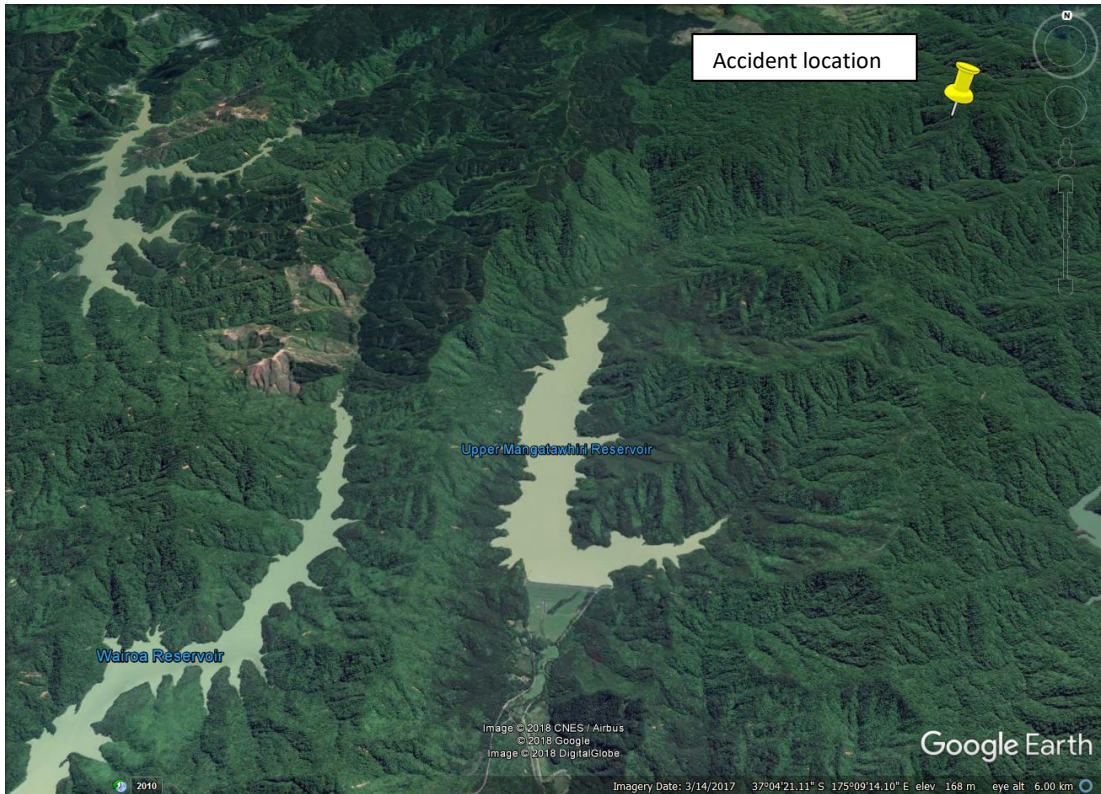
Figure 4: Aerial view of the Wairoa Reservoir, Upper Mangatawhiri Reservoir and accident location (Google Earth).

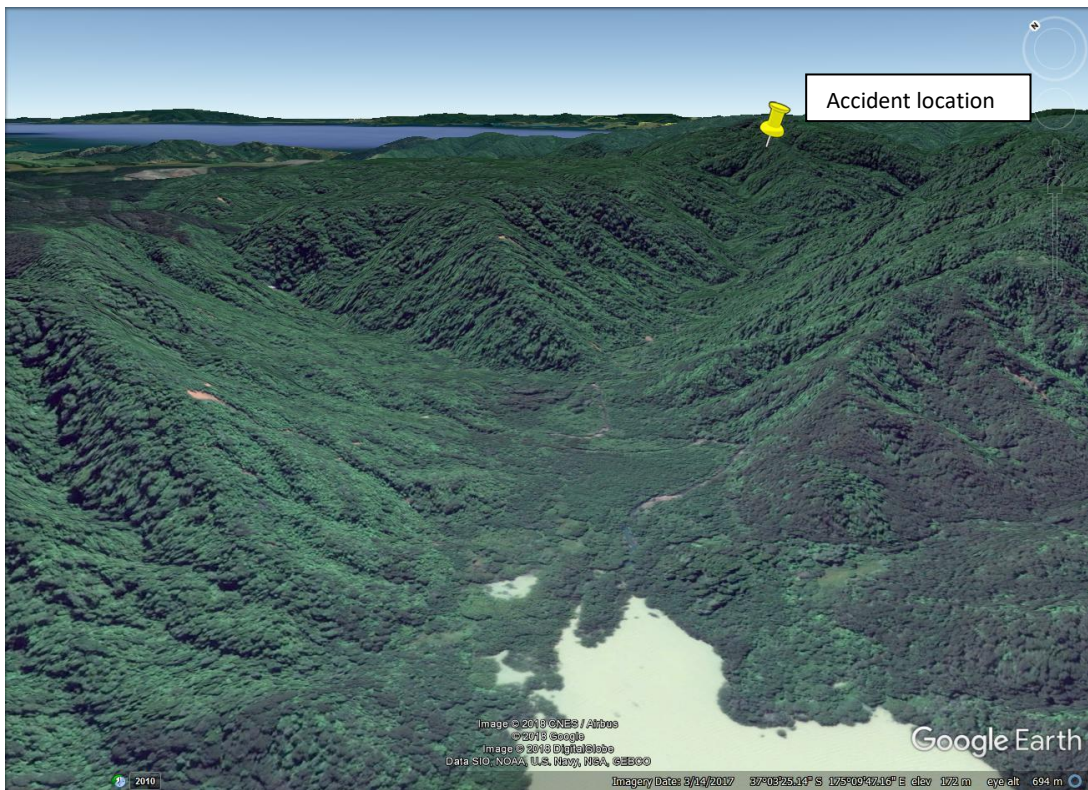
Figure 5: Aerial view from the northern end of the Upper Mangatawhiri Reservoir looking up towards the accident location (Google Earth).
