Safety Investigation Brief

Microlight Windscreen Failure

Aircraft manufacturer and model		Aeroprakt Limited, A-22LS, Ser. No 198
Engine manufacturer and model		Bombardier-Rotax 912 ULS
Registration		ZK-LFD
Location of incident		Near Waihi,
Date and time of incident		29/03/18, 1510 hours
Flight rules applying		Private
		Visual (VFR)
Occurrence number		18/1472
Injuries	Crew	One- Head injury and bruising
	Passengers	One- Bruising
	Others	Nil

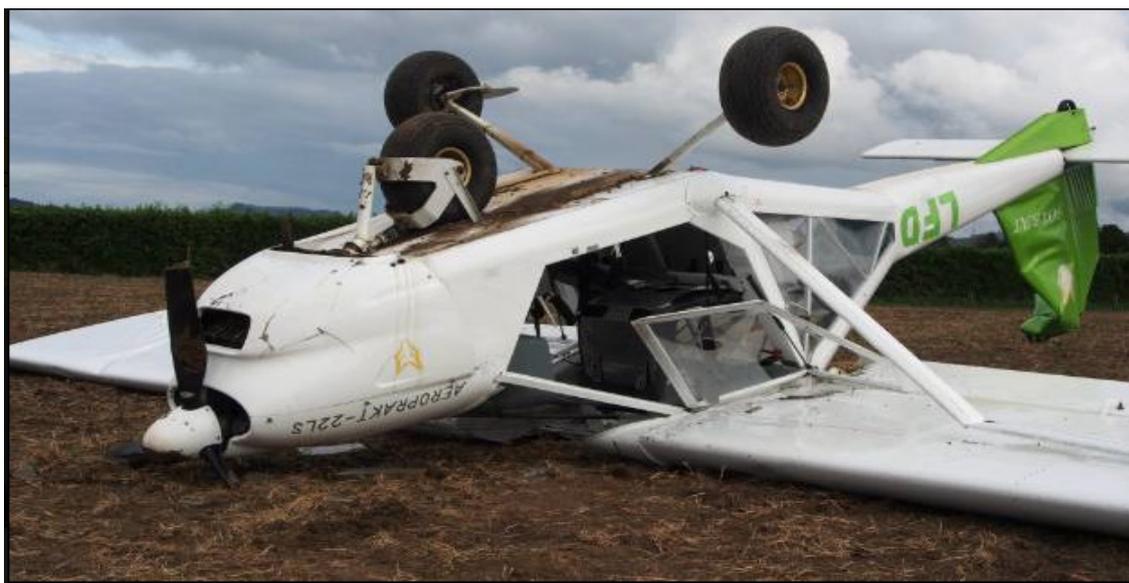
The sudden inflow of air caused both cabin doors to come open and aerodynamic control became compromised. The pilot elected to make a forced landing onto open ground to the south of the town. While a successful approach was made to the chosen farm paddock, following touch down the aircraft bounced and was inverted, injuring the occupants (Refer Figure 2). Emergency services attend and provided assistance.

Figure 2. Image of aircraft at accident site (Source: Police)

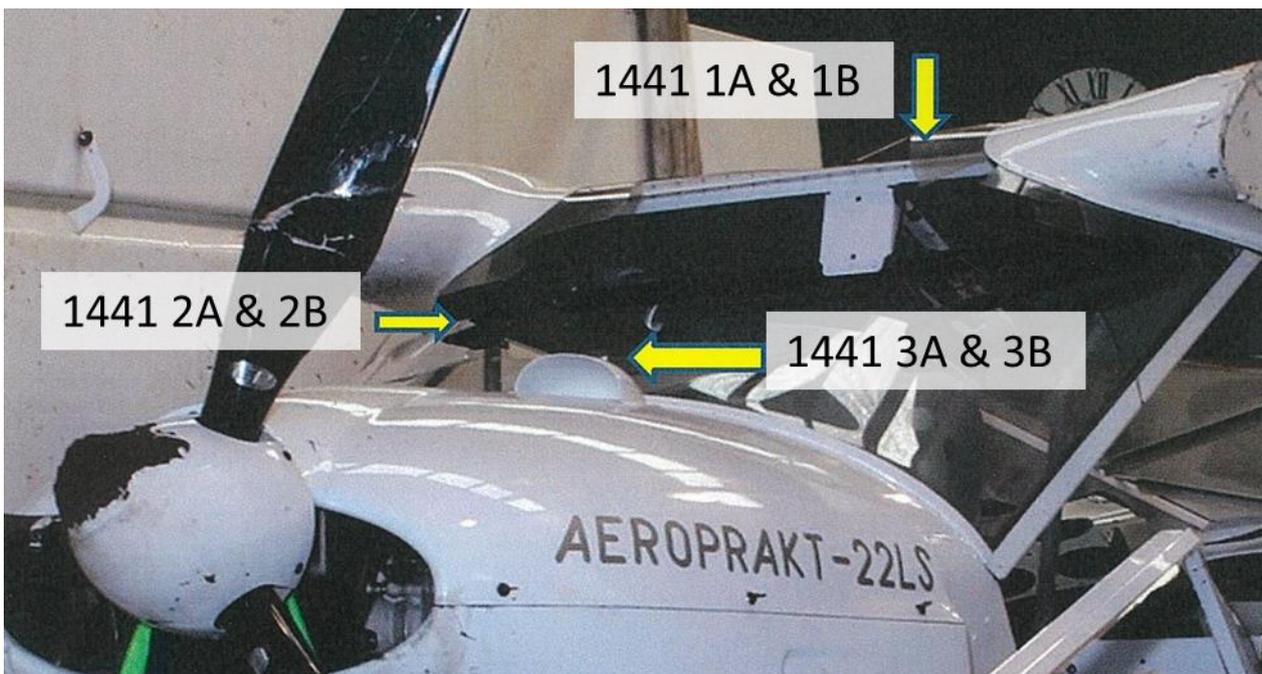
8. Samples of the damaged windscreen were provided from different location on the windscreen as indicated in Figure 1 below. Duplicate subsamples were taken from each location as well as from a selection of additional windscreen fragments whose original locations were unknown.

Figure 1: Locations of known windscreen samples as indicate by yellow arrows along with corresponding DTA sample numbers (image provided by CAA).

yellowness index the greater the degree of yellowing in the sample. From the known sample locations it appears that the samples increase in yellowness from bottom to top of the windscreen.

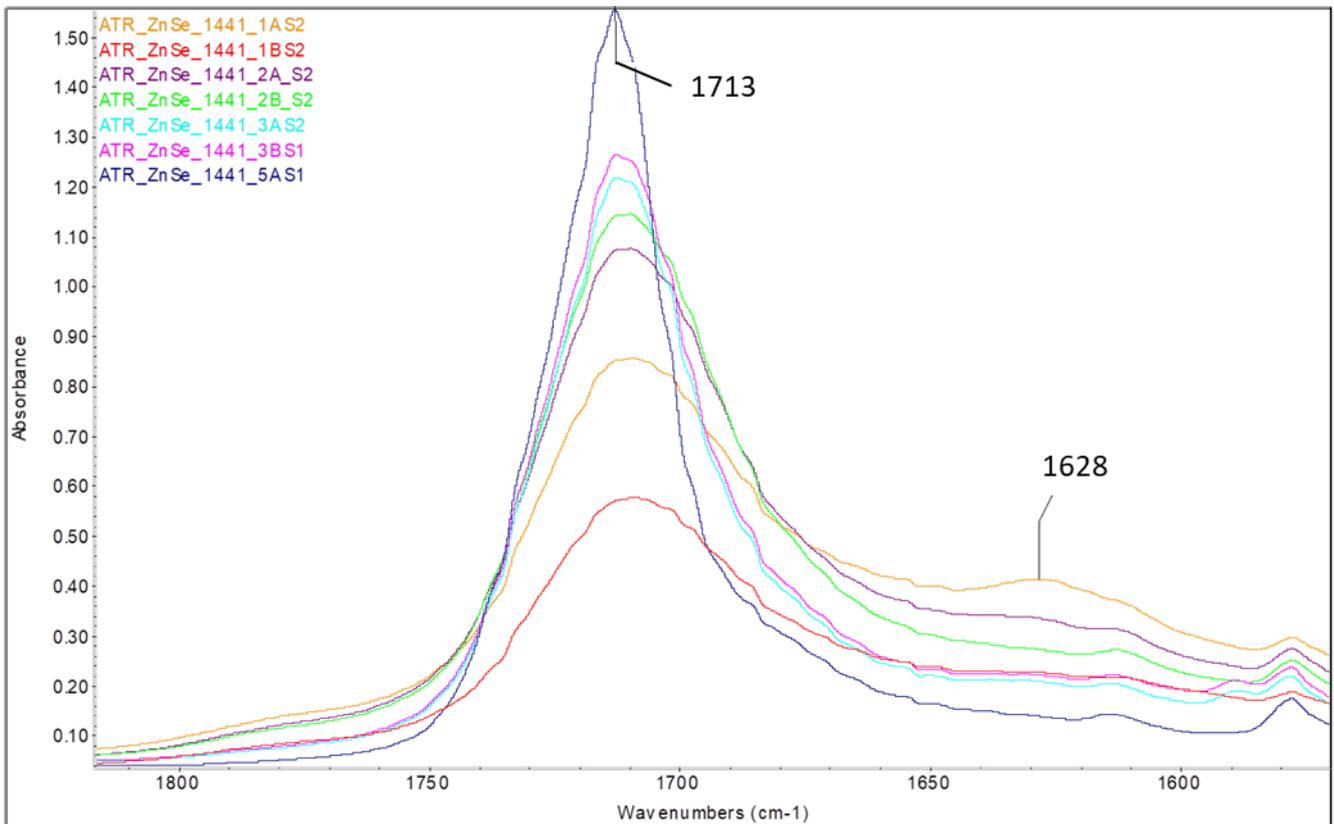
11. Degradation of the windscreen surface causes a number of changes to be observed in the FTIR spectra of the material. A key area to observe these changes is the region between 1800 - 1600cm⁻¹ where the carbonyl peaks in the original material and degradation products strongly absorb the infrared light. Figure 2 shows this region for the exterior surface of each of the samples along with one interior surface for reference. All exterior surfaces show a reduction in the terephthalate peak (from the original material) at 1713cm⁻¹ indicating some degradation or loss of this component. Peak broadening due to the formation of new compounds is also seen on the exterior surfaces. The reduction and broadening of the peak at 1713cm⁻¹ matches the degradation mechanism described in reference [3] and trends from bottom to top across the windscreen. The exterior surfaces show an increase in absorption at 1628cm⁻¹ which also has a trend based on location with the upper areas of the windscreen showing a greater increase than the lower. These results show that significant degradation of the original material has occurred particularly in the upper

sections of the windscreen. It should be noted that this only refers to the first 1- 2 μm of the sample which is only 0.1% of the total thickness of the windscreen material.

12. The trends mentioned in paragraph 11 above also match well to the yellowness index values in table 1 confirming that the yellowing of the material is likely related to the breakdown of the original polymer material.

Figure 2 ATR- FTIR results zoomed to the $1800 - 1600\text{cm}^{-1}$ region for exterior surfaces of windscreen sections at different locations showing changes in adsorption at 1713cm^{-1} and 1628cm^{-1} . Locations are top (1441 1A & 1B), middle (1441 2A & 2B) and bottom (1441 3A & 3B). Sample 1441 5A is from the interior surface of the windscreen.

18. The windscreen material does appear to have suffered from UV degradation on its exterior surface and this is more pronounced on the upper areas.

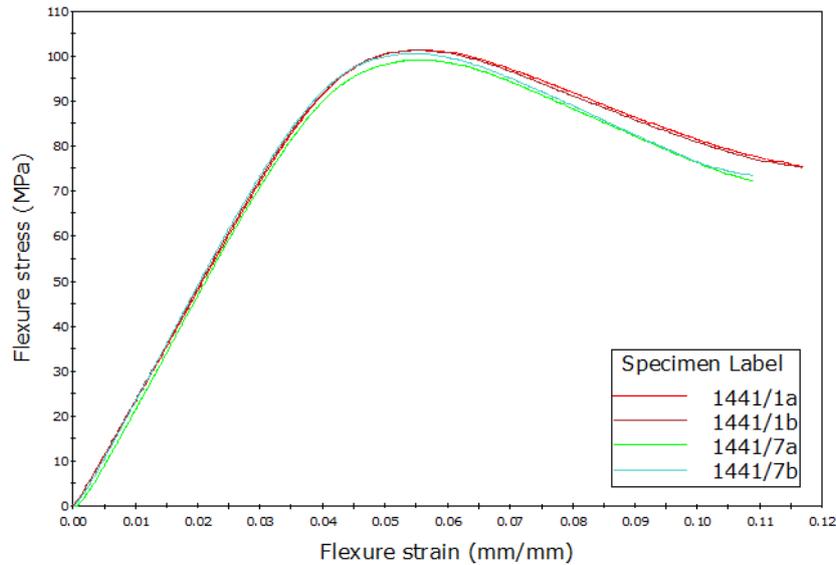
14. Tests were performed on the most and least yellow specimens. The most yellow specimens, from the top of the windscreen (1441/1a and b) had a slightly different performance at high strain, but there was insignificant difference in maximum flexural stress from the least yellow specimens (1441/7a and b). The stress strain chart for these tests is presented in figure 3

Figure 3. Flexural stress vs strain diagram for the most (1441/1a and b) and least (1441/7a and b) yellow specimens as tested in three point bending.

19. UV degradation does not appear to have reduced the flexural stress properties of the windscreen.
