AIRCRAFT ACCIDENT REPORT
CAA OCCURRENCE NUMBER 08/5163
PACIFIC AEROSPACE CRESCO 08-600
ZK-LTC
TARATA, NEAR INGLEWOOD
14 DECEMBER 2008

AIRCRAFT ACCIDENT REPORT

CAA OCCURRENCE No. 08/5163

Aircraft type, serial number and registration:	Pacific Aerospace Corporation Limited Cresco 08-600, 020, ZK-LTC
Number and type of engines:	1 Pratt & Whitney Canada PT6A-34AG
Year of manufacture:	1997
Date and time:	14 December 2008, 1155 hours ¹ (approximately)
Location:	Tarata Latitude ² : S39° 08.169' Longitude: E174° 21.710' Elevation 410 feet amsl
Type of flight:	Agricultural – Topdressing
Persons on board:	Crew: 1
Injuries:	Crew: 1 fatal
Nature of damage:	Aircraft destroyed
Pilot's licence:	Commercial Pilot Licence (Aeroplane)
Pilot's age:	48 years
Pilot's total flying experience:	12,100 hours (approximately)
Information sources:	CAA field investigation
Investigator in Charge:	Mr C P Grounsell

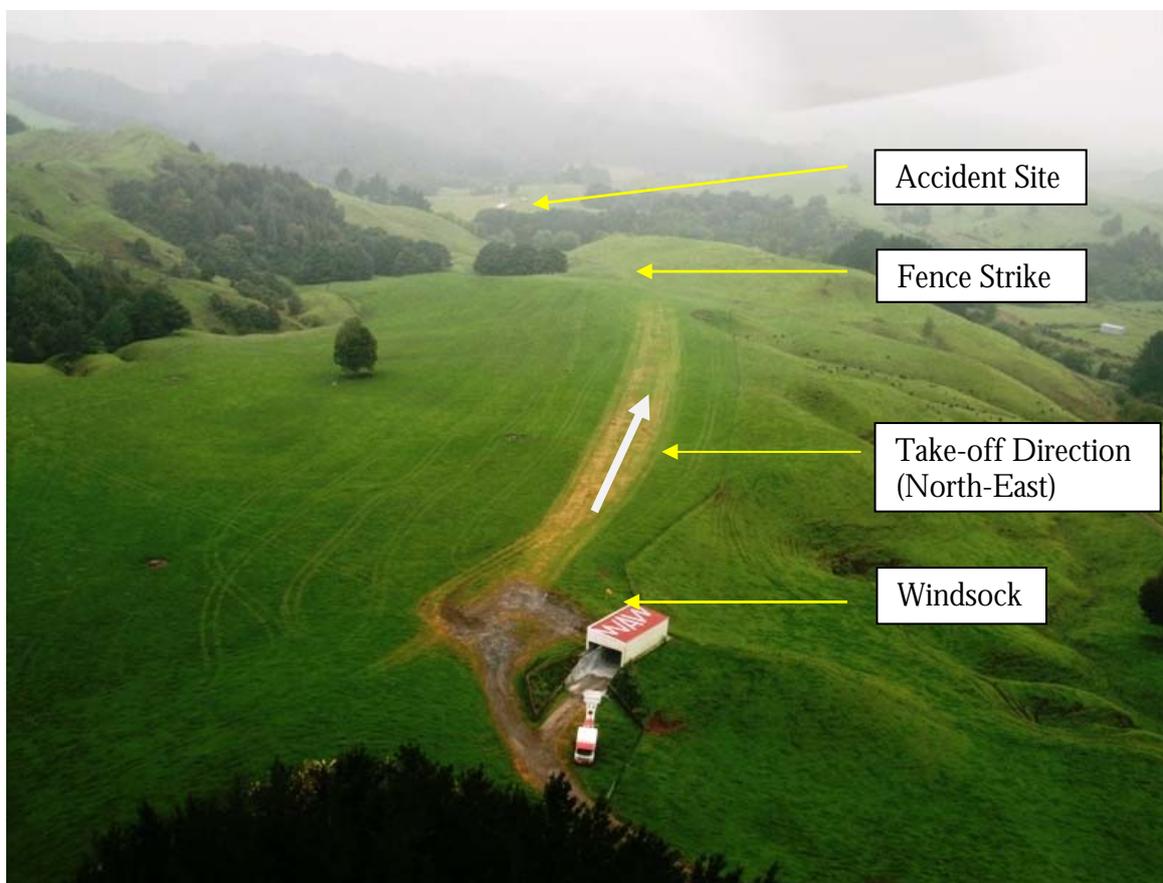
Figure 1: Airstrip Overview

1.10.1 The grassed airstrip runs the length of a small ridge with an elevation of 410 feet amsl. The airstrip is 390 metres in length with a take-off direction towards the north-east. The airstrip surface was generally firm, however some isolated soft patches were observed where the aircraft wheels had broken through the grass layer during the previous flights. The initial 70 metres of the airstrip from the loading area had a down-slope of five degrees. The strip then sloped at a lesser angle to the half-way mark, from where the remainder of the strip was level.

- 1.10.2 A small windsock had been placed adjacent to the loading area on the southern side of the airstrip to indicate wind direction and velocity to the pilot – see Figure 1.

- 2.8 The windsock was positioned adjacent to the loading area on the south side of the airstrip. In this location the windsock would have provided very little useful information to the pilot for take-off and landing. Discussions with experienced agricultural pilots indicated that it would have been more useful to have the windsock located approximately one half to two thirds of the way along the airstrip. This position would give the pilot more useful and reliable wind information during the critical part of the take-off and landing phases of flight.

- 3.7 The windsock was not in the most suitable position to indicate the wind conditions to the pilot.
- 3.8 Partial or full load jettisons had taken place on previous flights, indicating that the pilot was having difficulty achieving the required aircraft performance during or after take-off.

4.3 CAA Safety Action Recommendation (No. 10A989) was raised on 30 November 2009 for the CAA Rotary Wing Unit to advise agricultural pilots and operators as to the best practice with regard to the placement of the windsock(s) to provide the best possible wind information to pilots when operating from remote airstrips.

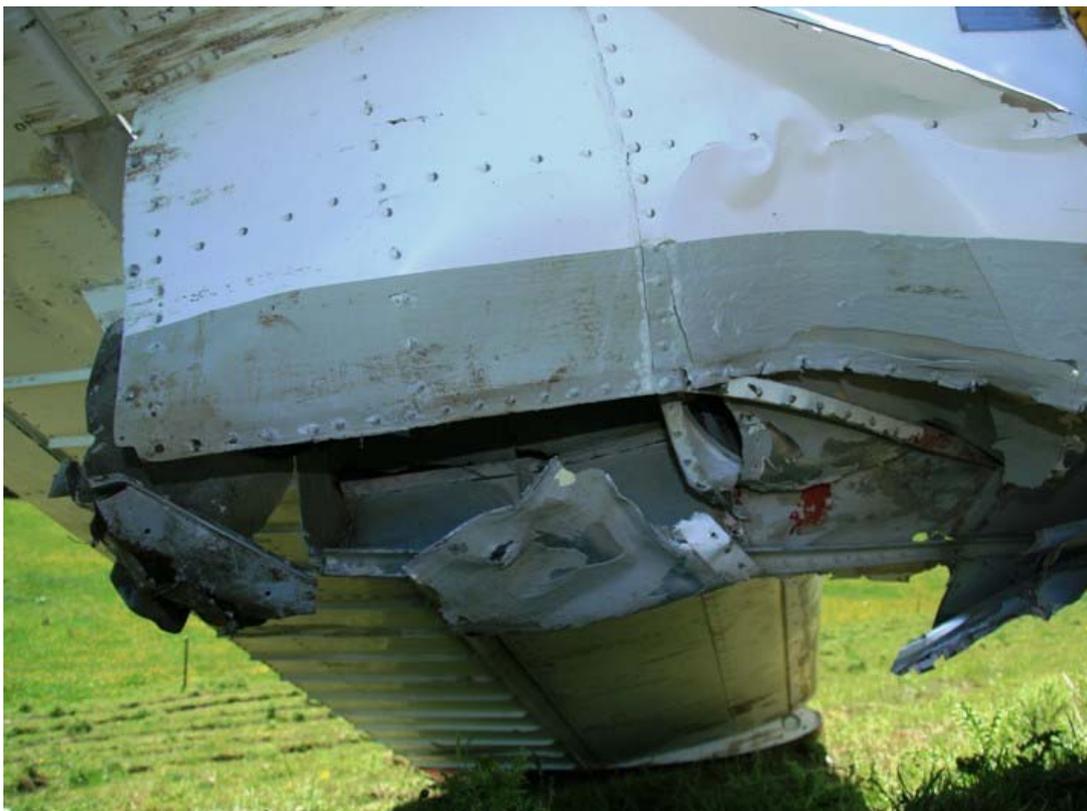
Figure 2: Damage to aft fuselage caused by fence strike

- 1.12.1 Prior to the impact with the fence, the aircraft had turned slightly left after descending off the end of the airstrip. A lime trail, consistent with the hopper contents being jettisoned, commenced 15 metres from the end of the airstrip. The trail continued past the initial point of the fence strike and was visible in an irregular pattern to approximately 500 metres from the end of the airstrip.
- 1.12.2 Along the fence line paint flakes, fibreglass, and small pieces of aluminium were found. The paint flakes and aluminium were identified as coming from the aft lower fuselage of the aircraft just forward of the tail bump stop. The small piece of fibreglass was matched to the tail-cone of the aircraft.

- 2.13 The collision with the fence damaged the lower aft fuselage, jamming the elevator control cable system with the elevator deflected in an aircraft nose-up position. That would have severely limited the pilot's ability to control the aircraft. There was also major structural damage to the fuselage section immediately forward of the tail fin and elevator.

- 3.2 The aircraft had been operating normally from the airstrip up to the time of the accident.
- 3.3 The aircraft descended after take-off and struck a fence. The collision with the fence damaged the elevator control cable system which jammed the elevator control surface. This resulted in the pilot being unable to adequately control the aircraft in pitch, and the aircraft subsequently struck the ground.

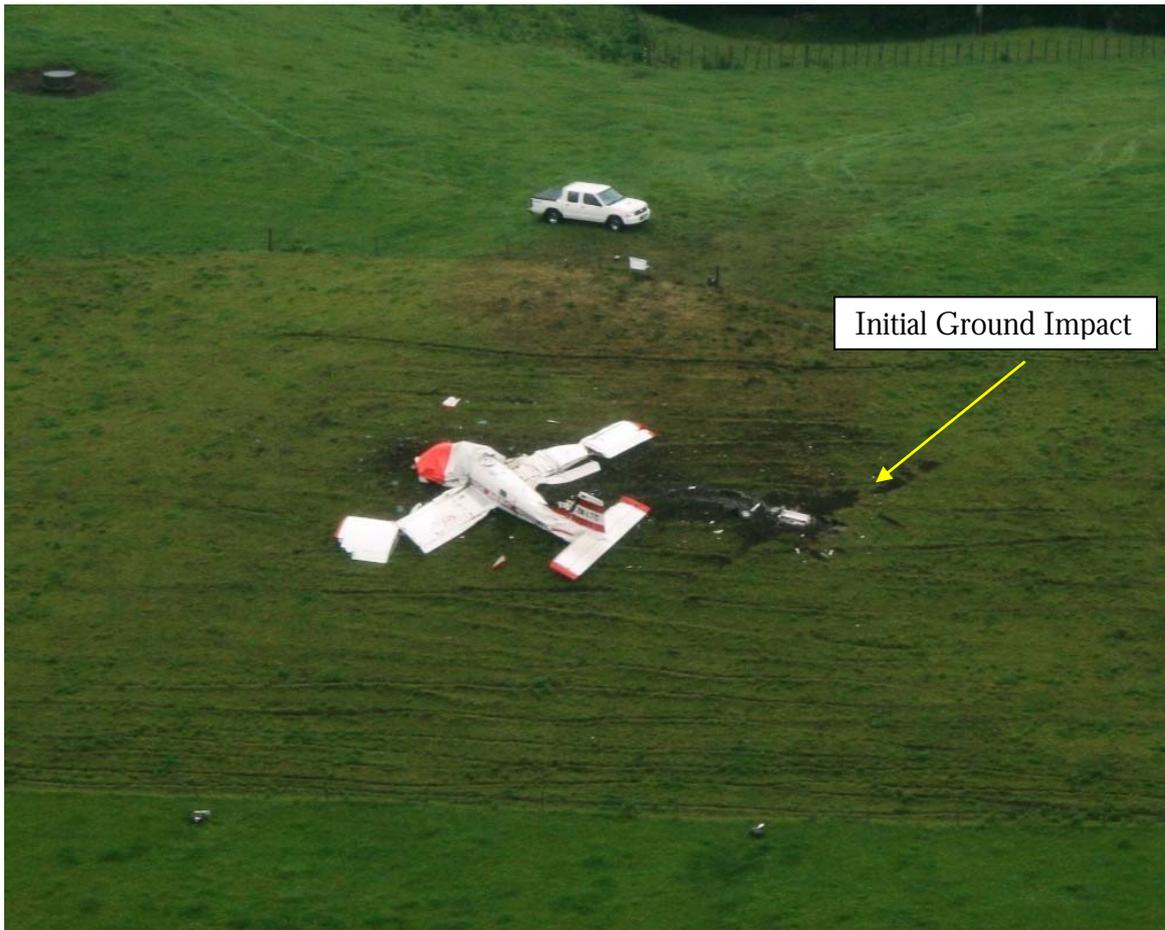
Figure 3: Accident Site

- 1.12.7 After initial ground impact, the aircraft had slewed to the left by 12 metres before finally coming to rest. The outer wing panels had detached from their rear mounts and had slewed forwards. The engine reduction gearbox with propeller attached had almost completely separated from the engine, and was at a 90 degree angle to the right of the aircraft. The tail section was attached but displaced to the right where the fuselage had buckled forward of the tail assembly, possibly due to being weakened by the fence strike and impact forces.

- 1.12.8 All parts of the aircraft were accounted for and the integrity of the flight controls and respective control runs was confirmed. The flaps were in the up (retracted) position with the flap lever in the 30 degree (full down) position. Impact marks on the underside and trailing edge of the flaps suggest that they were down at the time of impact. The flaps and associated operating mechanism were damaged by the main undercarriage wheel assemblies during the accident sequence.

1.12.10 There was major structural deformation of the fuselage forward of the wing. The occupiable space in the cockpit area between the seat and aircraft firewall had been significantly reduced.

- 2.15 The aircraft struck rising ground mid-way up a small hillside. To the left of the rising ground was a flat paddock which would have been suitable for an emergency landing. At the top of the small hill was an open area which also could have been used to land the aircraft. This is possibly what the pilot was attempting to do. Due to the damage received in the fence strike, the pilot most likely had insufficient control to achieve a safe forced landing.
