AIRCRAFT ACCIDENT REPORT
OCCURRENCE NUMBER 06/307
TWO PIPER PA-28-161
ZK - MBD and ZK - MBL
LOCATION 4.4 KM N OF SHANNON
09 FEBRUARY 2006

AIRCRAFT ACCIDENT REPORT

OCCURRENCE No 06/307

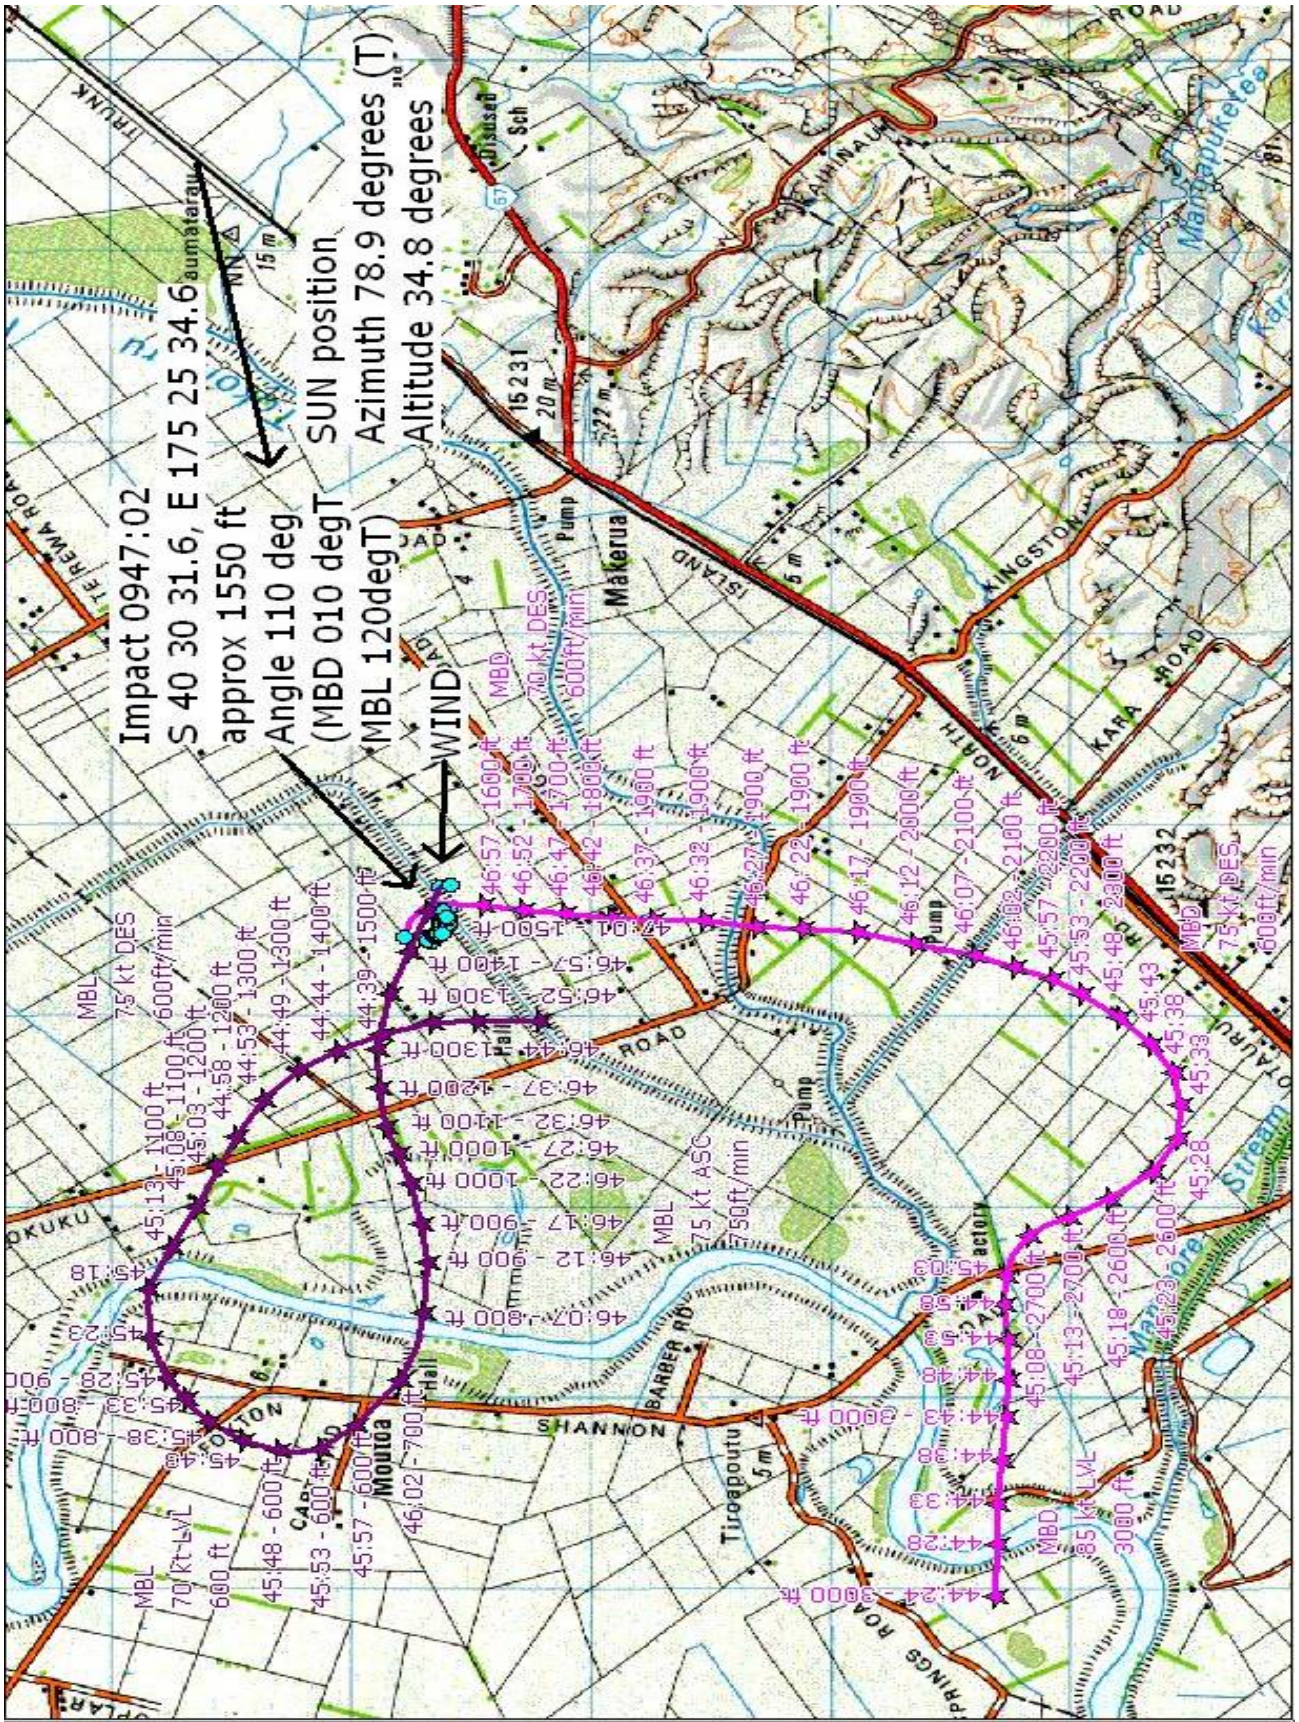
Fig. 1 (Radar Plot)

1.1.6 At 0944:24 NZDT ZK-MBD was flying in an easterly direction and commenced a descent from 3000ft AMSL at a rate of 600ft/min. At 0945:03 the aircraft turned right towards the south before commencing a left hand descending turn through 180° to track towards the north. The aircraft maintained this heading and rate of descent until the collision with ZK-MBL.

At time 0946:32 ZK-MBL commenced a right turn onto a heading of approx 098°M⁵ and maintained this heading until the collision with aircraft ZK-MBD.

1.1.7 Figure 1 depicts the radar plot of both aircraft for the final two and a half minutes prior to collision.

1.12.2 The radar plot showed that ZK-MBD was heading approximately 348°M descending at 600ft/min. ZK-MBL was heading approximately 098°M and climbing at 750ft/min. The collision took place at an altitude of approximately 1550ft AMSL at an angle of 110° relative to each aircraft.

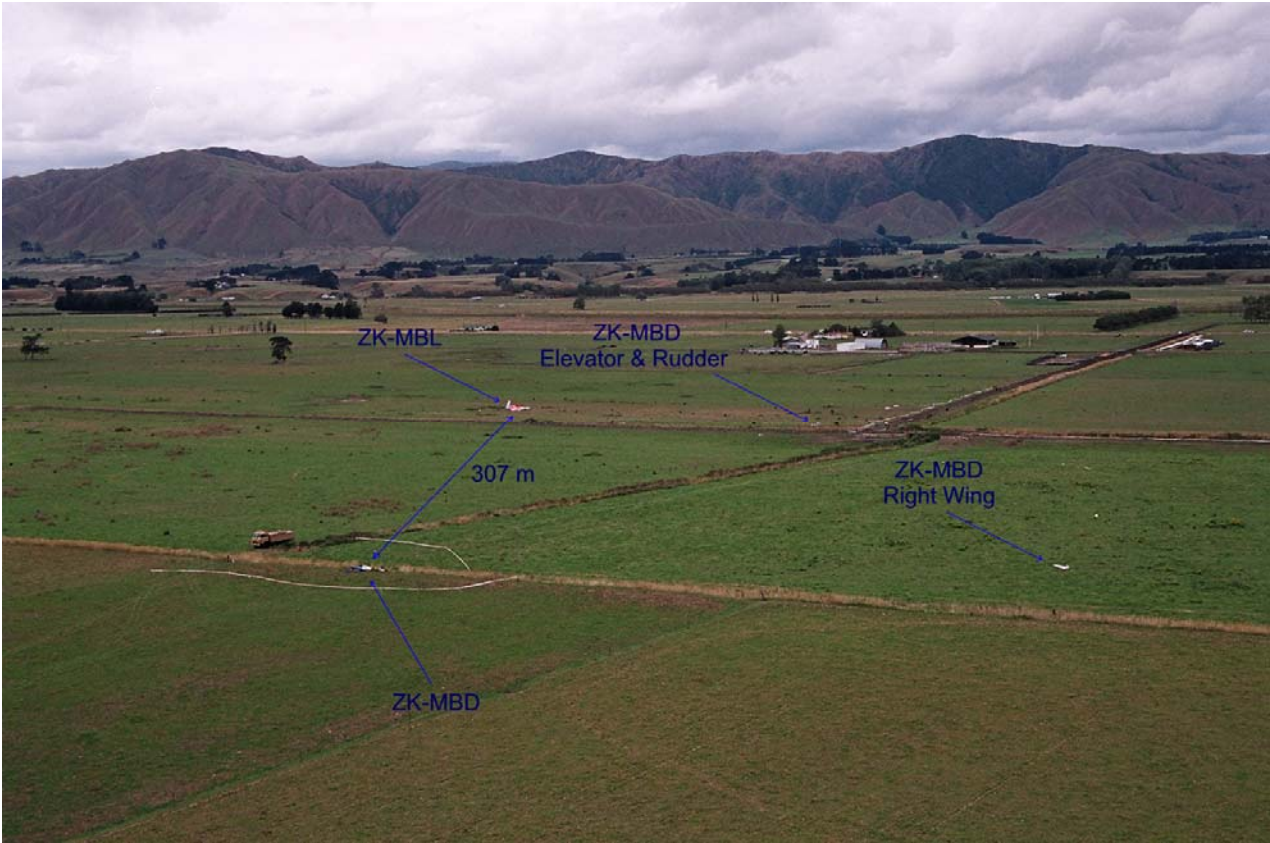
ACCIDENT SITE

1.12.1 The accident site was located in a dry flat pasture approximately 1200m, on a bearing of 003°M from the junction of Okuku and Ngui Roads and 4.4km, 354°M from Shannon. The wreckage of each aircraft was displaced approximately 150 metres east and west of this point.

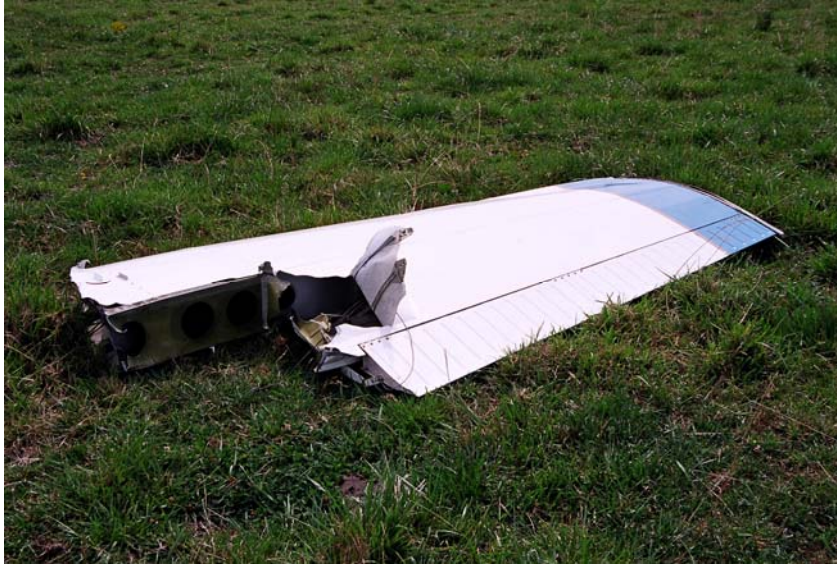
ZK-MBD - Right Wing

- 1.12.5 The aircraft impacted the ground in an almost vertical attitude and came to rest in a drainage ditch on its roof. The majority of the impact forces were absorbed by the engine compartment and roof section.
- 1.12.6 The wreckage trail extended over approx 300m on a heading of 296°M from the mid-air impact point. The wreckage trail consisted mainly of small pieces of aircraft structure and windscreen Perspex™, with some larger components dispersed along the main axis. It was determined that the majority of the debris in the trail was from ZK-MBD.
- 1.12.7 The right wing of ZK-MBD had separated in flight, after being severed by the propeller of ZK-MBL, and fell to the ground approx 100m to the south of the main wreckage.

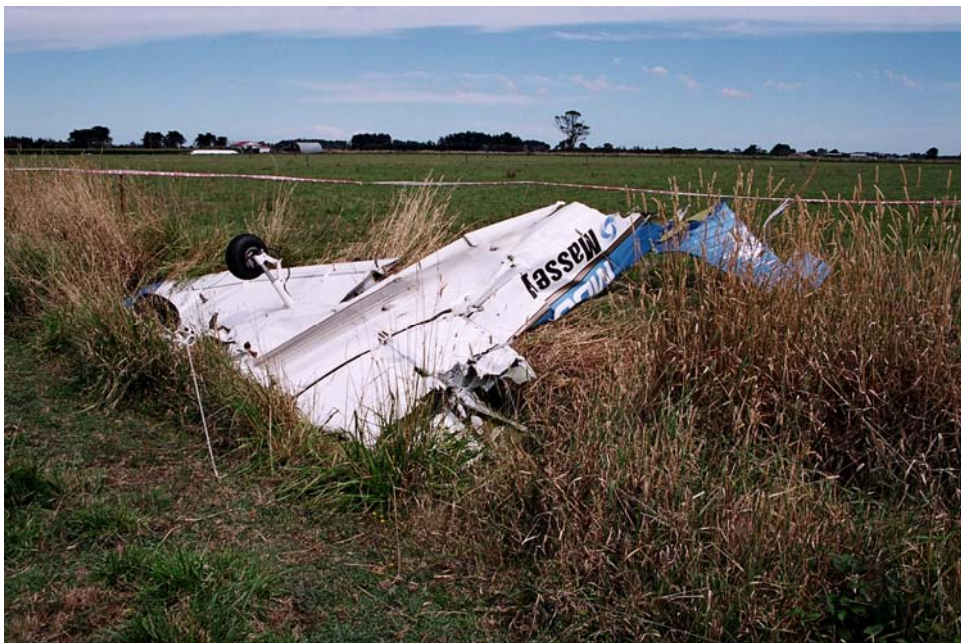
ZK - MBD

- 1.12.8 The horizontal stabiliser and lower portion of the rudder fell almost vertically from the mid-air impact point, as described by a witness, and was displaced 240m from the main fuselage.
- 1.12.9 The right main undercarriage was found near the fuselage of ZK-MBL. There was evidence that it had collided with the right wing of ZK-MBL and had been torn off and carried with that aircraft for some distance.

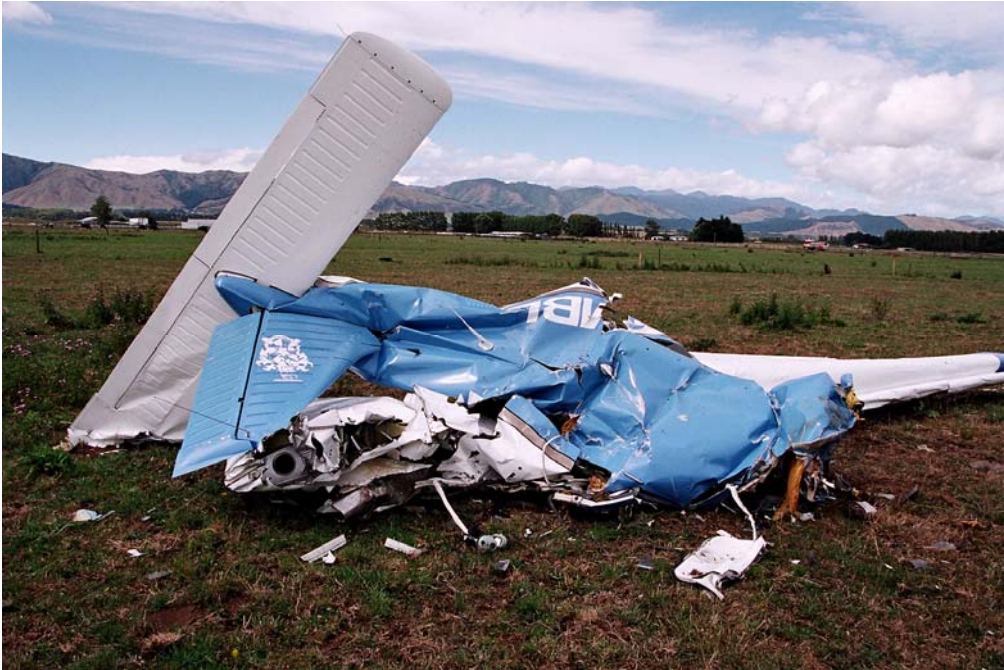
ZK-MBL

- 1.12.10 The aircraft impacted the ground in a vertical attitude making an impact crater of approximately half a metre deep. The impact forces were absorbed mainly by the engine compartment and leading edge of the left wing.
- 1.12.11 The right wing had been severed by impact with the right undercarriage of ZK-MBD, but the wing had been carried with the aircraft attached only by the control cables.
- 1.12.12 The aircraft structure remained intact with very little dispersion over the wreckage trail.

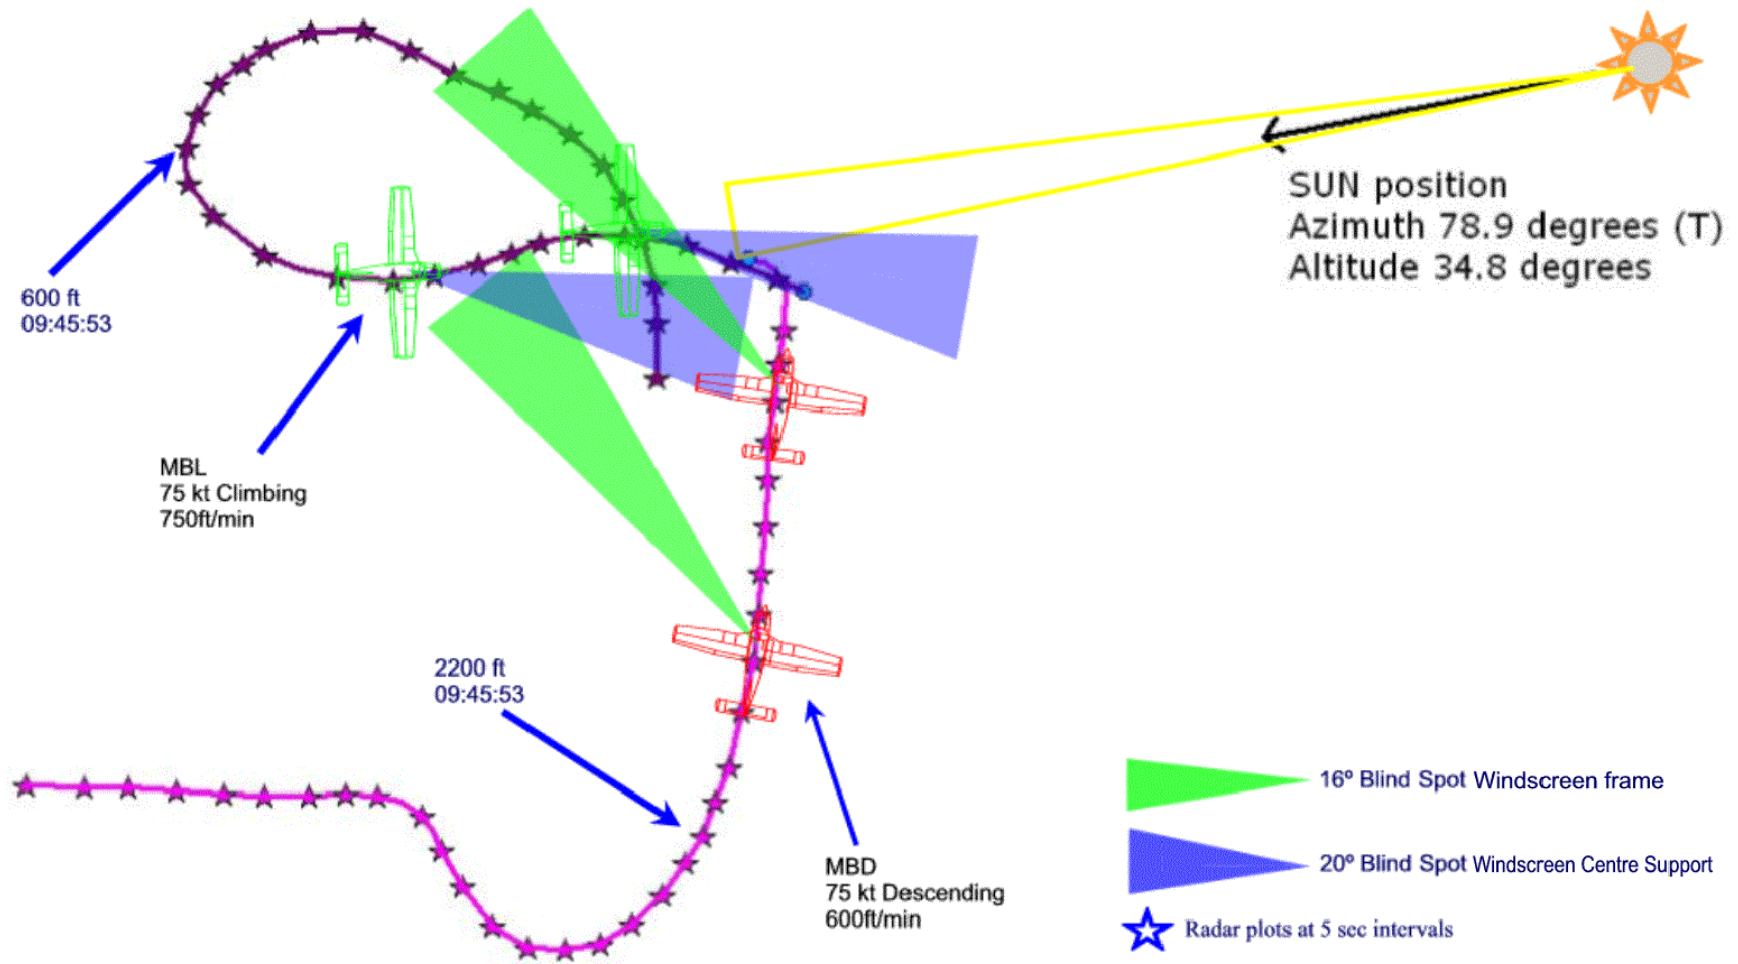
Fig 2 (Blind Spots)

The helicopter had earlier come into close proximity to ZK-MBL. It could not be determined if ZK-MBL had sighted the helicopter, but given the information from the radar plots it is possible that the helicopter was in one of the blind spots outlined in fig 2.

2.3 The sun position and elevation on the day (fig. 2) would have placed aircraft ZK-MBL flying directly into Sun on the climb out after the PFL. This would have made it almost impossible for the pilot to sight other aircraft in the vicinity. It has been determined that the right turn prior to impact may have been an attempt by the pilot to point the aircraft away from the Sun.

- 2.4 The blind spots⁶ of both aircraft were taken into consideration (fig. 2) and it is evident that for the majority of time, prior to collision, each aircraft would have had the other aircraft in a blind spot. Fig 2 does not detail all the blind spots for this type of aircraft, but excludes engine cowl and port wing of ZK-MBD. The blind spots depicted are those considered to be the most contributing factors.
- 2.5 The aircraft collided in mid-air, with ZK-MBL striking ZK-MBD from underneath the left side. The propeller of ZK-MBL severed the right wing of ZK-MBD with the right undercarriage of ZK-MBD severing the right wing of ZK-MBL. The loss of these primary surfaces rendered the aircraft uncontrollable.

⁶ The blind spots depicted in fig.2 are the left side windscreen support (16°) and the centre windscreen brace including the magnetic compass (20°).

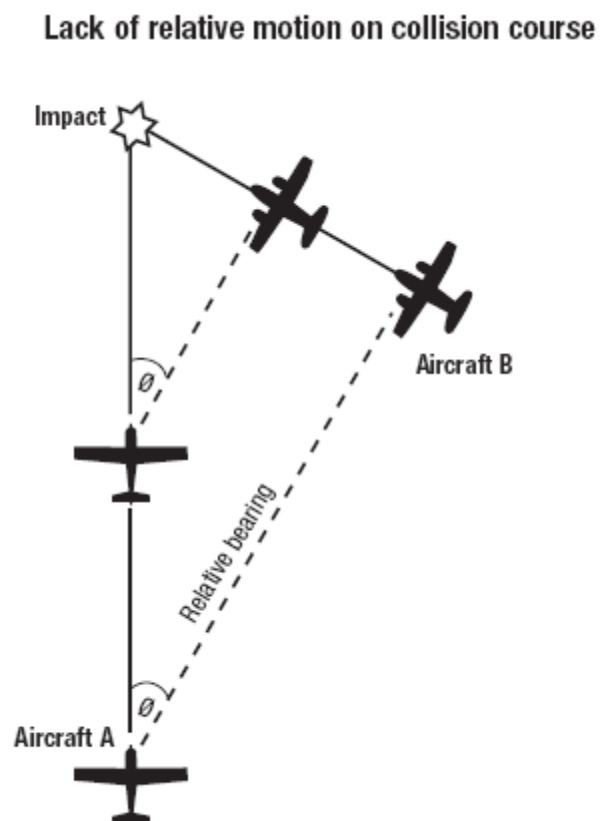
The human visual system is particularly attuned to detecting movement but is less effective at detecting stationary objects. Unfortunately, because of the geometry of collision flight paths, an aircraft on a collision course will usually appear to be a stationary object in the pilot’s visual field.

If two aircraft are converging on a point of impact on straight flight paths at constant speeds, then the bearings of each aircraft from the other will remain constant up to the point of collision. From each pilot’s point of view, the converging aircraft will grow in size while remaining fixed at a particular point in his or her windscreen.

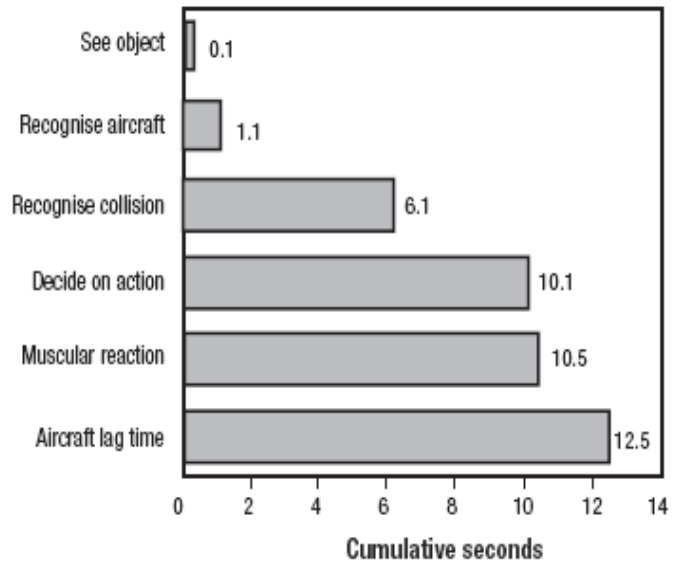
Time to react to collision threat from FAA advisory circular

The United States of America Federal Aviation Administration advisory circular 90-48-C provides military-derived data on the time required for a pilot to recognise an approaching aircraft and execute an evasive manoeuvre. The calculations do not include search times but assume that the target has been detected. The total time to recognise an approaching aircraft, recognise a collision course, decide on action, execute the control movement and allow the aircraft to respond is estimated to be around 12.5 seconds.

Therefore to have a good chance of avoiding a collision, a conflicting aircraft must be detected at least 12.5 seconds prior to the time of impact. However, as individuals differ in their response time, the reaction time for older or less experienced pilots is likely to be greater than 12.5 seconds.
