AIRCRAFT ACCIDENT REPORT
OCCURRENCE NUMBER 03/2557
CESSNA T188C AG HUSKY
ZK-MJD
KAI IWI, NEAR WANGANUI
6 SEPTEMBER 2003

AIRCRAFT ACCIDENT REPORT

OCCURRENCE No 03/2557

Aircraft type, serial number and registration:	Cessna T188C Ag Husky, T18803385T, ZK-MJD
Number and type of engines:	1 Continental TSIO-520-T(3)
Year of manufacture:	1979
Date and time:	6 September 2003, 1515 hours ¹ (approx)
Location:	Kai Iwi, near Wanganui Latitude ² : S 39° 50.5' Longitude: E 174° 55.2'
Type of flight:	Private
Persons on board:	Crew: 1
Injuries:	Crew: 1 fatal
Nature of damage:	Aircraft destroyed
Pilot-in-command's licence:	Commercial Pilot Licence (Aeroplane)
Pilot-in-command's age:	45 years
Pilot-in-command's total flying experience:	1508 hours, 60 on type
Information sources:	Civil Aviation Authority field investigation
Investigator in Charge:	Mr A J Buckingham

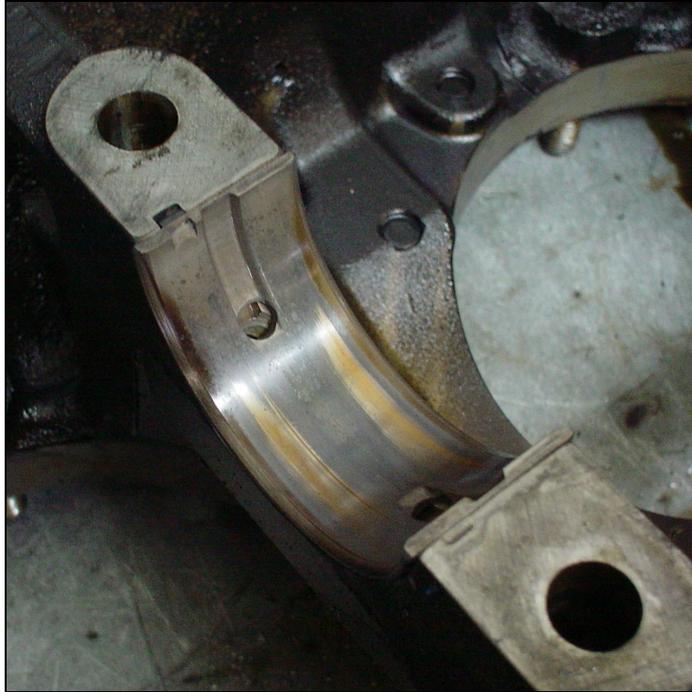
Figure 1: main bearing wear

1.16.6 All main bearings had worn through to the copper layer, and the big end bearing shells had worn through the lead layer. Five of the six inlet valve faces were

- 1.16.7 Apart from the bearing wear, which was consistent with hours run, and the severe wear of the inlet valves (reportedly not uncommon on the turbocharged 520-series engines), no abnormalities were found with the engine.
- 1.16.8 No fuel sample was available from the engine, but a sample from the farm installation was tested after a black deposit appeared when the sample was swirled in a glass container. The contaminant was a mixture of fine sand, dust, and unidentified fibre particles, all fine enough to pass through the in-line filter used on the installation.

- 2.6 Although there was no firm link established between the engine’s condition and the accident, it is nonetheless disturbing to find that the engine was in poor internal condition, particularly with badly-worn main and big-end bearings, and severely worn faces on five of the six inlet valves. The latter, even if they did not contribute to the accident situation, were undoubtedly going to cause performance problems in the not-too-distant future.

- 3.5 The rules regime that permitted the operation of the engine “on condition” is currently under review, with some major improvements proposed.
- 3.6 Post-accident strip examination of the engine found it to be in poor condition, with worn bearings and severely worn inlet valves.

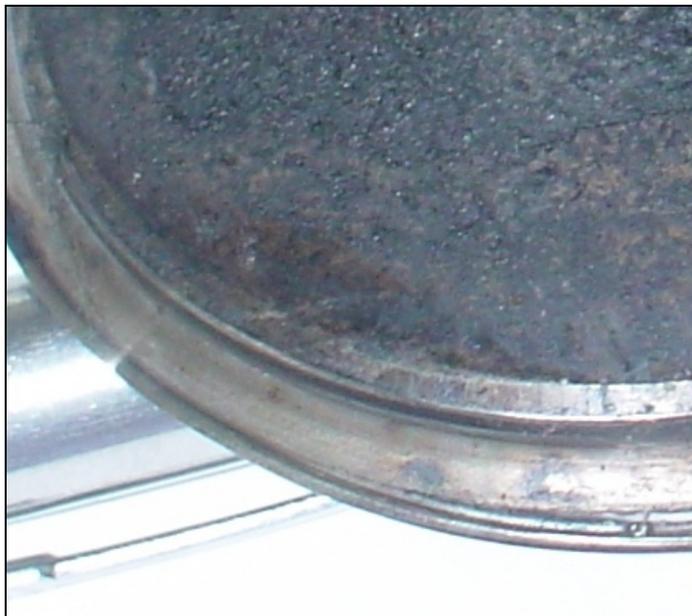
Figure 2: number 5 inlet valve wear

found severely worn, outside manufacturer's limits. See figures 1 and 2 respectively.

(Note - there is some impact damage on outer edge)
