**CAA Safety Investigation Report**  
**Engine failure after take-off**  
**ZK-SMF Titan T-51D Mustang**  
**Matamata Aerodrome**  
**18 October 2016**

CAA Final Report 16/5545  
[04 October 2018]

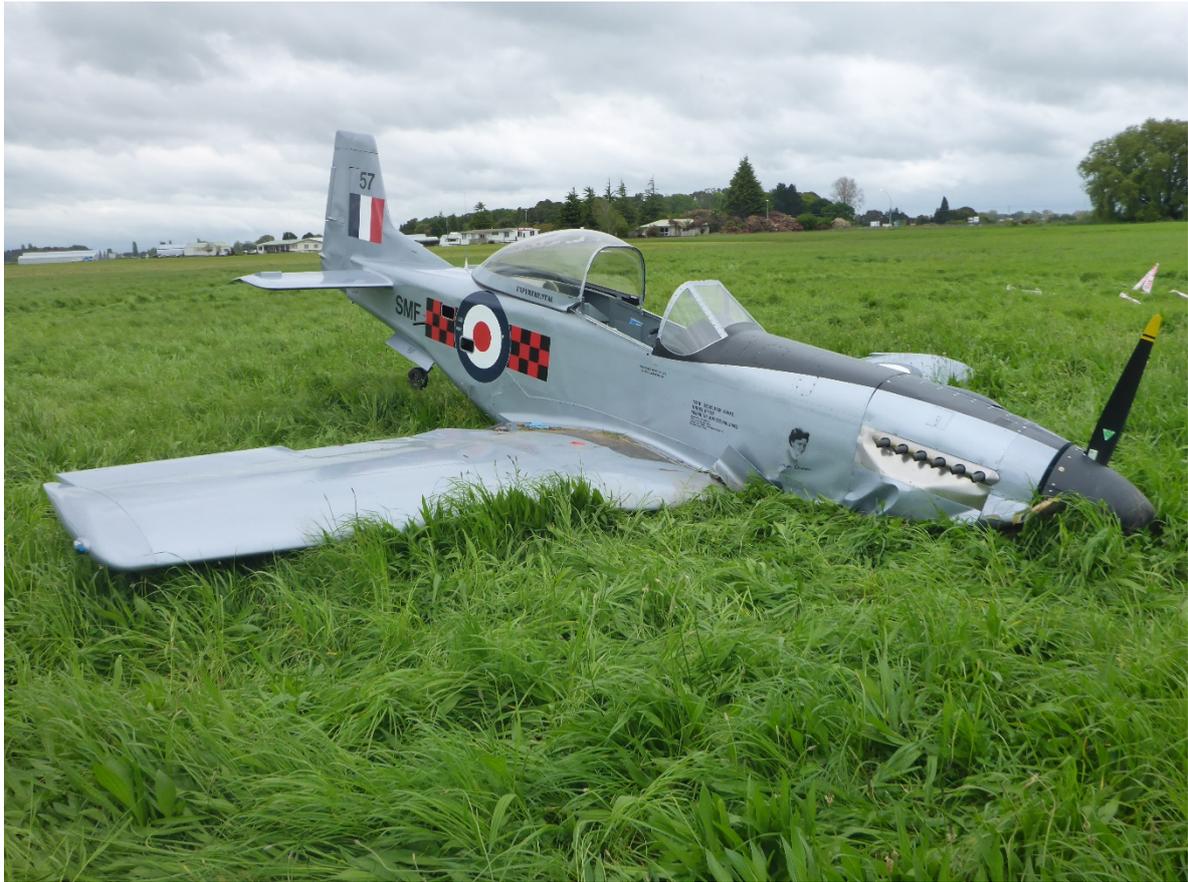
Figure 3: Accident site (CAA photograph)

On the day of the accident the pilot had intended to carry out a local flight. During take-off, an engine power loss occurred at approximately 250 feet above ground level (AGL). The aircraft was observed to descend steeply and strike the ground approximately 40 metres off the end of the runway.

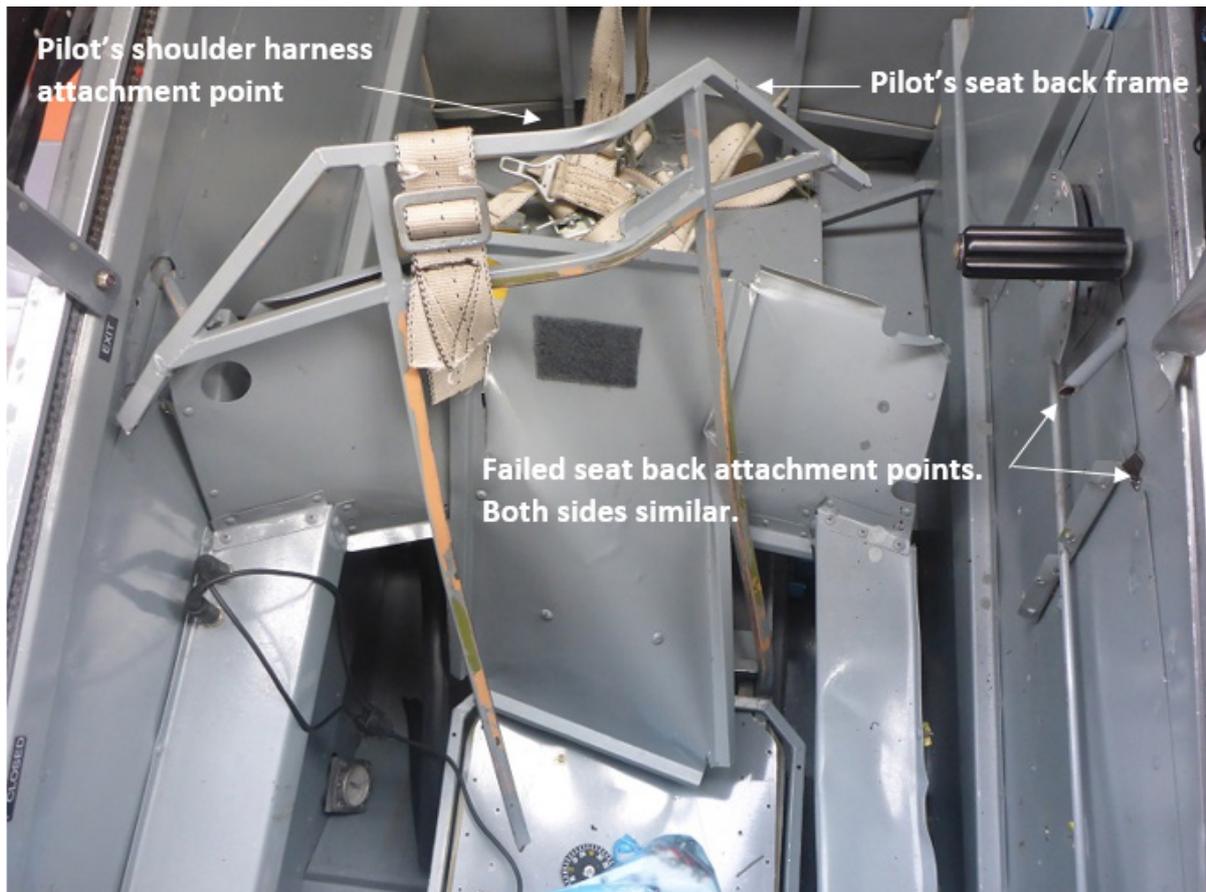
When the aircraft struck the ground, the forces applied to the seat back frame by the pilot’s weight on the shoulder harness caused the pilot’s seat back to fail (Refer to figure 4). This resulted in the pilot’s upper body being unrestrained allowing him to flail forward and strike the instrument panel. The resulting blunt force trauma injuries proved to be fatal.

During aircraft construction, the top bar of the pilot’s seat back frame was chosen as the anchor point for the seat belt shoulder harness. The CAA safety investigation determined that the shoulder harness attachment point to the aircraft structure, had not been specified by the Titan Aircraft Company. However, given the length of the harness webbing supplied with the kitset, it can only be attached to the upper or lower horizontal bars on the pilot’s seat back.

Figure 4: Failed pilot seat back frame. Shoulder straps were cut by first responders (CAA photograph)

- *The failure of the frame was due to the inability to accommodate the load applied during impact to the frame by the seat belt without dynamic deformation and ductile fracture of the frame elements and fixtures*
- *The weld quality was acceptable*
- *The frame material was identified as low alloy steel AISI 4130 in a normalised and tempered condition*

As a result of this accident, and following advice from the kitset manufacturer, CAA Continuing Airworthiness Notice 25-001 *Titan Aircraft Company T-51D Mustang – Seat Belt Attachment* was raised. The Continuing Airworthiness Notice advises that the Titan Aircraft Company does not recommend attaching the shoulder harness restraint to the upper bar on the seat back frame (Refer to Appendix 1).

*It is recommended that the seat structure could be strengthened by repositioning the seat belt attachment and by using larger stay tube, or adding additional bracing to the seat structure.*

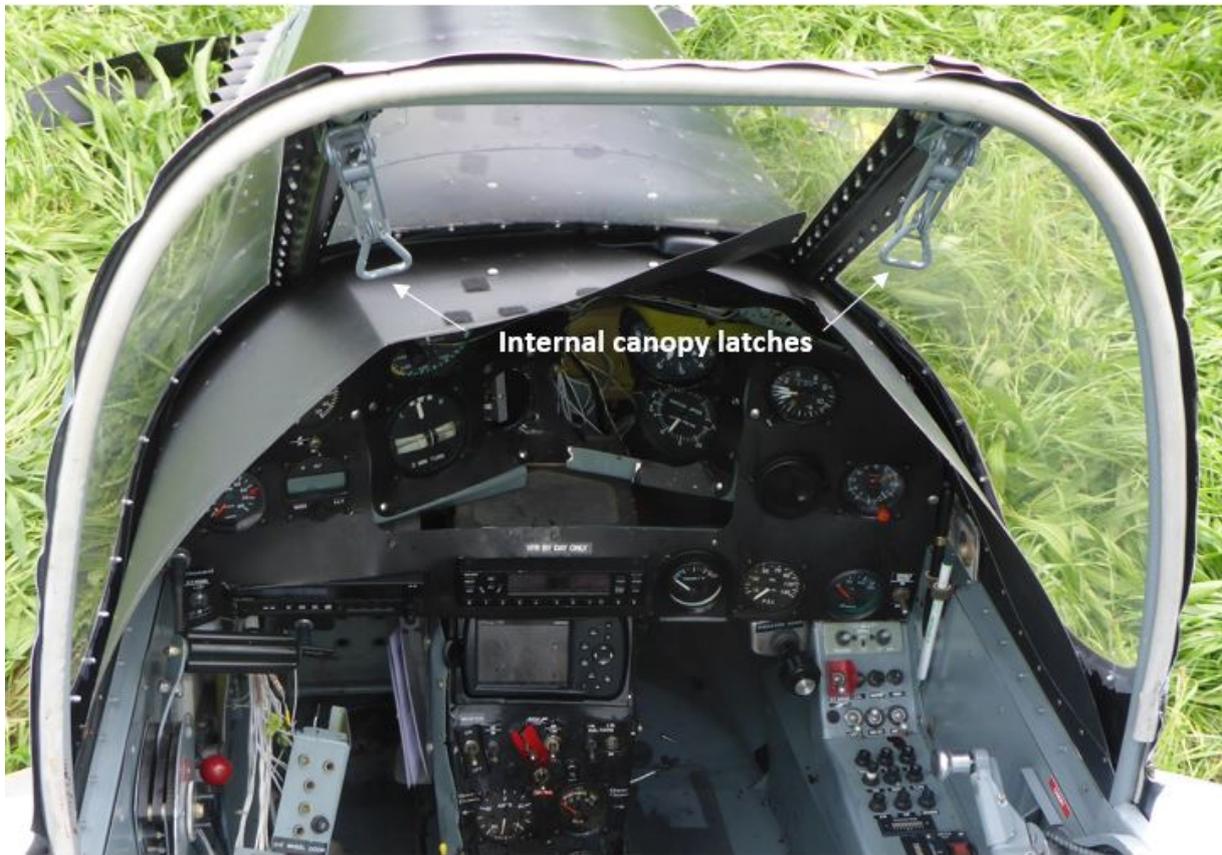
The Titan T-51D Mustang design provides for an external canopy release button, which on ZK-SMF was located on the right side of the fuselage. The pilot had modified the method of locking the canopy closed, by installing a locking mechanism which was accessible only from inside the cockpit (refer to Figure 5).

This modification made external access to the cockpit extremely difficult for the first responders until they managed to forcibly gain access to the internal canopy locks and open the cockpit canopy.

Figure 5: internal canopy latches installed by the pilot

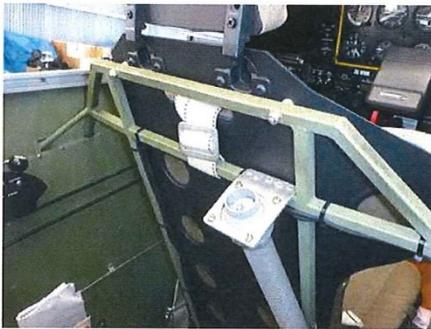
Shoulder harness attachment – correct position.

According to Titan Aircraft Company the attachment of the shoulder harness to the upper bar of the seatback frame is not a factory recommended position. To reduce the leverage on the seatback frame the shoulder harness should be attached to the lower bar of the seatback frame.

The CAA recommends an inspection of the shoulder harnesses for both the front and rear seats to determine the attachment position of the shoulder harness. If a shoulder harness is found attached to the upper bar, then reposition and attach the harness to the lower bar of the seatback frame.
