AIRCRAFT ACCIDENT REPORT
CAA OCCURRENCE NUMBER 11/1504
DYN'AERO MCR 01 CLUB
ZK-SML
CONTROLLED FLIGHT INTO TERRAIN
MOUNT DUPPA
09 APRIL 2011

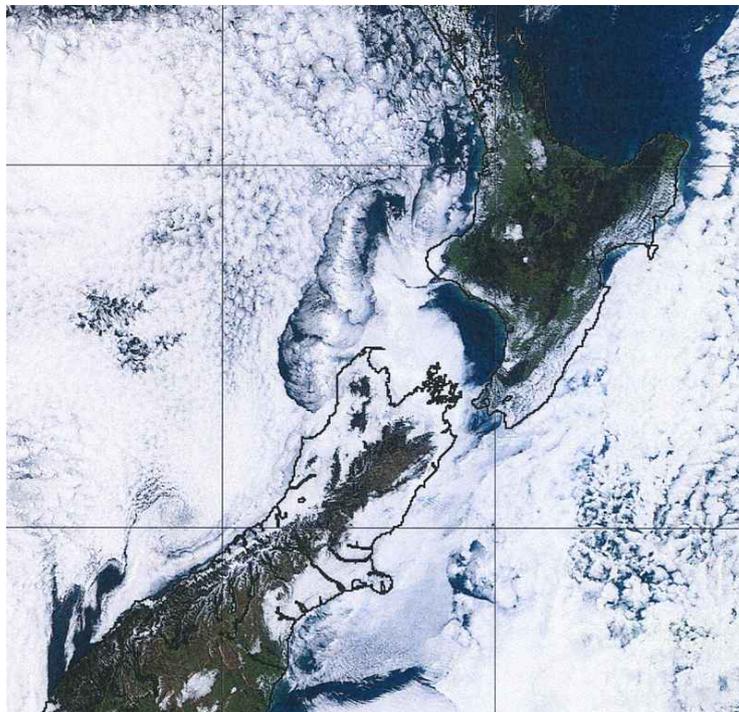
Figure 1: Satellite Imagery

- 1.7.1 At midday on the day of the accident, a large anticyclone was centred in the Tasman Sea. A south to south-west airstream covered the North Island and the north of the South Island, however a localised low level northerly airstream affected the top of the South Island.
- 1.7.2 Satellite imagery taken at approximately 1100 hours on the day of the accident shows extensive Stratocumulus type cloud cover surrounding the upper South Island. Refer to figure 1 below.

- 1.7.5 Two experienced pilots, both of whom had either been flying or driving through the Bryant Range area around the time of the accident, described the weather conditions being extremely poor with a low cloud base of approximately 1200 feet AGL and a light drizzle. The majority of the Bryant Range including Mount Duppa was obscured by cloud.

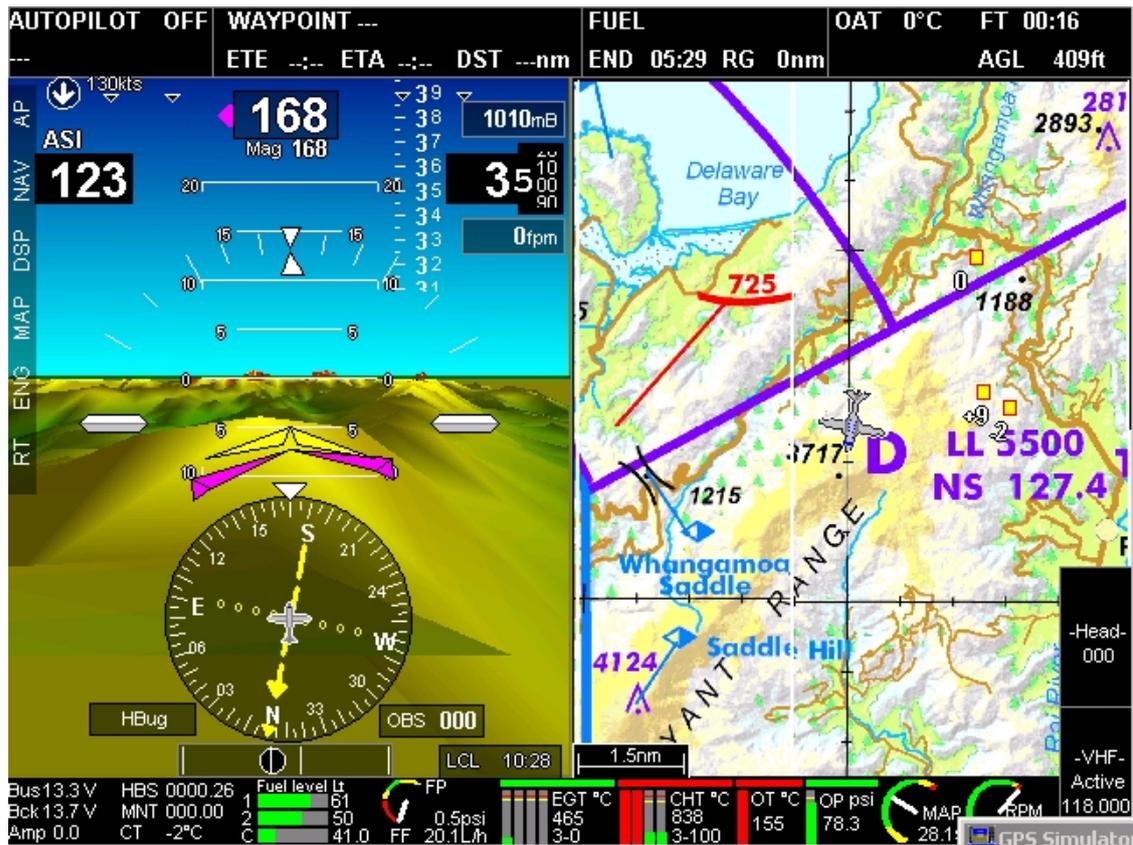
Figure 2: EFIS screen display

- 1.16.2 It was found that the moving map display did not accurately display the 3717 feet spot height for Mount Duppa. Due to the positioning of a map join which passes through the '3', the spot height for Mount Duppa was corrupted and was displayed as 1717 feet. Refer to the spot height next to the aircraft symbol on the map display in figure 2.

- 1.16.3 A further error affected the synthetic terrain display and warnings. An error of approximately 600 feet existed between the actual terrain height and the modelled terrain height in the EFIS terrain data base for the accident flight. This error led to the synthetic terrain displaying terrain indications associated with the modelled terrain of approximately 600 feet lower than the actual terrain.

- 1.16.4 The New Zealand agent for MGL Avionics Ltd immediately contacted the manufacturer and reported these errors. It transpired that the New Zealand terrain data used by MGL Avionics Ltd was based on publically available terrain data available from NASA. The NASA terrain data used averages of the surrounding spot heights which had induced errors leading to the under reading of the actual terrain heights displayed on the EFIS.

- 2.11 The synthetic terrain colouring displayed on the EFIS screen will show green for when the aircraft's projected flight path clears terrain by greater than 1000 feet AGL, yellow for terrain clearance within 1000 feet AGL, and red, warning that collision with terrain is imminent. The terrain shown immediately ahead of the aircraft (Mount Duppa) displayed to the pilot at the height he approached it was coloured yellow, the correct colouration should have been red. Refer to the left hand screen display in figure 2.

1.16.5 In response to this, MGL Avionics Ltd amended the New Zealand terrain data base by using higher resolution NASA terrain data to reflect the actual spot heights which greatly improved the terrain accuracy. As soon as the amended data base was available, all New Zealand users of the MGL Avionics Enigma and Odyssey systems were notified and supplied with the amended data base.

- 4.1 Immediately after the discovery of the errors in the terrain data base highlighted during the CAA Safety Investigation, MGL Avionics Ltd worked to correct these errors by utilising higher resolution NASA terrain data. New Zealand users of the MGL Avionics EFIS systems were supplied with a corrected terrain data base file on 01 June 2011.
