AIRCRAFT ACCIDENT REPORT

OCCURRENCE NUMBER 05/40

SEAWIND 3000C

ZK-SWT

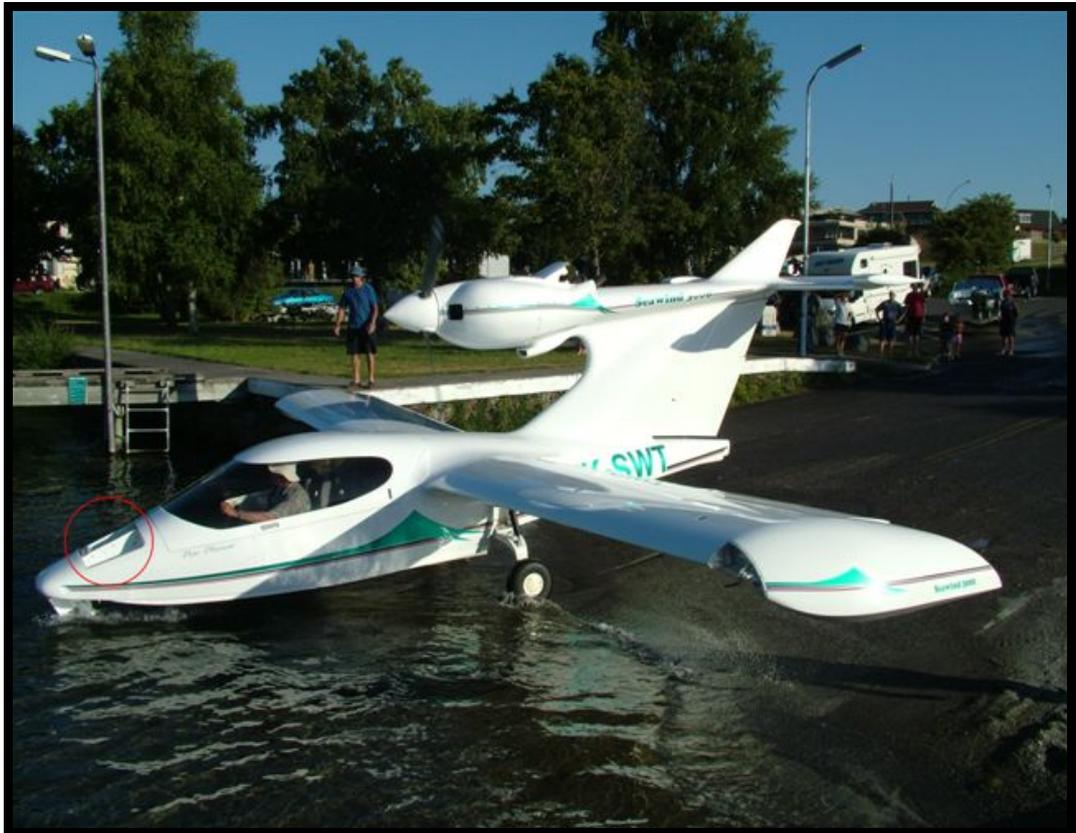
Figure 1: Missing hatch (circled) while leaving boat ramp for third attempt.

2.3 The aircraft struck a wake on the first take-off attempt with sufficient severity to cause bruising to a passenger, and the impact damaged the nose landing gear doors and blew off the nose locker hatch due to the inrush of water through the nose landing gear wheel well. The design of the door system is such that the lightly skinned doors have no internal stop to limit door movement inwards from water contact, and the doors rest on the nose wheel. Water impact forces are transferred to the doors, then the wheel and retraction mechanism. The failure of a ball end in the retraction mechanism at this point (which required a replacement part to be obtained) is significant as the same part was found broken after the fourth and final take-off attempt later in the day. Enquiries revealed that damage to the doors had occurred to this aircraft four times previously and at least once to the other Seawind operated in New Zealand.

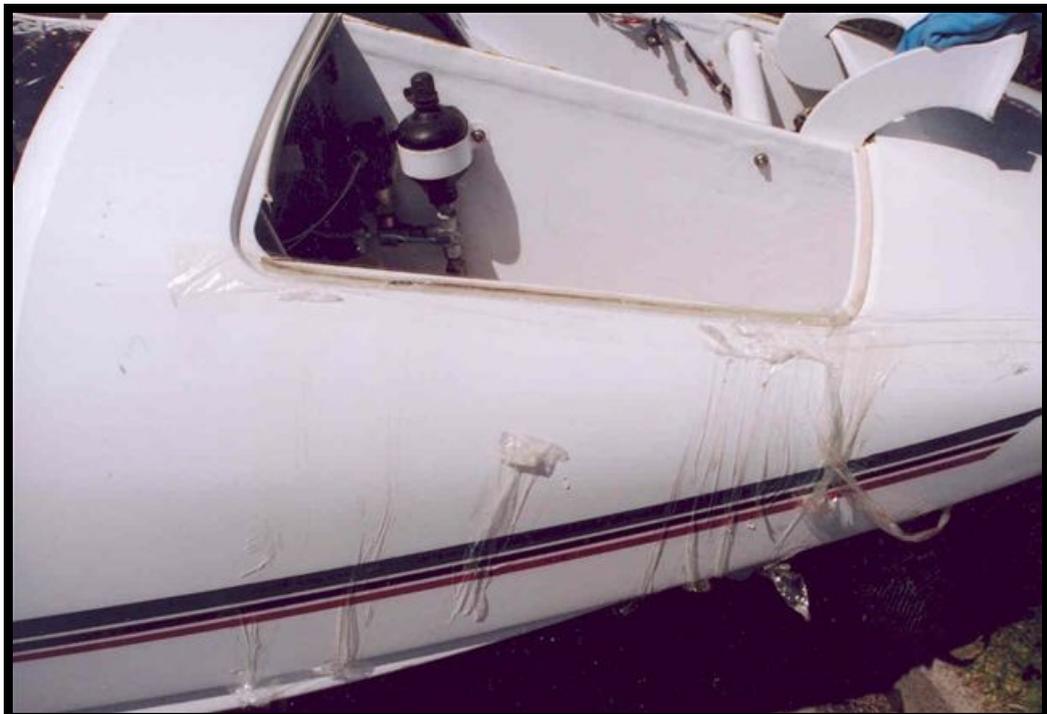
- Mixture: FULL RICH
 - Throttle: IDLE
 - Fuel shut off: ON
- 1.12.6 The nose section inspection showed the nose locker hatch separated at the glue line of the hinge. This had occurred at the first take-off attempt. Lengths of a clear Sellotape type material remained on the hatch and nose section. The red "Danger" sign that had been covering the nose landing gear was found split in two along the fold line and some red dye/ink from the sign had transferred to the right side of the aircraft nose.

Figure 2: Failed Sellotape used to secure nose hatch for flight

- 2.14 The nose locker hatch was also secured with Sellotape. The hatch had previously failed at the hinge, which was a glued joint. The numerous strips of Sellotape showed overload stretching failure consistent with being forced off from a water load coming up through the nose locker. This water entered via the nose landing gear door area. This method of securing the hatch is even more remarkable given the aircraft design with the propeller placed immediately above and behind the cabin, as severe propeller damage would have been likely if the hatch had departed the aircraft during flight.

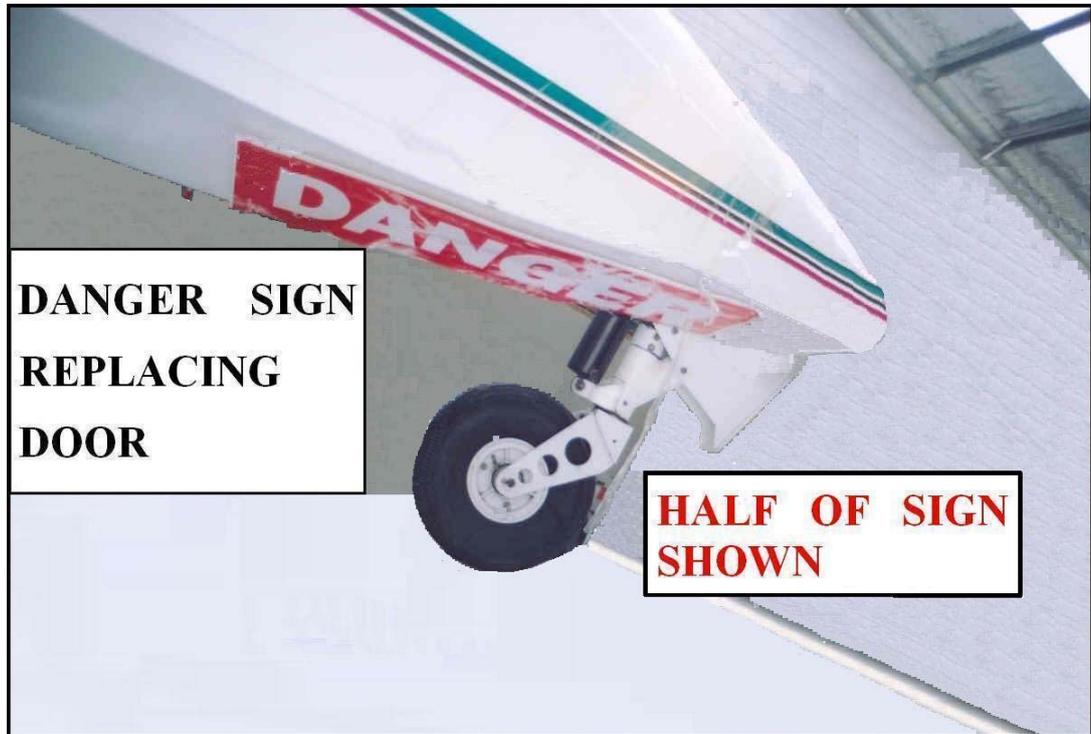
Figure 3: Danger sign fitment with one piece of Sellotape on each side. Nose landing gear would have been retracted.

- 2.13 Attachment of the folded “Danger” sign to cover the nose landing gear area was achieved by application of only one piece of Sellotape either side of the sign, in contrast to the multiple strips of Sellotape used on the hatch. Once the aircraft was airborne it would have been possible to lower the landing gear and “blow” the danger sign off, thus allowing a land based landing at Tauranga airport.

- 3.3 While a number of scenarios exist, no conclusive reason could be determined for the aircraft pitching down onto the water again.
- 3.4 On contact with the water during the pitch-down the signage covering the nose landing gear failed and the bulkhead acted as a water-brake, causing the aircraft to porpoise.

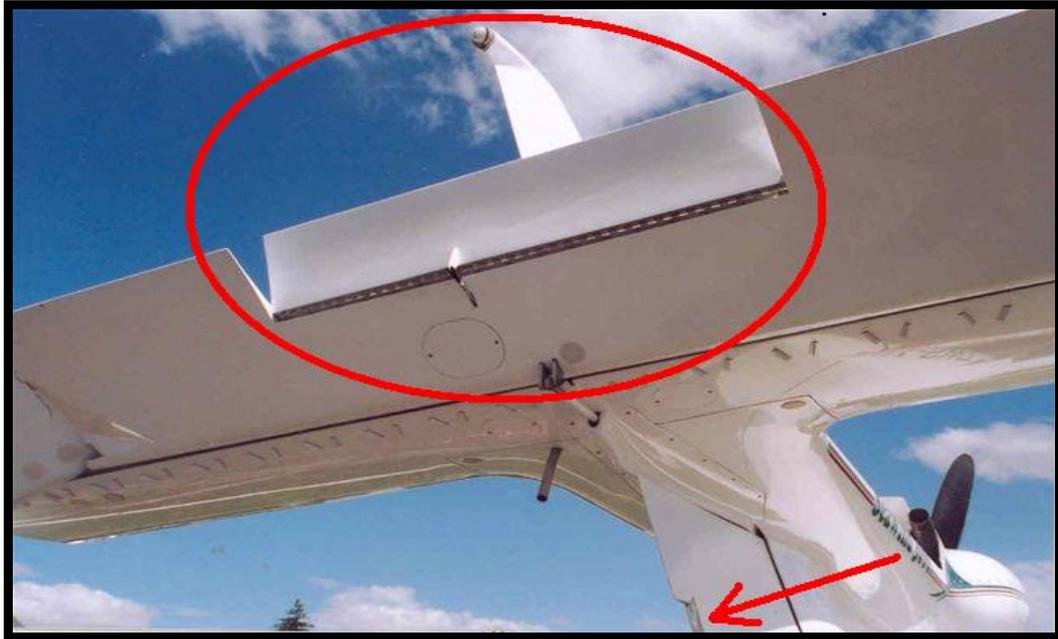
- 2.17 The exact cause of the upset which produced the pitching of the aircraft into the water through porpoising actions could not be identified with certainty. However the aircraft did get airborne off the water. The elevator trim tab being fully up would indicate that the pilot was trimming the aircraft to the nose down position. It was confirmed by examination that the flaps had been set for take-off. The rudder trim was at full right and the aircraft contacted the water left wing down.

- 2.18 The extreme elevator trim position suggests that the aircraft may have been out of balance longitudinally during the take-off. That might be attributed to undetected water in the keel from the previous incidents. Also a lateral imbalance may have been present due to a fuel imbalance from previously working on the aircraft while beached – the left wing was the low wing during that work exercise. These possibilities could not be determined at the accident site. The elevator trim is an electric trim system which could have motored to that position after the accident due to water contact. An experienced operator in Australia also raised the possibility of inadvertent trimming of the elevator, which he had experienced and written about. In that article he had suggested a change to the trim switch.

Fig 4: Elevator trim tab (circled) trimmed Nose Down, and rudder trim tab (arrowed) deflected full Right.

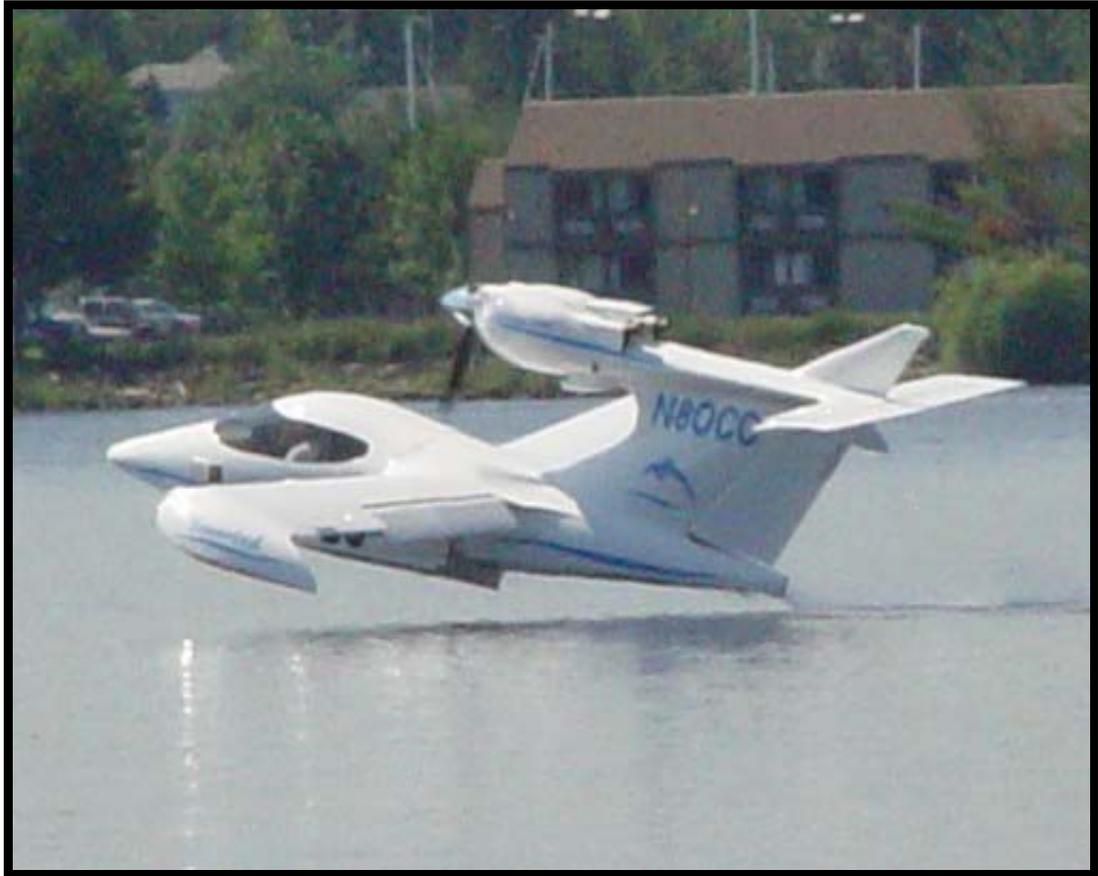
Fig 5: Typical take off attitude in smooth water conditions.

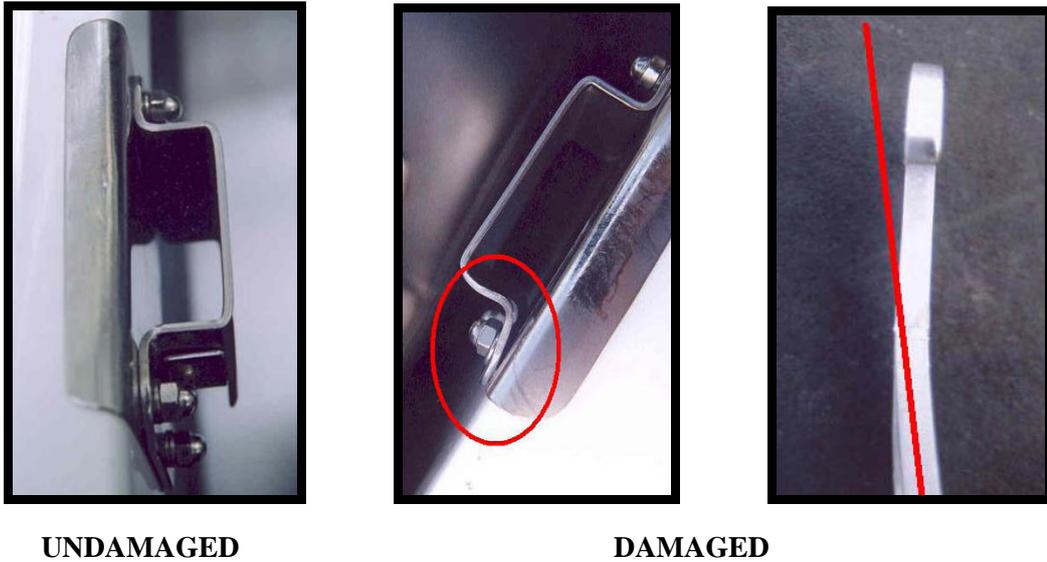
- 1.12.4 The cockpit canopy was shattered with only the rearmost section remaining. The canopy latch on the right (passenger's) side was distorted while the left (pilot's) side latch was undamaged.

- 2.24 The aircraft entered the water left wing down and the cabin canopy was forced off to the right. The loss of the canopy probably contributed to the pilot's head injuries rendering him unconscious. That circumstance, combined with the aircraft flipping inverted in the water, turned this survivable accident into a fatality.
- 2.25 The lack of any damage to the pilot's side cabin latching mechanism consistent with that found on the passengers latch mechanism indicates that the pilot's side may have been unlatched, although the departure sequence of the canopy could not be determined as it was not recovered.

Figure 6: CANOPY LATCHES: pilot's undamaged latch bracket (left) and passenger's damaged latch bracket (centre) and bent latch (right).
