Safety Investigation Brief

Landing Accident on Waitemata Harbour

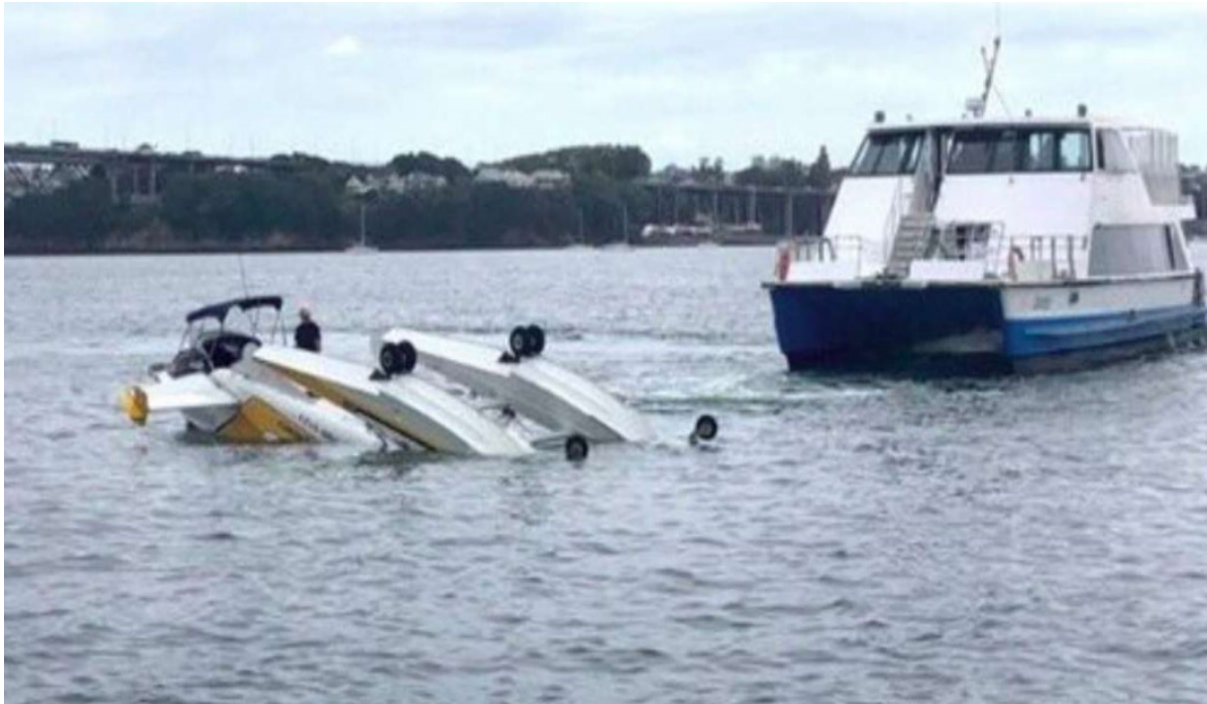
The amphibious floatplane landed on the Auckland Harbour water aerodrome and tipped over during the landing. It remained afloat but inverted, supported only by its floats (refer Figure 1). The pilot in command was the only person on board.

The aircraft was being re-positioned from Ardmore Aerodrome. Observers on the ground at the aerodrome noticed that the aircraft's wheels were not retracted after take-off.

Observers in the vicinity of the Auckland Harbour water aerodrome also noted that the aircraft's wheels were down during its approach and landing.

The pilot omitted to raise the wheels after take-off from Ardmore Aerodrome and did not use the required cockpit checklist when executing the flight. He instead relied on his memory to carry out the various checks.

Figure 1. Inverted floatplane showing wheels extended.
