CAA OCCURRENCE 22/554

Sonex Aircraft LLC Waixex

ZK-YEX

ENGINE POWER LOSS AND LOSS OF CONTROL AFTER TAKE-OFF

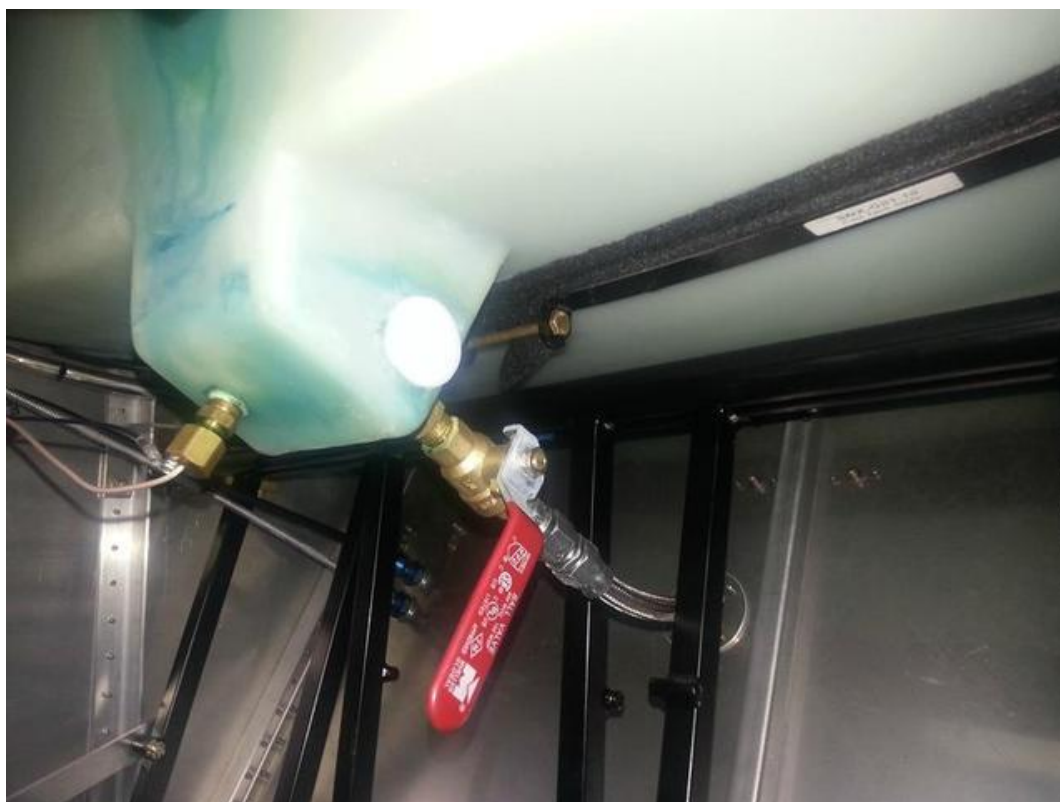
- 1.5.10 The fuel supply from the fuel tank passed through a conventional in-line shut-off valve situated in the fuel supply line at the outlet of the fuel tank sump, see figure 1. An electric fuel pump and an engine-driven, diaphragm-type fuel pump delivered the fuel to the carburettor. The location of the fuel shut-off valve is close to the pilot's legs when their feet are on the rudder pedals.

- 1.5.11 The handle of the fuel shut-off valve installed in ZK-YEX had been extended. The extension was designed to show a placard when in the 'off' position. This type of local modification is permitted by the civil aviation rules (CARs) for microlight aircraft. It could not be determined whether the pilot could notice the 'off' position placard without actively checking.

Figure 1. Example of Sonex Waix fuel shut-off valve in the 'off' position. Source: Chris Madsen (2015), accessed May 2023, [SonexBuilders.net](https://sonexbuilders.net)

- 1.5.12 The CFI reported that the pilot tended to open and close the fuel shut-off valve using his feet, when seated in the aircraft, as it was difficult to reach the valve lever to move it by hand. The flight manual procedure for starting the engine included a check that the fuel valve is selected to 'on'. For the 'on' selection, the handle is moved forward, away from the pilot.

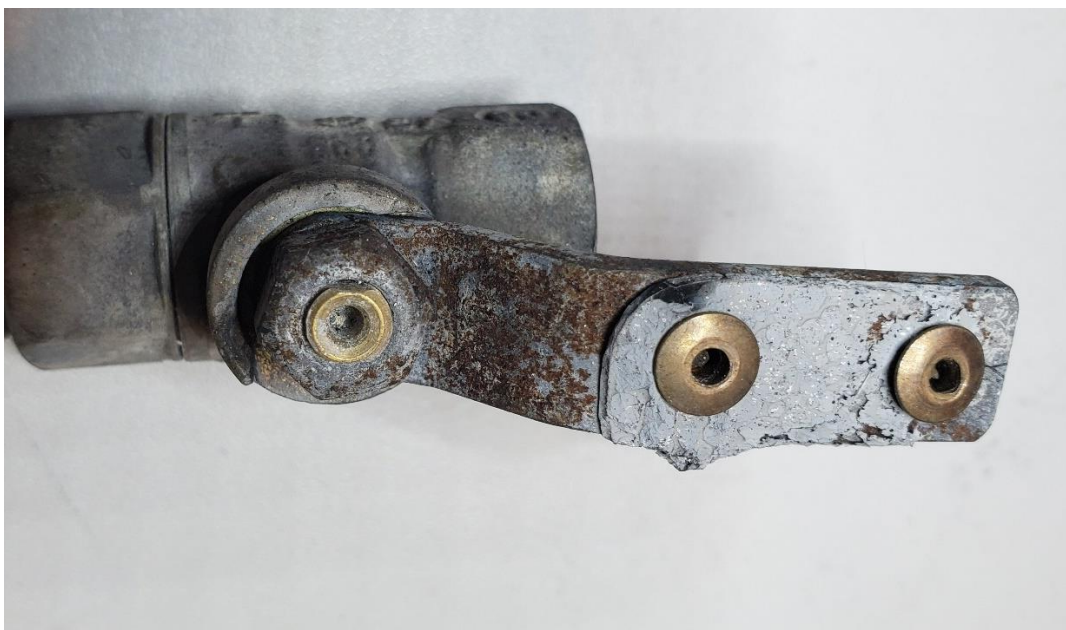
Figure 2. Fuel shut-off valve from ZK-YEX showing remnants of the handle extension, post-accident. (Note the position of the handle in the photograph does not reflect a position pre-impact). Source: CAA photo.

- 2.5 Possible reasons for in flight fuel starvation include unintended interference with the fuel shut off valve, a blockage in the engine fuel system including the fuel pump, a blockage in the airframe fuel system, a blockage in the fuel tank vent. None of these possibilities could be positively determined as being a factor in the accident, due to the aircraft being consumed by fire.

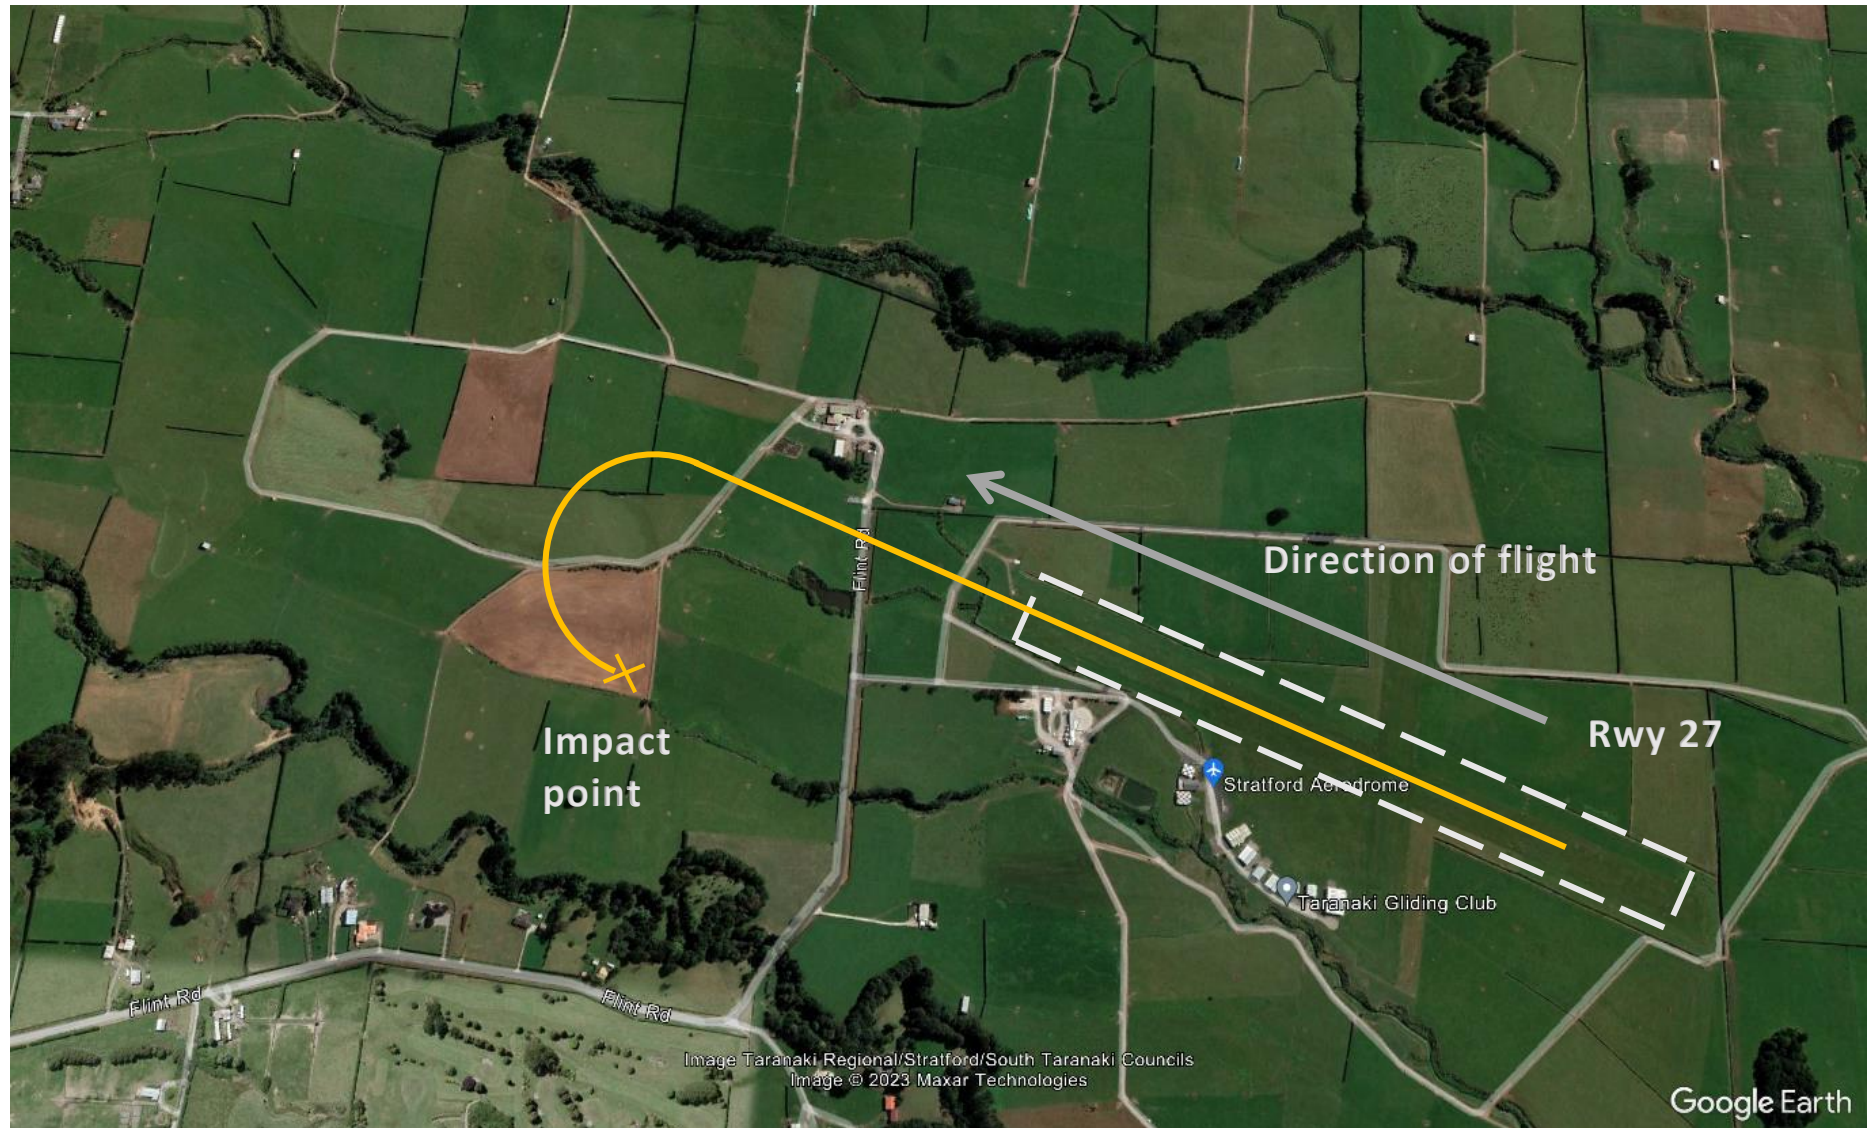
- 2.6 It is likely that, faced with a rough-running engine and partial loss of power at a height of 200-300 feet, the pilot decided to attempt a return to the aerodrome and initiated a left turn against the published circuit direction. There was an option available to the pilot to conduct an emergency landing straight ahead, see figure 3.

Figure 3. Stratford Aerodrome and approximate flight path of ZK-YEX
