AIRCRAFT ACCIDENT REPORT
OCCURRENCE NUMBER 12/218
AEROSTAR YAK-52TW
ZK-YTW
ELEVATOR CONTROL RESTRICTION
TIMONA PARK, FEILDING
23 JANUARY 2012

1. Factual information

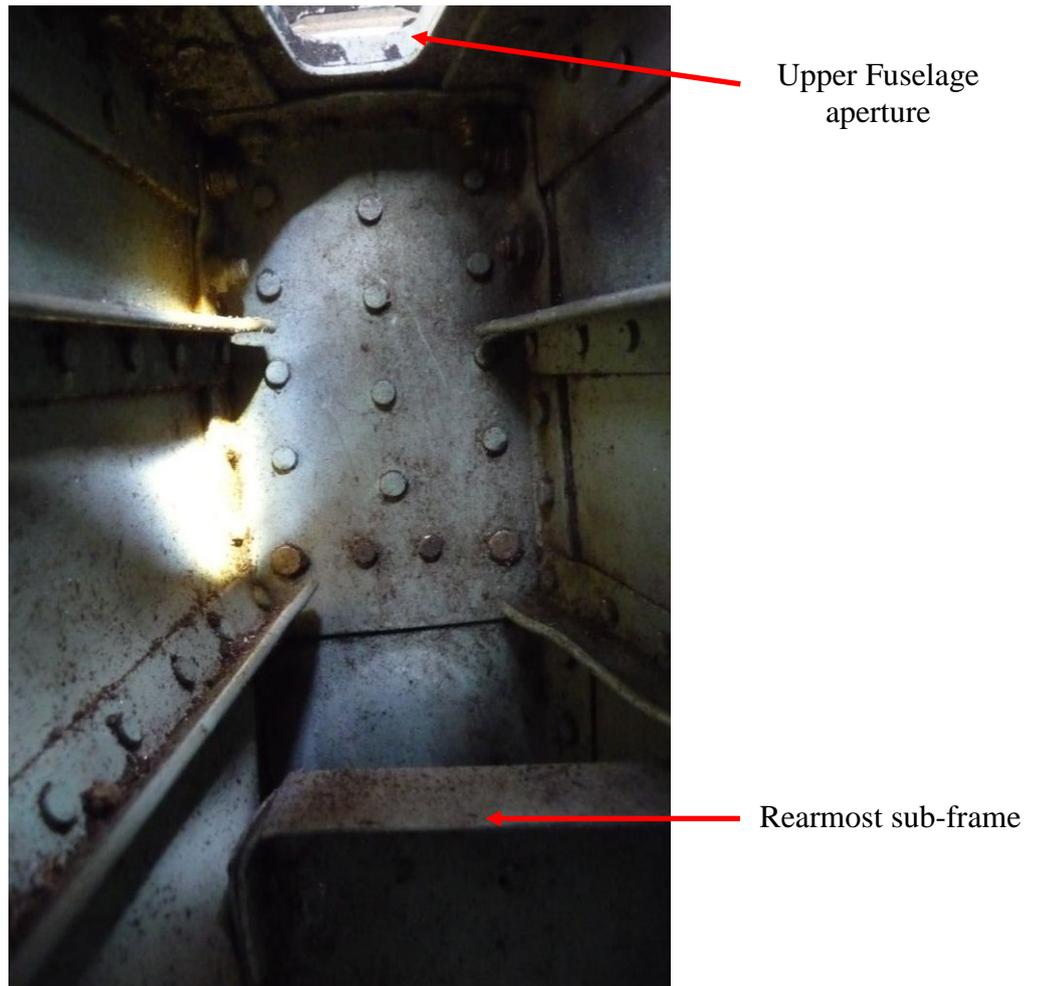
Figure 1: Aperture and Sub-frame illustration ZK-YTW

- 1.6.6 The elevator control functionality on ZK-YTW consisted of a pushrod to connect together the fore and aft control columns. A bell-crank assembly transferred the means of control from pushrod to cables which ran aft to a quadrant mounted inside the aft fuselage. The elevator control surfaces and a mass balance weight were bolted to the quadrant and there was an aperture (see Figure 1), cut into the

top of the aft fuselage to allow the quadrant to pass through thereby providing a full range of elevator travel.

- 1.6.7 Inspection of the aft section of the empennage was achieved from the rear seat in the cockpit, however, rearward viewing would have been compromised by equipment mounted in the rear fuselage. An inspection panel was also provided under the left horizontal stabiliser. However, owing to the tail-wheel installation, a strengthening sub frame is fitted approximately 75mm forward of the end of the fuselage. This would make inspection of the area behind the subframe impossible without a boroscope type tool. (see Figure 1).

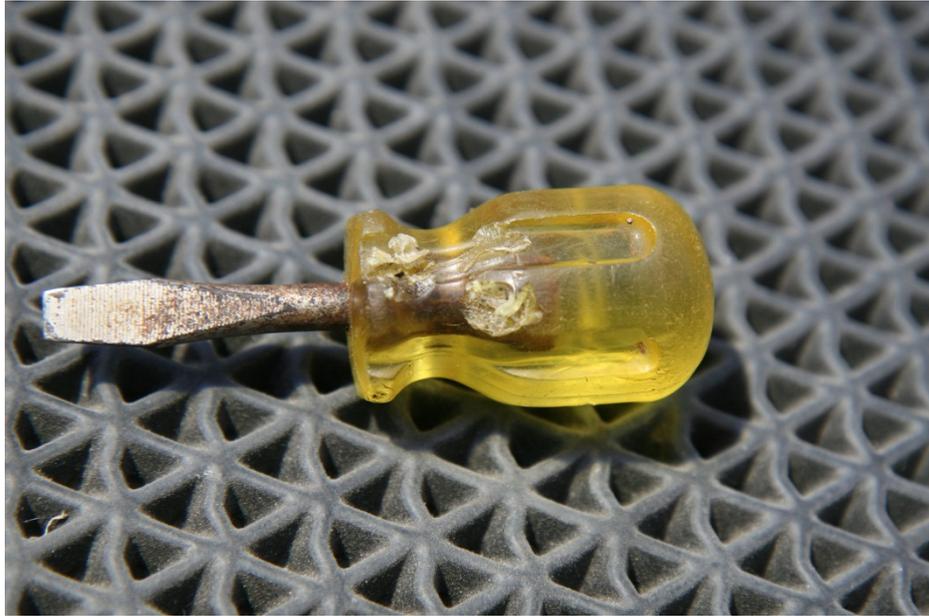
Figure 2: Screwdriver from accident site

- 1.12.5 A “stubby” type screwdriver was located approximately 15 metres from the main impact site and its position aligned with the tail wheel 100 metres away and the tail section in the wreckage. The screwdriver had rust on the blade and on the tang of the blade inside the handle. A number of fresh looking abrasions were apparent on several areas of the handle (see Figure 2).

- 1.12.6 Further on-site investigation determined that the screwdriver had ejected from the aircraft's tail section during the accident sequence. However, the origin of the screwdriver could not be immediately established.

- 1.16.8 The multiple abrasions on the screwdriver handle indicated that the pilot had made a number of attempts to free the control restriction. Various combinations in the positioning of the elevator control quadrant and the screwdriver were then tested. It was found that once the screwdriver had become pinned at the waist of the handle and forced against the narrowest section of the upper rear fuselage aperture, the effects of continued negative G during the exit from the slow roll and the shape of the screwdriver handle may have prevented the screwdriver from becoming dislodged.

- 2.8 The physical condition of the screw driver suggests it was exposed to moisture over some time. It is not inconceivable that the screwdriver had been in the rear of the aircraft for a long period. From the results of the post-accident research, ZK-YTW may have completed many aerobatic flights in New Zealand in the past with the screwdriver remaining out of sight behind the rearmost sub-frame.

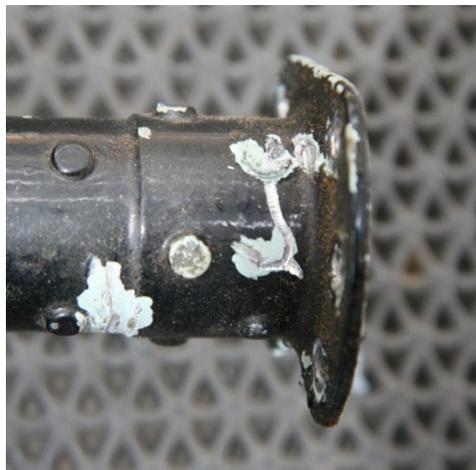
Figure 3: Marks on the left elevator attachment assembly made by the screwdriver.

- 1.12.8 Inspection of the left elevator attachment fitting revealed gouges not consistent with damage caused during the impact. The entire wreckage was removed from the accident site and taken to a secure facility for further examination.

- 1.16.5 The gouges on the elevator attachment flange showed that the screwdriver blade had been resting against it. The screwdriver had then been rotated by the elevator quadrant in response to an elevator up control input. As a consequence, the screwdriver had then jammed the elevator control mechanism in three places:

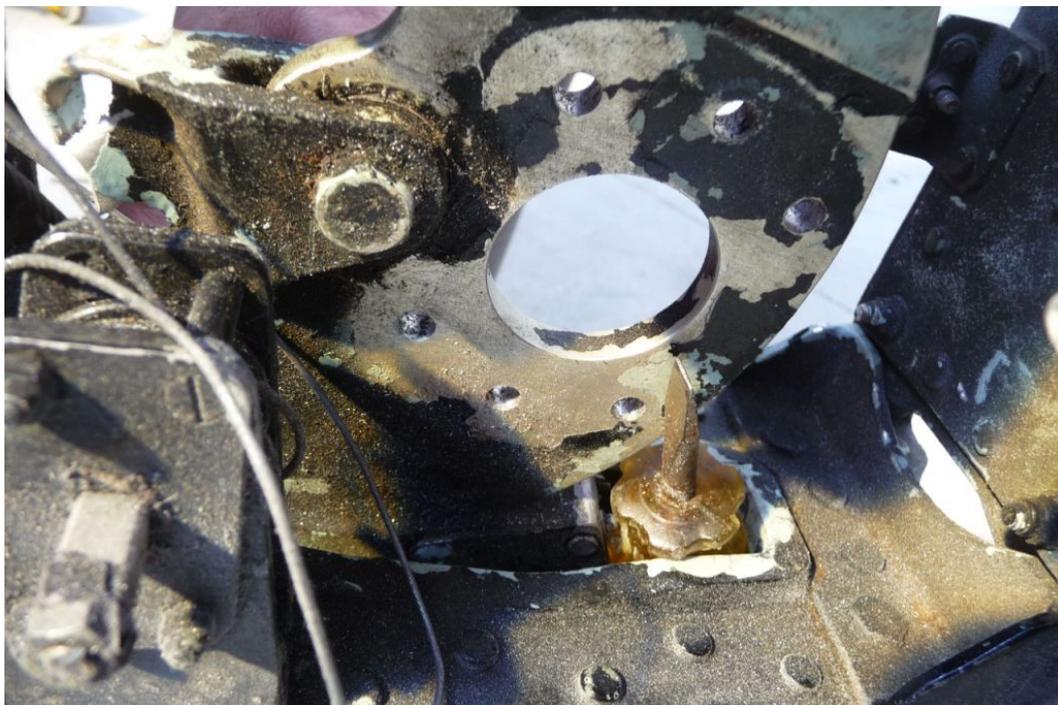
Figure 4: Screw driver pinned in aperture (approximation only)

- 1.16.4 It was determined that the screw driver had entered the tail section via the aperture in the top of the rear fuselage. In order for that to have occurred, the aircraft needed to have been subjected to negative G or inverted flight, coupled with an elevator down input by the pilot.

- the handle had jammed against the rear of the aperture
 - the handle was pinned by the cable end fitting on the other side of the handle; and
 - the screwdriver blade had jammed against the elevator attachment flange (see Figures 4 and 5). Figure 5 is shown with the elevator removed for clarity.

- 2.3 From the tests and research, it is likely that the screwdriver lodged in the elevator control system after an elevator down input was made by the pilot. This would have provided sufficient clearance in the aperture for the screwdriver to pass through.

- 4.1 Immediately after the accident and finding the elevator controls had likely been restricted by FOD, the CAA notified all Yak 52 operators to carry out a thorough inspection for loose articles prior to further flight.
- 4.2 Given the frequency of accidents involving the Yak series aircraft worldwide, the CAA issued an AD in March 2012, mandating the fitment of a barrier into the rear fuselage of all Yak 52 models. The AD also includes the requirement to thoroughly inspect fore and aft of all fuselage frames for the presence of FOD prior to fitment of the barrier.
- 4.3 This report will be made freely available on the CAA website to all interested parties.
