**AIRCRAFT ACCIDENT REPORT  
OCCURRENCE NUMBER 05/3501**

**Eurocopter EC120B**

**ZK-HTF**

**4 November 2005**

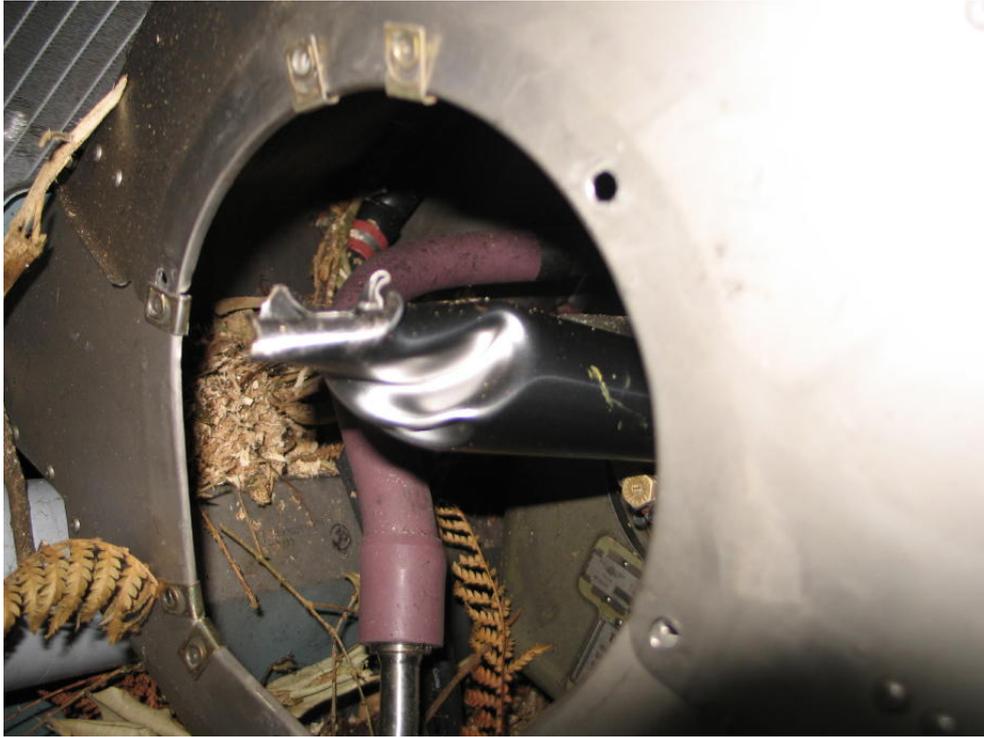
- 1.12.12 The main rotor head became anchored in the fork of a large tree and the fuselage was suspended from this point. The engine continued to run and, in attempting to drive the main rotor, fractured the engine to gearbox driveshaft in torsion. See Figure 3.

Figure 3  
Torsional twisting of drive shaft.

- 2.19 The engine was producing power at impact as evidenced by the twist of the driveshaft. The engine examination revealed no similarities with previous known engine failures in this type of helicopter.
- 2.20 The VEMD did not record any engine limitations being exceeded during the accident flight, and the mobile phone video footage confirmed normal engine operating performance during departure.
- 2.21 Realisation that the helicopter was missing was significantly delayed because the SARTIME had been nominated for completion of the flight at Queenstown and the pilot had not activated the flight plan.
- 2.22 The pilot had limited first-hand experience in extended cross country flight and weather decision-making, having flown with instructors or safety pilots on most such flights since obtaining his PPL(H).

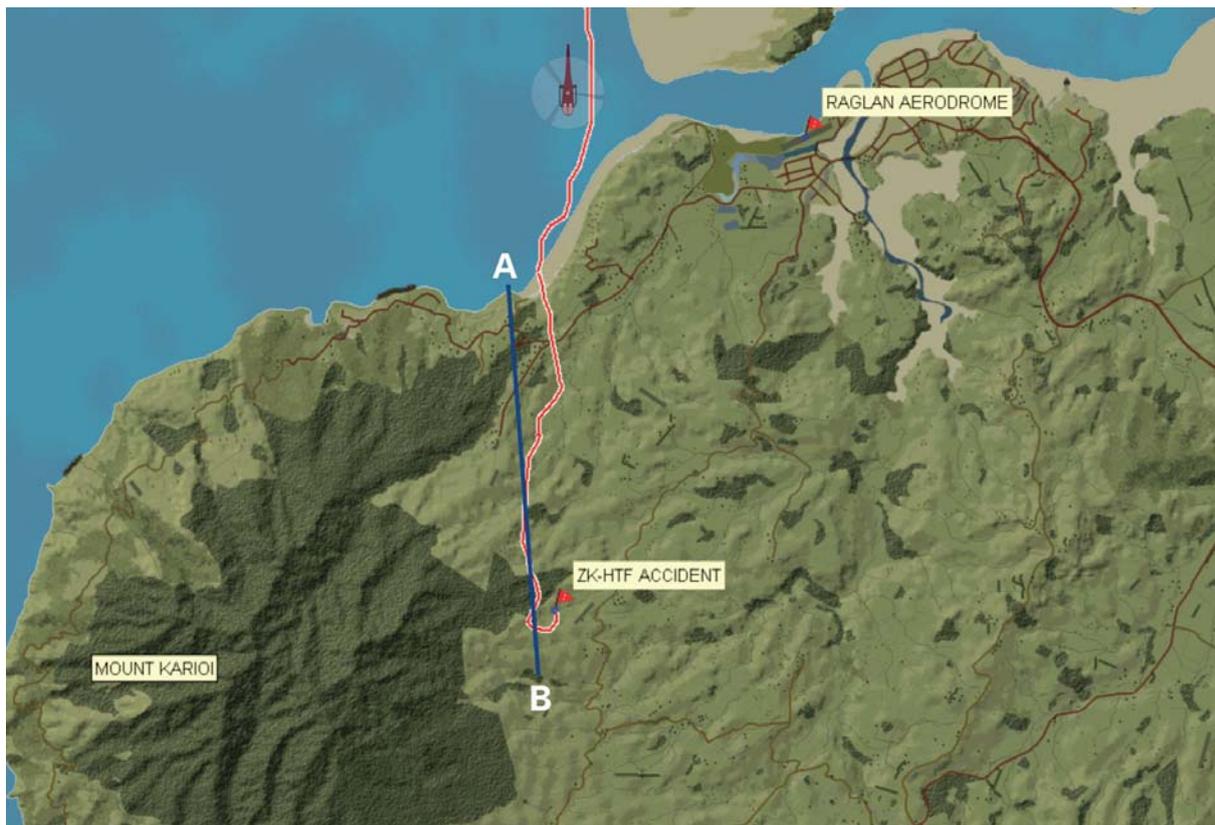
Figure 4

- 2.9 The pilot probably did not appreciate the significance of the forecast deteriorating weather.
- 2.10 The pilot appears not to have considered better weather options in the central and eastern areas of the North Island, but may have decided on the route before checking the weather because the pilot had flown the route previously.
- 2.11 Radar plots show the helicopter passed 1.5 nm seaward of Raglan Aerodrome and continued on a direct route to Wanganui Aerodrome. In doing so the helicopter was flying towards high ground of approx 900 ft, rather than following the coastline around Mount Karioi. See Figure 4.

Representation of the Helicopters flight path.

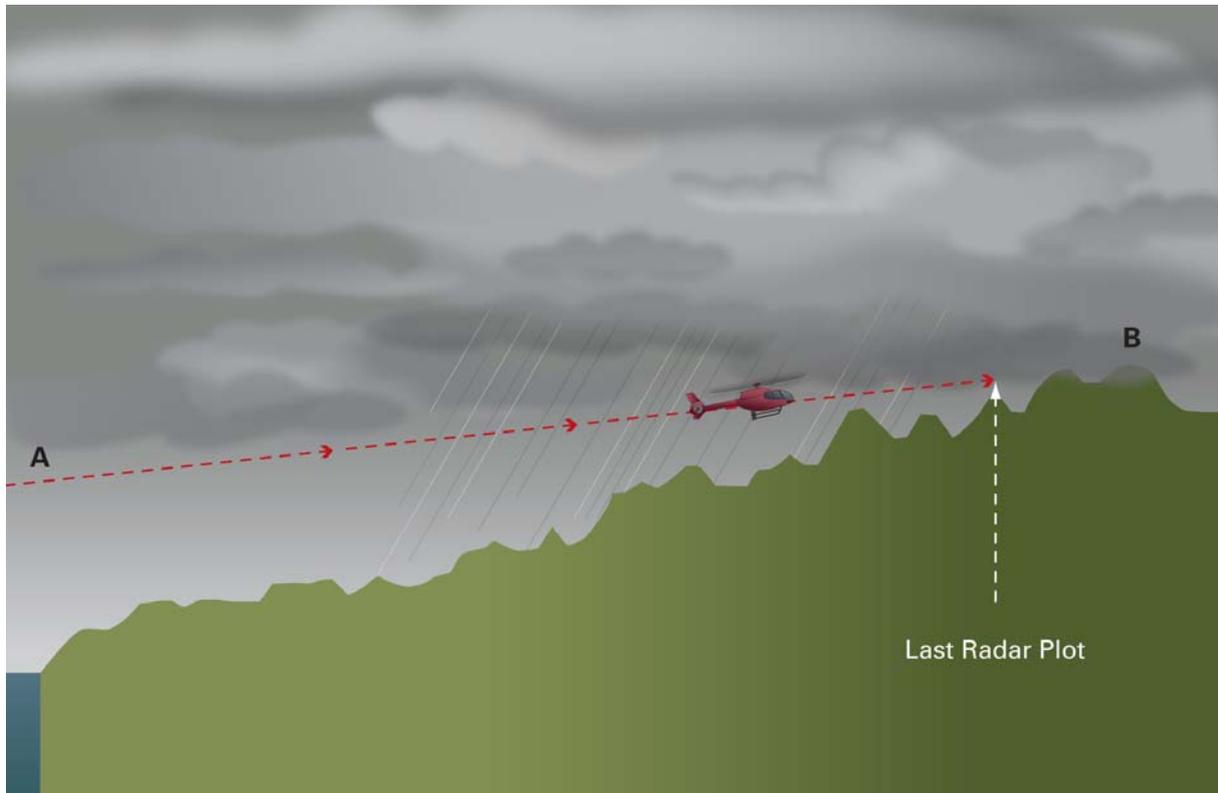
Figure 5

- 2.14 Witness statements suggest the helicopter encountered weather conditions of increasing wind strength, low cloud and drizzle at this stage.
- 2.15 The combination of rising terrain, weather conditions, and helicopter ground speed would have limited the pilot's ability to manoeuvre in the clear air available to maintain VFR flight. Light precipitation on the windscreen of the helicopter would have further reduced the pilot's forward visibility. See Figure 5.

Cross section representation of the helicopter's flight path.
