2025-00556

Dingle Burn, 29 March 2025.

Loss of control during low level turn.

Investigation Final Report

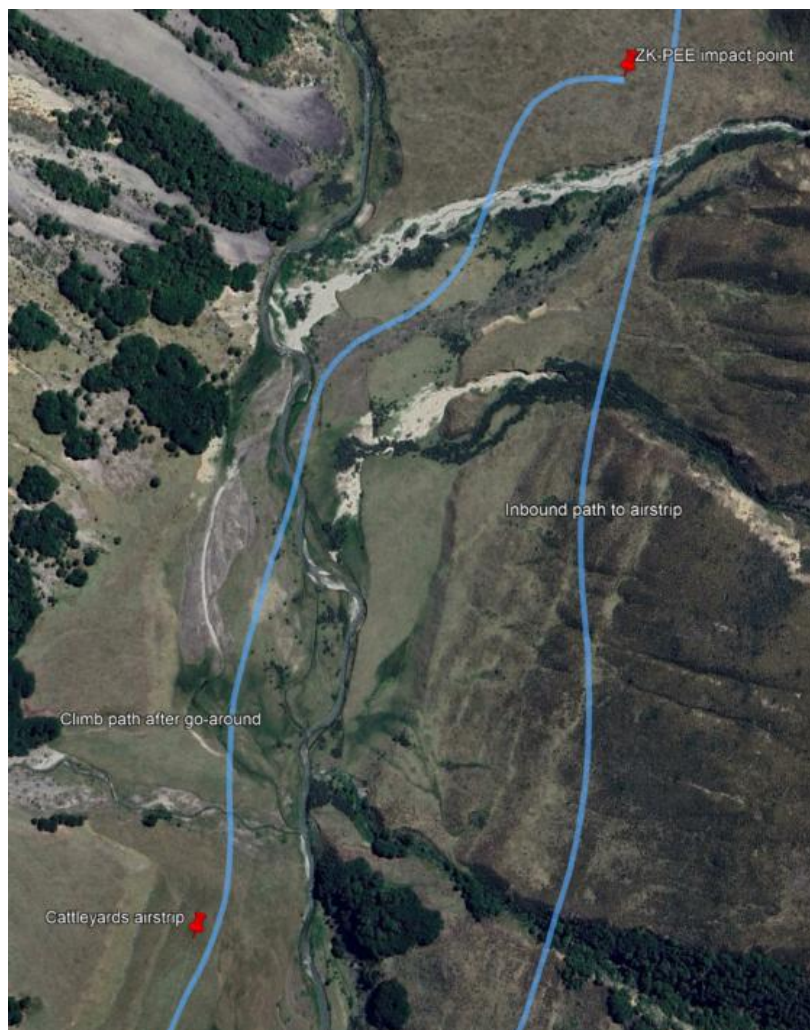
Above is a Google Earth image showing the airstrip and impact point in the Dingle Burn valley. True north is at the top of the image with the aircraft's track overlaid. The track line on the right is the inbound path of the aircraft from north to south (top to bottom).

56. After the pilot commenced the go-around¹⁹, the aircraft climbed at an average rate of climb of 306 fpm²⁰ as it largely tracked the extended centreline of the airstrip for 1.0 km on a north-easterly heading. A witness at the airstrip stated the aircraft 'was climbing well in a gentle right hand turn'.
57. At this distance the aircraft's ground speed reached a maximum of 62 kts when the pilot commenced a brief right turn followed by a left turn to take up his original post go-around path. The aircraft was now closer to the eastern or true left side of the valley and headed for the gravel fan.

58. Fifty-one seconds after the go-around and now over the gravel fan, the pilot commenced another right turn through approximately 70° at an angle of bank of approximately 35° . Half way through this turn the aircrafts groundspeed decayed to 51 kts while it was approximately 69 ft above the ground. One second later the aircraft reached its maximum height since the go-around of approximately 78 ft above the ground but the ground speed had reduced to 45 kts.

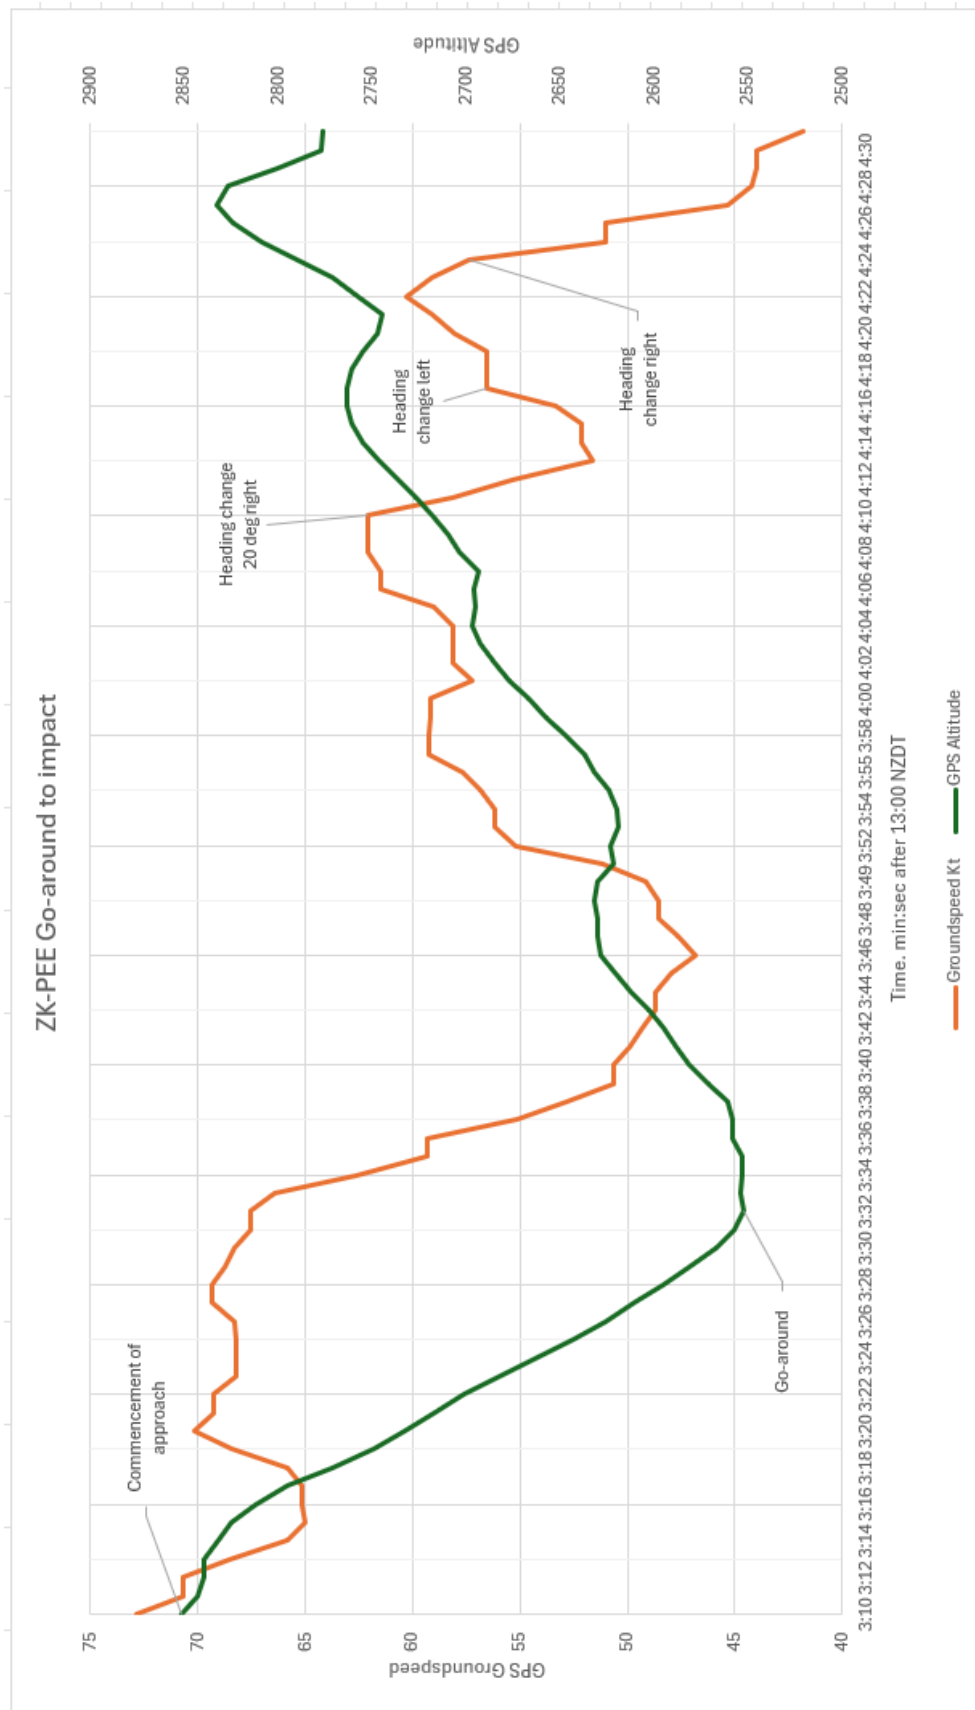
59. Adjusting the wings level, zero flap (idle thrust) stall speed²¹ for a 35° angle of bank, the aircrafts estimated AUW²² and the previously mentioned vortex generators derives a new stall speed of approximately 41 kts.

60. Approximately half way through the right turn, the aircraft has stalled aerodynamically and departed from controlled flight.
61. Five seconds after reaching its maximum height and one minute after the start of the go-around the aircraft impacted the gravel fan with an average rate of descent of 936 fpm and a groundspeed of 41 kts.

Graph of GPS altitude and groundspeed against time starting at 13:00 NZDT sourced from the pilots iPad.

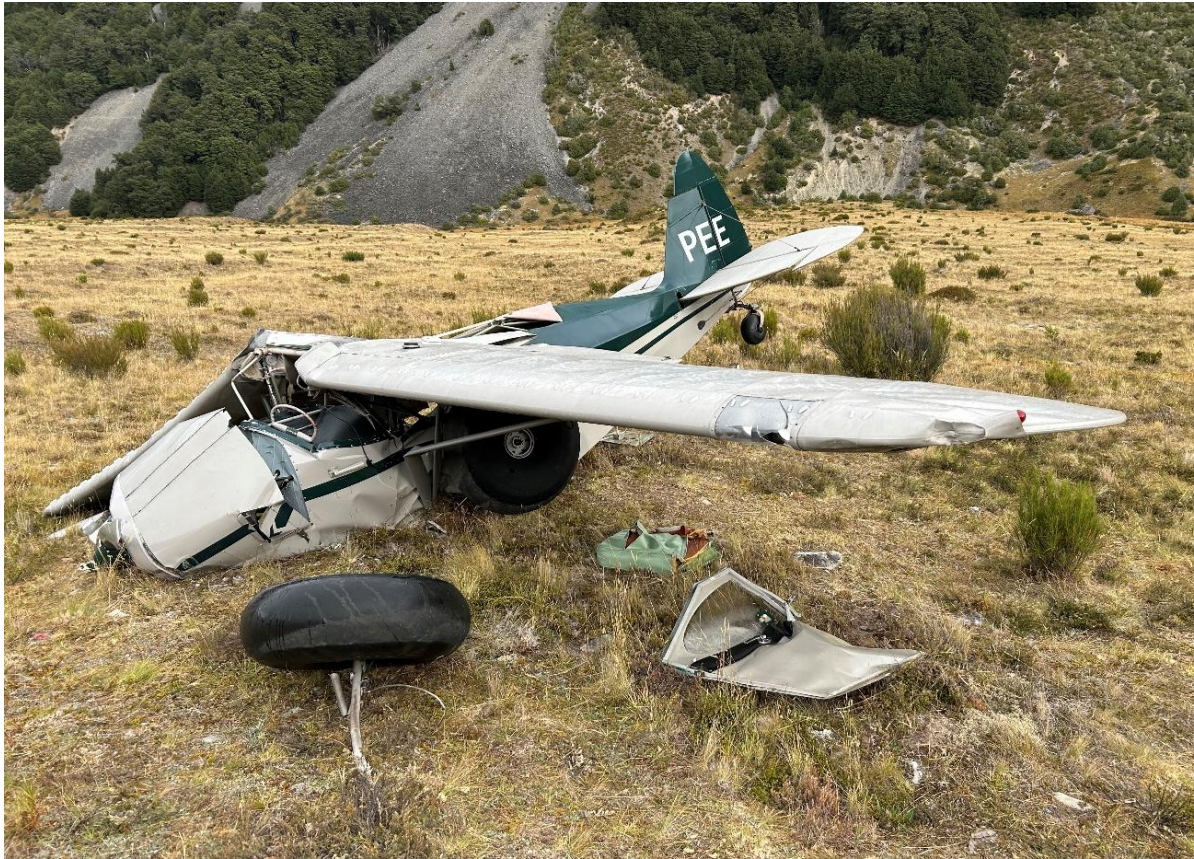
40. The aircraft struck a mildly sloping gravel fan on the true left (east) side of the Dingle Burn valley 1.2km north-east of the airstrip at an elevation of 2755 ft amsl. At the initial impact the aircraft was on an easterly heading in an approximately 45° nose down and slight right wing low attitude. There was no wreckage trail and the entire structure of the aircraft could be accounted for at the accident site. The only separated component was the RH wheel and tyre assembly.
41. The nature of the damage to both wings and their position relative to the fuselage indicated the aircraft had not entered a spin. The damage was consistent with the aircraft impacting the ground with a low forward speed but a high rate of descent. The cockpit and cabin structure

was significantly compressed in length and height and the disruption to its structural elements initially hindered paramedics access to the pilot and passenger.

Piper PA-20-135 Pacer, ZK-PEE. S/n 20-962, Dingle Burn valley. The left hand rear cabin door, part of a seat base and a shoulder harness were removed from the aircraft by first responders to aid their access and placed in the locations as seen above. The RH main wheel is in its final resting place and position as found by the people who walked from the airstrip. (CAA photo)

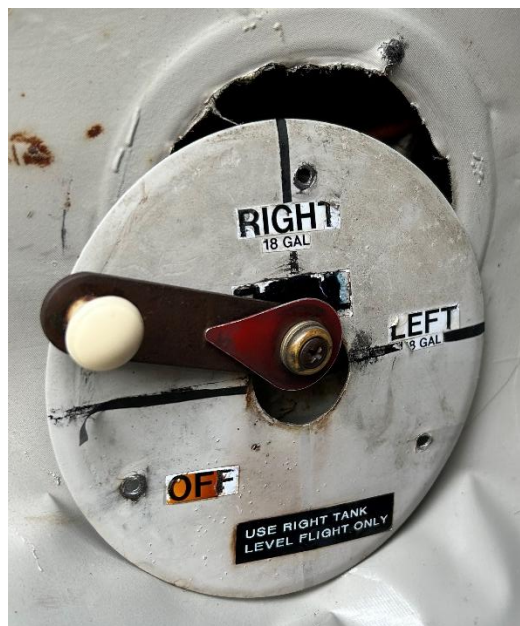
ZK-PEE Fuel tank selector control. (CAA photo)

49. At the accident site, both the ignition switch and fuel tank selector were found in their respective OFF¹⁶ positions.
50. The six Fly In attendees and one FENZ volunteer who were at the accident site and who provided written statements to the Police did not state they turned the fuel and/or ignition off when they reached the aircraft. When these same people were later reinterviewed by the CAA investigator, five said they had not moved any of these controls but one said he 'may have instinctively but could not recall'.

54. Therefore, it is likely that impact forces acting upon the limbs of the pilot or passenger moved the ignition to OFF during the initial impact/rebound and the pilot intentionally moved the fuel tank selector to OFF after the aircraft came to rest.

The fuel tank selector is located on the lower left portion of the cockpit sidewall, adjacent to where the pilots lower left leg would have been. Impact forces have dislodged the cover panel, rotating it approximately 20° anticlockwise. The selector handle is in the OFF position.

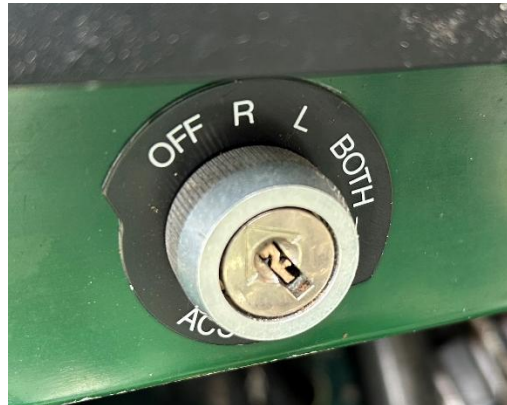
ZK-PEE Ignition switch. (CAA photo)

51. It is possible that despite his injuries the pilot may have carried out these two discrete actions himself which would be consistent with how pilots are trained to respond to such emergencies. However, the ignition key was found broken off¹⁷ from the ignition switch which retained the broken remains of the key in the switch barrel and the other half was found on

the cockpit floor. It is unlikely the pilot would have been able to turn the ignition off with the broken key.

52. It cannot be ruled out that movement of the pilot or passenger's limbs due to impact forces moved the ignition switch to the off position while simultaneously breaking it. However, due to the location of the fuel tank selector in the cockpit and its plane of rotation, it is unlikely it was moved in this way.

The switch is in the OFF position. The key has broken at impact and the remains of it can be seen in the key barrel.

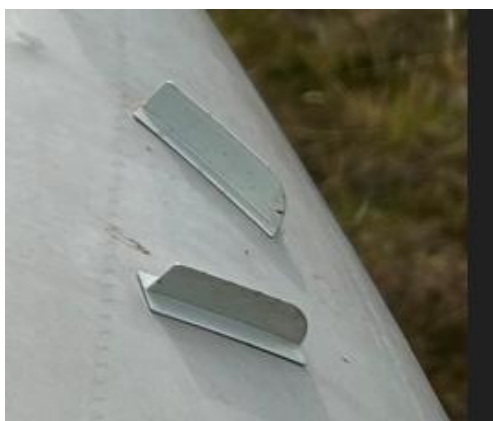
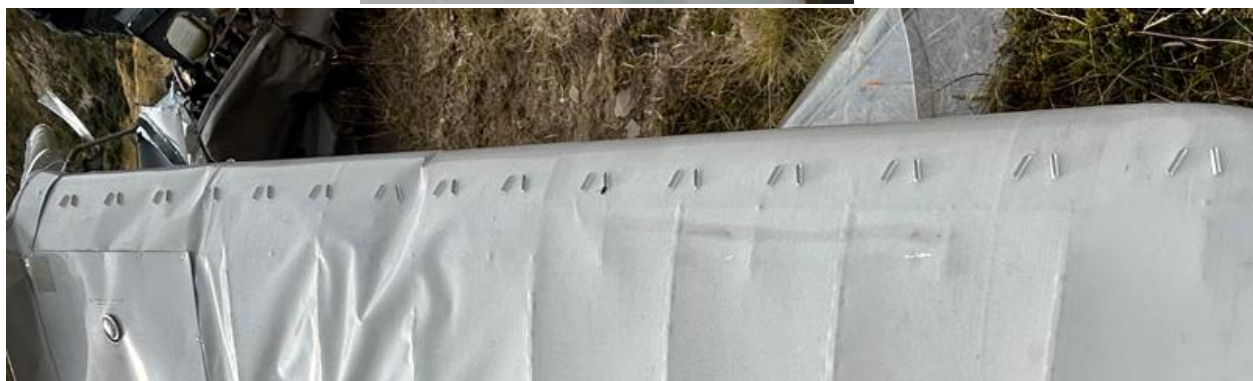
32. Under another STC, the top surfaces of the aircraft's wings were fitted with vortex generators¹⁰ enabling an approximately 4kt to 5kt reduction in the aircrafts stall speed.

Vortex generators on the top surface of ZK-PEEs right wing. These ‘fins’ are approximately 3.8 cm long and 1.3 cm high. They are attached in pairs on the top surface of both wings. Their purpose is to keep the air flowing across the top of the wing attached to the surface at high angles of attack where ordinarily the airflow would become detached resulting in a loss of lift. However, there is still an angle of attack limit at which the vortex generators will cease to function. (CAA photo)

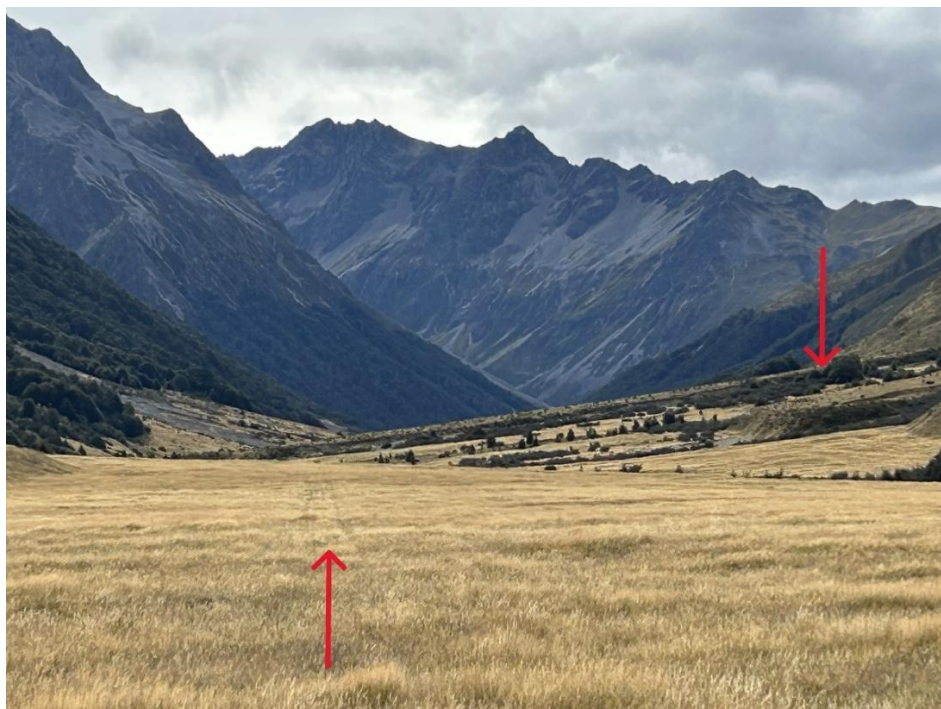
Above, the Dingleburn valley looking along the Cattleyards airstrip in the foreground. The lower left arrow indicates the landing direction (up-slope) with aircraft wheel tracks still visible. The upper right arrow indicates the location of the accident site, 1.2km away on a gravel fan. Note the gravel fan also rises steadily from the valley floor. (CAA photo)
