**AIRCRAFT ACCIDENT REPORT**  
**CAA OCCURRENCE NUMBER 09/919**  
**SKY ARROW 450T**  
**ZK-SKA**  
**LOSS OF PITCH CONTROL**  
**NEAR INANGAHUA JUNCTION**  
**15 MARCH 2009**

## AIRCRAFT ACCIDENT REPORT

### CAA OCCURRENCE No. 09/919

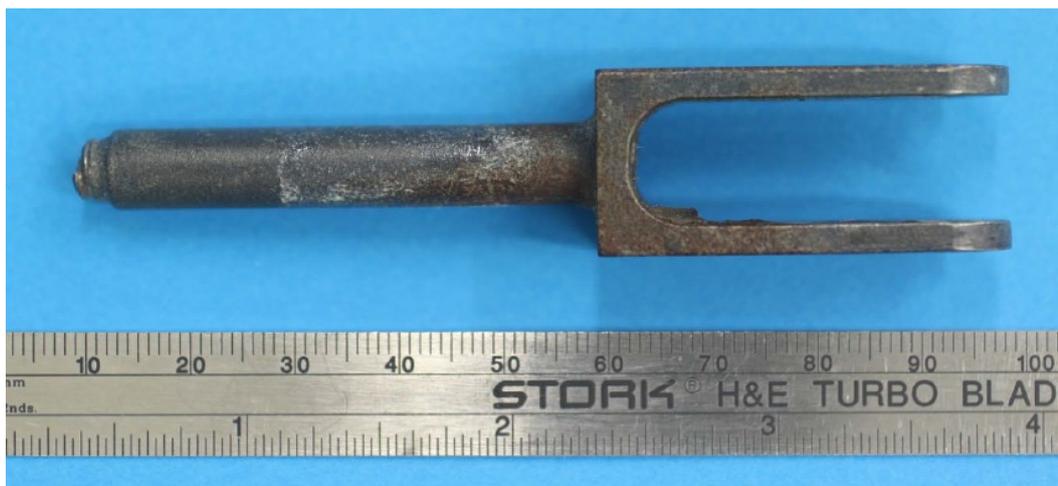
**Figure 2: Failed upper end fitting**

- 2.8 The fatigue fracture of the elevator control rod end fitting would not have been detected by a visual inspection, either during the aircraft's annual inspection on 8 March 2009 or the pilot's preflight on the day of the accident.

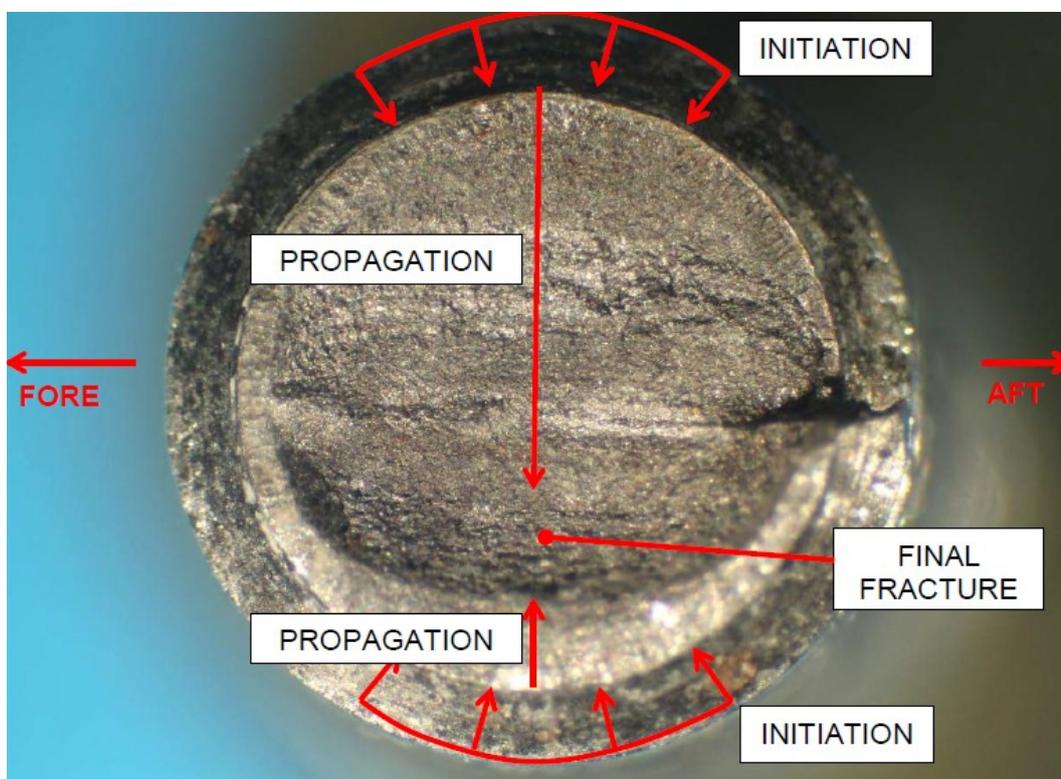
**Figure 3: Upper end fitting fatigue failure**

1.16.6 The investigation also found that the carbon steel used for the failed top and bottom fittings was of a different hardness, which may have indicated that the top fitting had been replaced at some stage.

- 2.9 A detailed examination of the elevator and attachments could not determine what had initiated the various cyclic loadings which caused the fatigue failure of both top and bottom elevator control arm fittings.

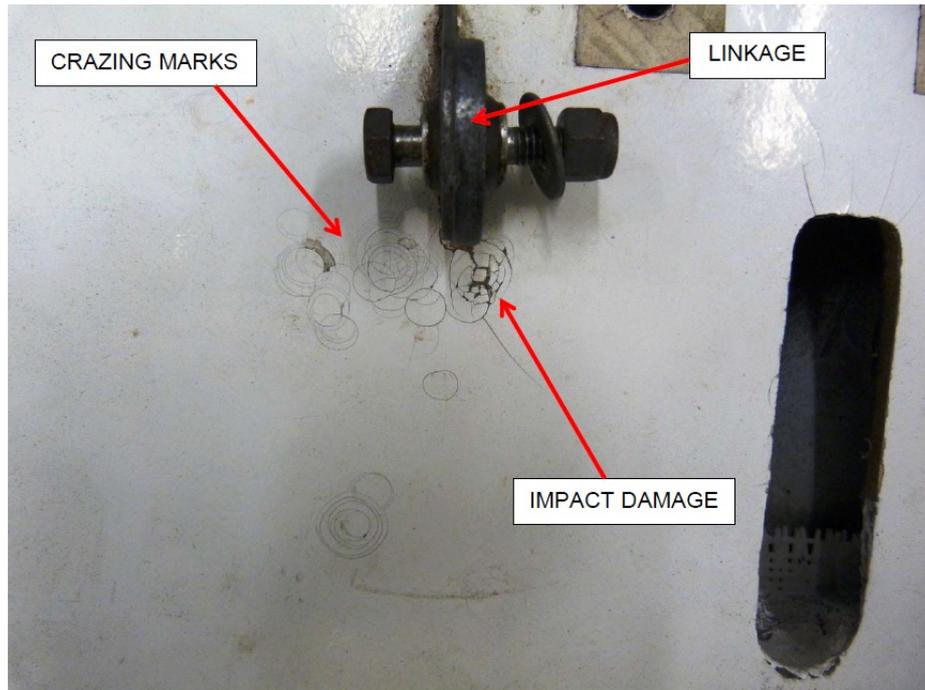
**Figure 4: Damage to elevator lower surface**

- 1.16.4 There were indications on the elevator lower surface adjacent to the end fitting attachment point where the broken end fitting had left impressions on the gel coat. Refer Figure 4.

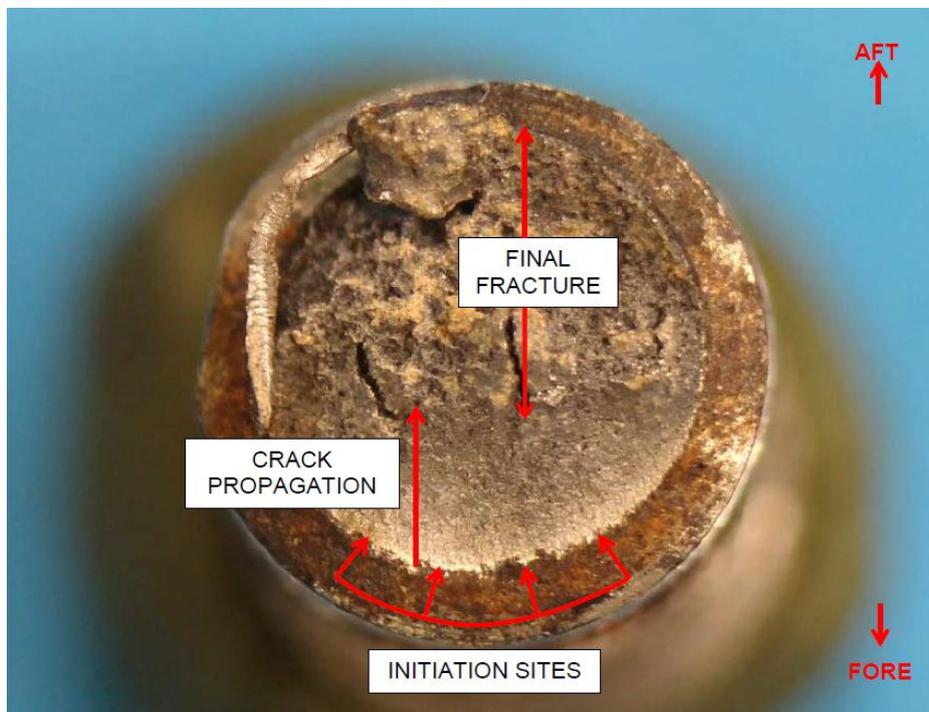
**Figure 5: Lower end fitting fatigue failure**

1.16.5 The metallurgical examination also showed that the bottom fitting on the elevator control arm was also subject to a partial fatigue failure with the crack propagating from the threaded section again. It was determined that the final failure of this component was a result of the accident impact. The fatigue cyclic failure mode was in a fore/aft direction. Refer figure 5.

- 4.1 The CAA Manager Fixed Wing, Recreational and Adventure Aviation Unit organised an inspection of the two other Sky Arrow aircraft on the New Zealand register as soon as the cause of this accident was found. This involved non destructive testing of the elevator control components which had failed on ZK-SKA. No fatigue cracks were found in these aircraft.
- 4.2 The CAA Manager Fixed Wing, Recreational and Adventure Aviation Unit endeavoured to contact the Italian manufacturer regarding the specifications of the
