Departure from controlled flight

ZK-GXG, Schempp-Hirth Discus-2C Glider

21 November 2017

CAA Final Report 17/7309

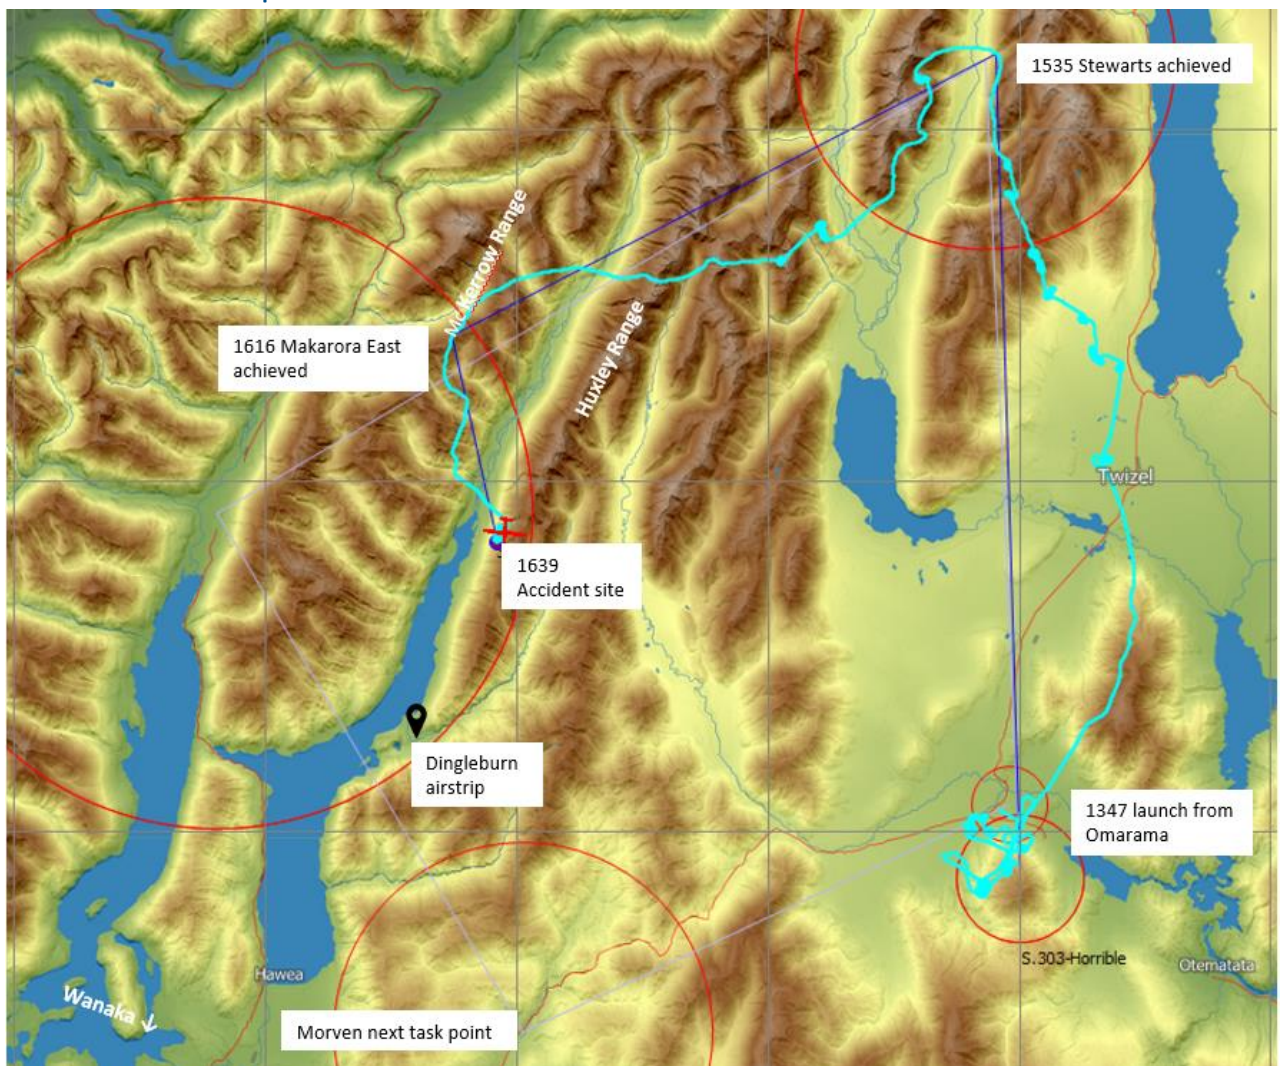
Figure 2: Map of flight path. (Source: Pilot's Oudie GPS)

Following what appears to be an uneventful flight, ZK-GXG achieved the Makarora East point and soared towards the Huxley Range and the next task point, Morven (refer to Figures 1 and 2).

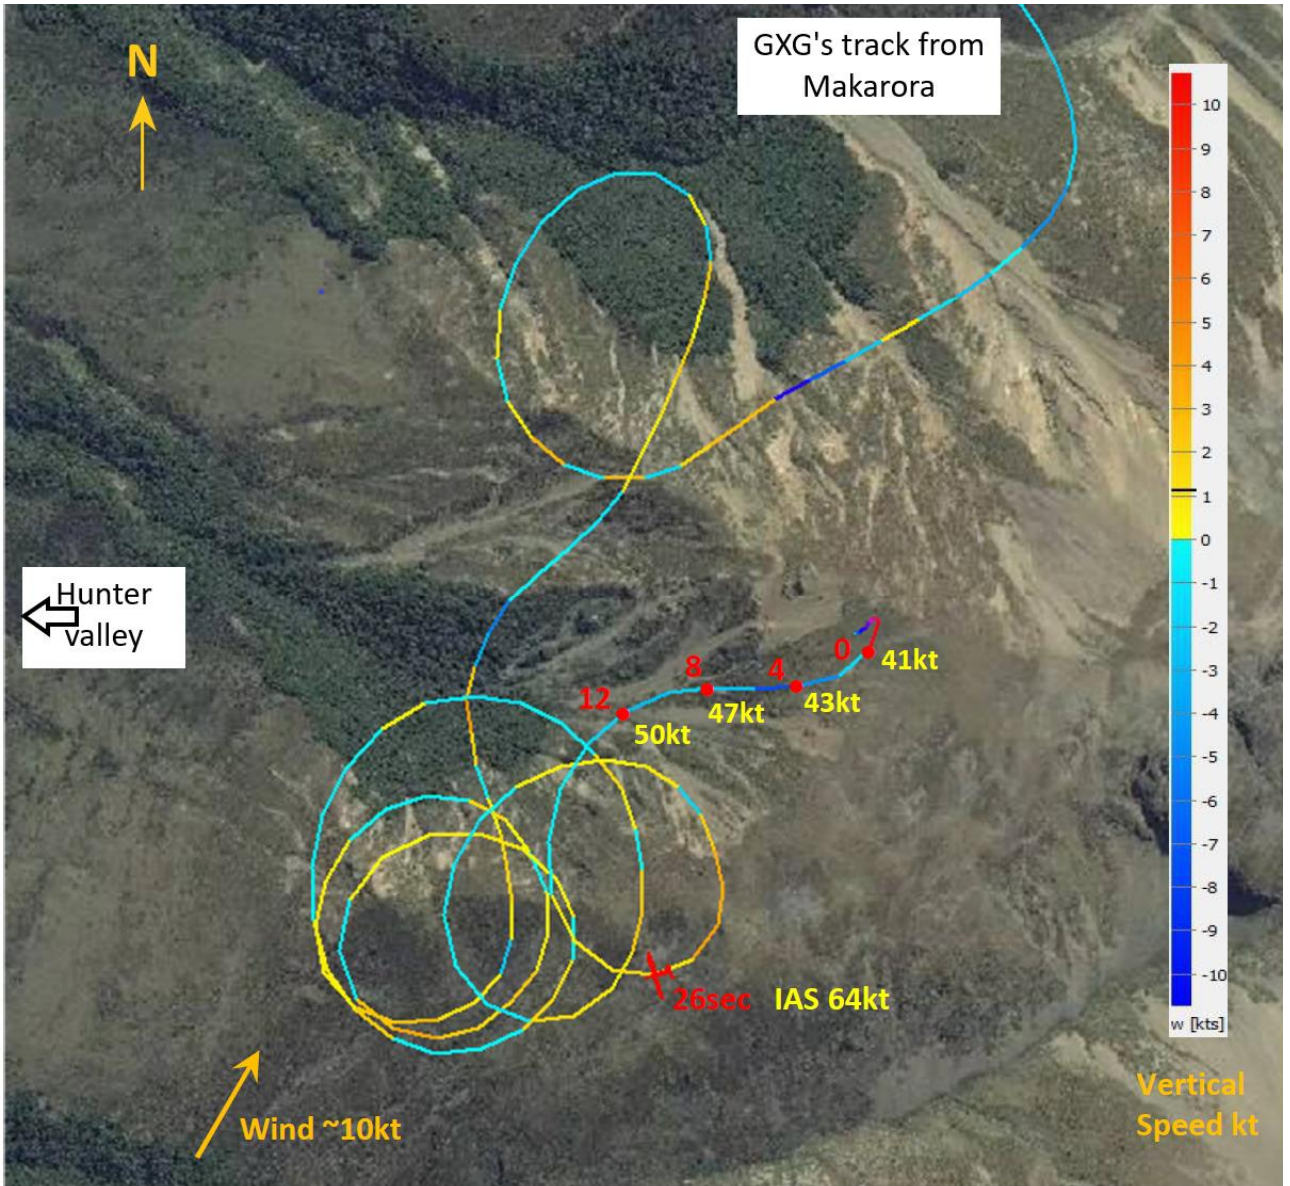
Figure 3: ZK-GXG's track below the Hunter Ridge showing spot speeds up to 26 seconds before the stall. Refer also to Figure 4. (Source: ZK-GXG LX9000)

Near the accident location, six right turns were completed close to the Hunter Ridge at between 300 to 1200 ft agl at an average IAS of 54 kt. After rolling out of the last right-hand turn, the glider progressively slowed as a left turn was initiated at around 4500 ft. The IAS reduced to 41 kt followed by a 30° bank left turn away from the ridge at 100 ft agl (refer to Figures 3 and 4). The glider descended rapidly, and the left wing impacted the terrain, followed shortly by the fuselage and right wing. After the initial impact, the glider slid forward on a westerly heading then rotated

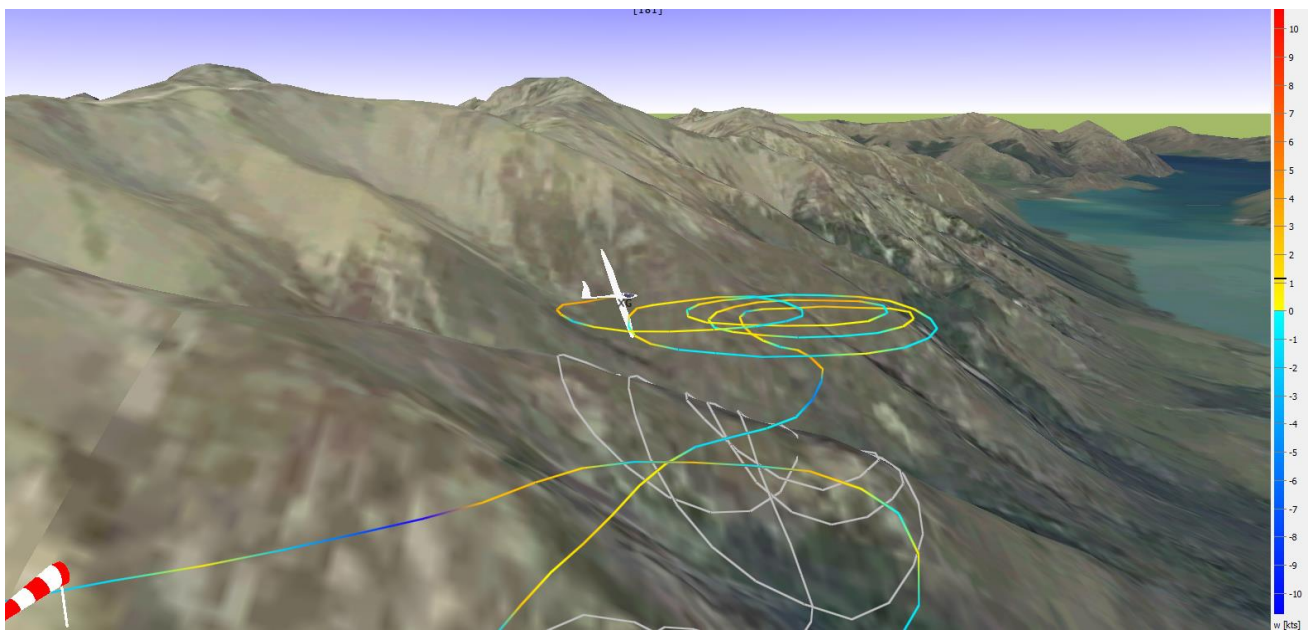
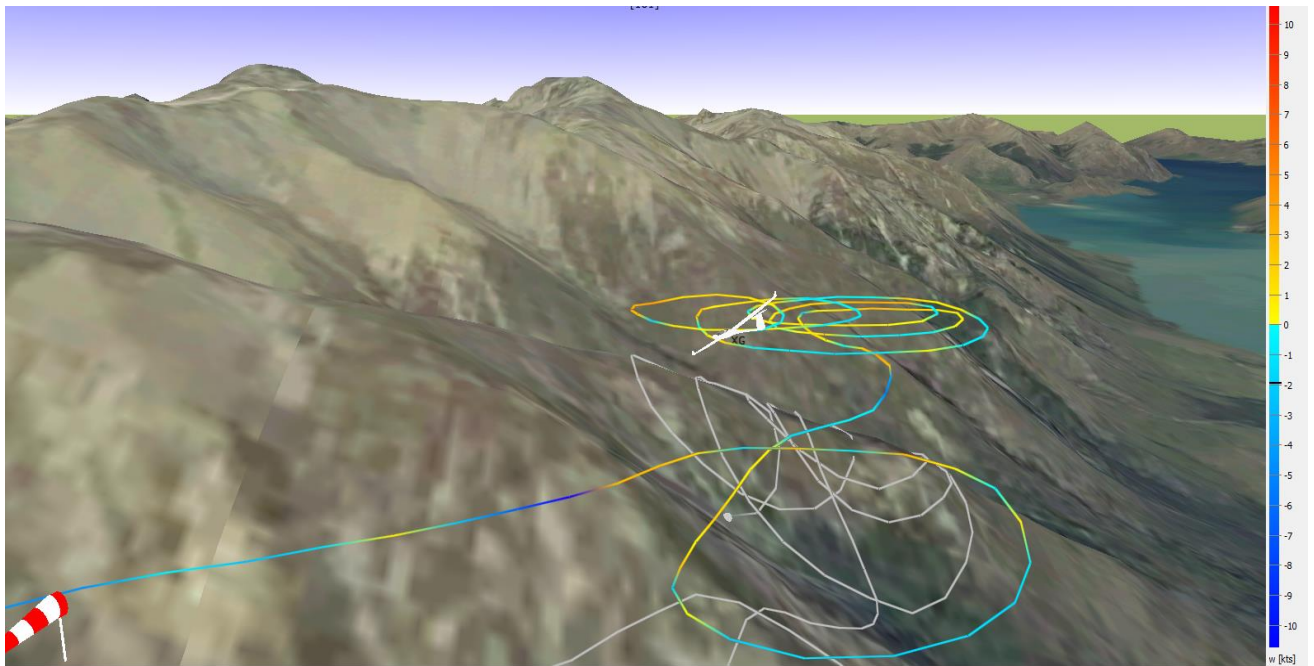
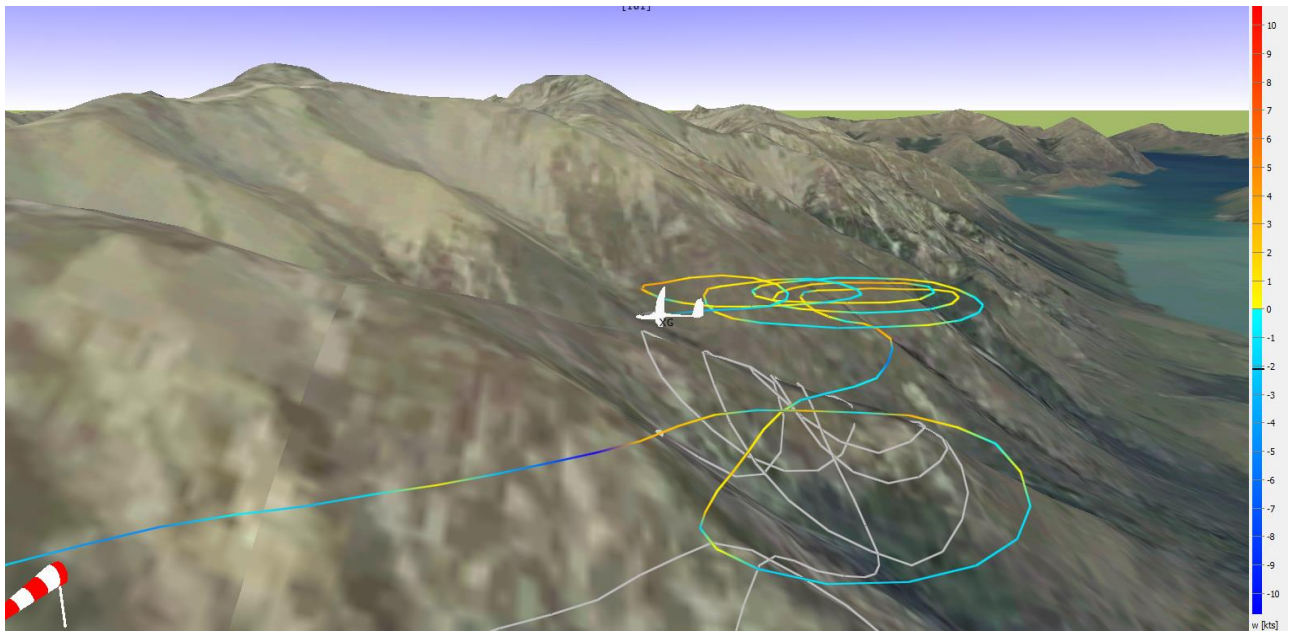
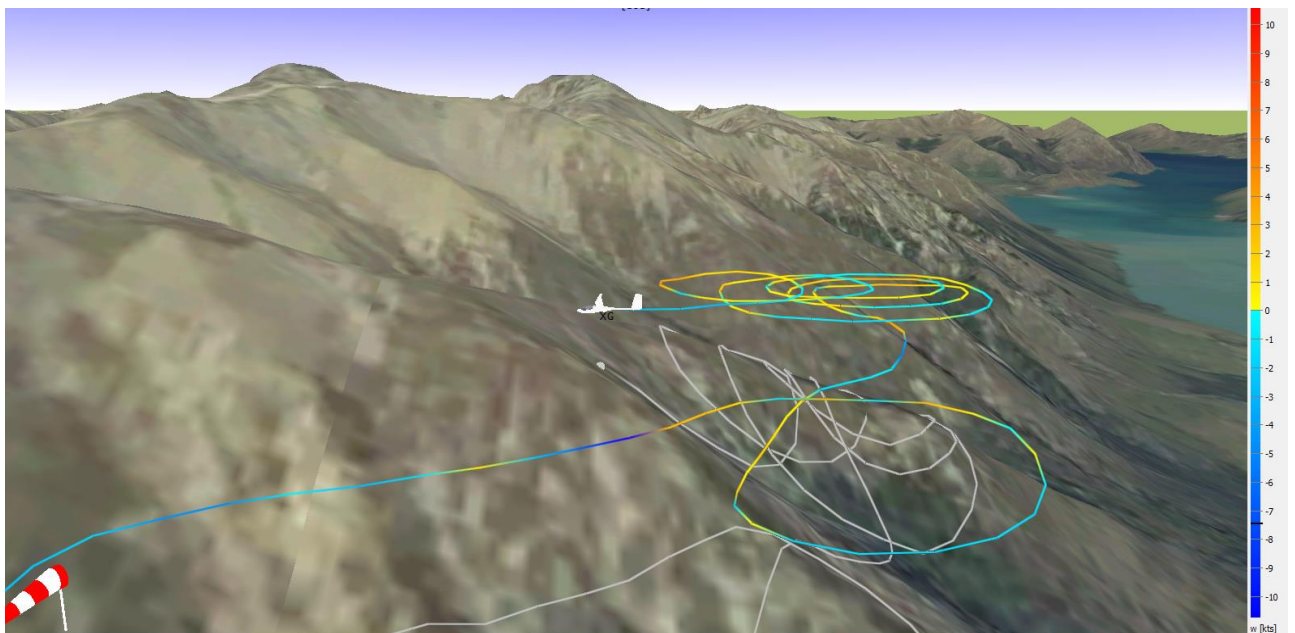
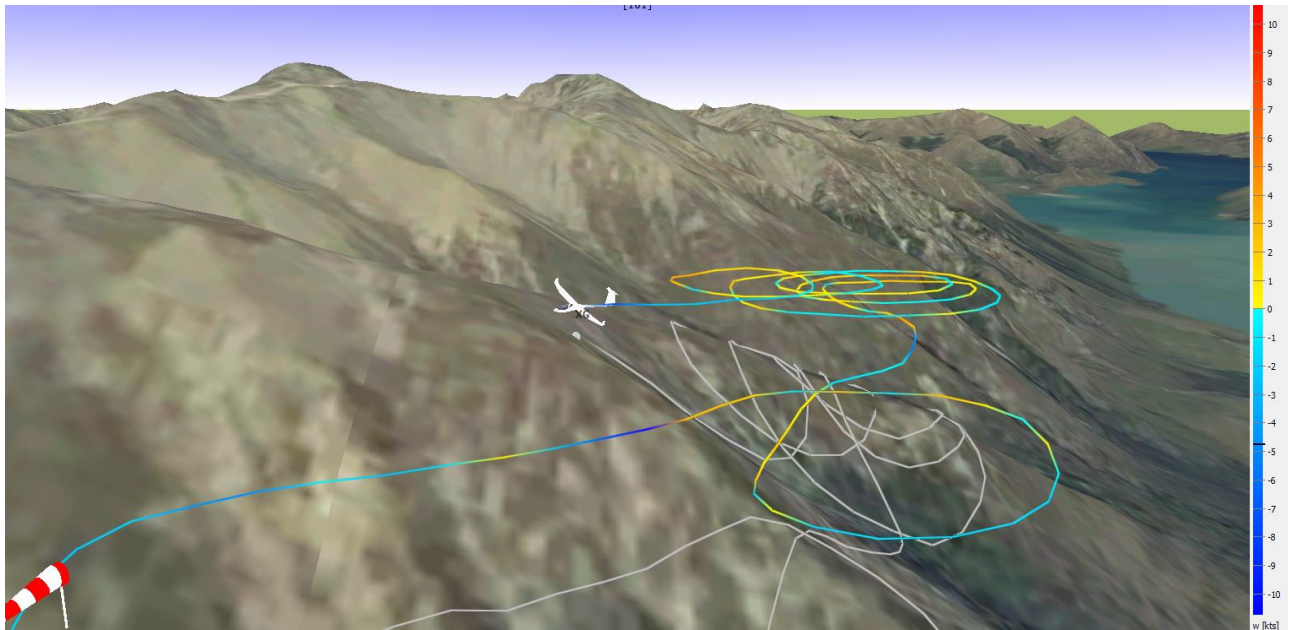
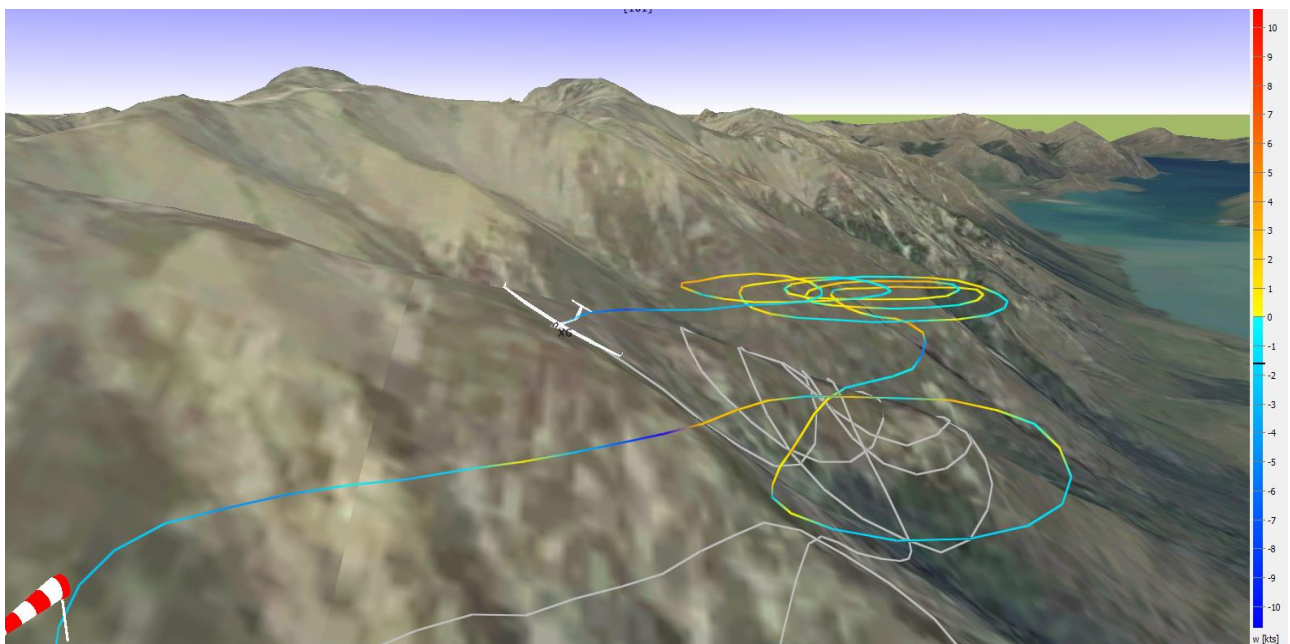
On the following page(s), Figure 4 shows a series of See You™ screenshots of the last 26 seconds of ZK-GXG's flight before the aerodynamic stall.

Figure 4: Series of See You™ screenshots of the last 26 seconds of ZK-GXG's flight (Source: GNZ from ZK-GXG LX9000)

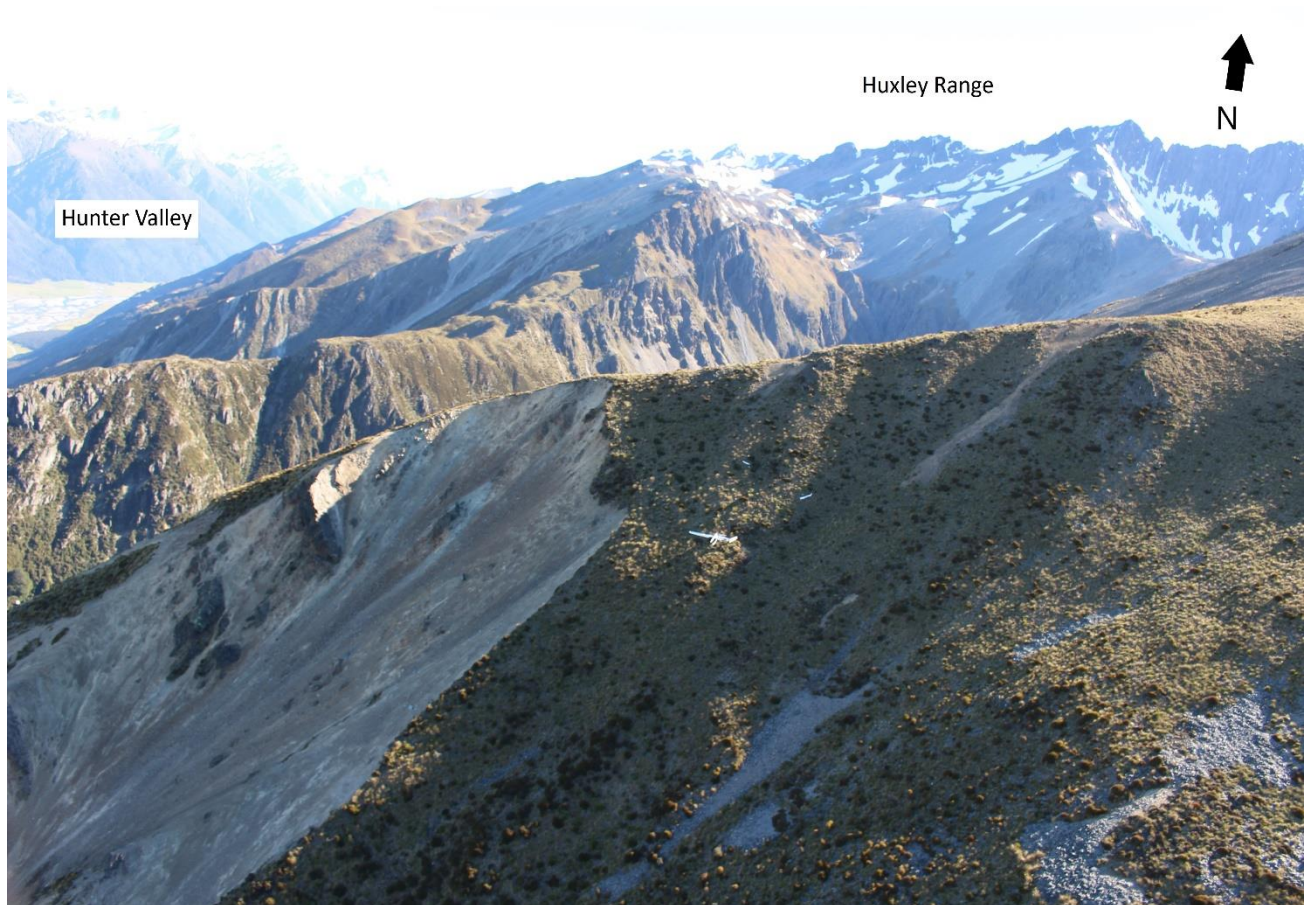
Figure: 5. ZK-GXG below a spur on the Hunter Ridge. Main fuselage is facing south.
(Source: CAA field investigation 0810 23/11/17 NZDT)

left to slide down the slope and come to rest approximately 25 metres from the initial impact point (refer to Figures 5 and 6).

The wreckage signatures and the track data indicated that the glider's critical angle of attack¹³ was exceeded, with a loss of lift, typical of an aerodynamic stall. There was insufficient height above terrain for the pilot to recover control.

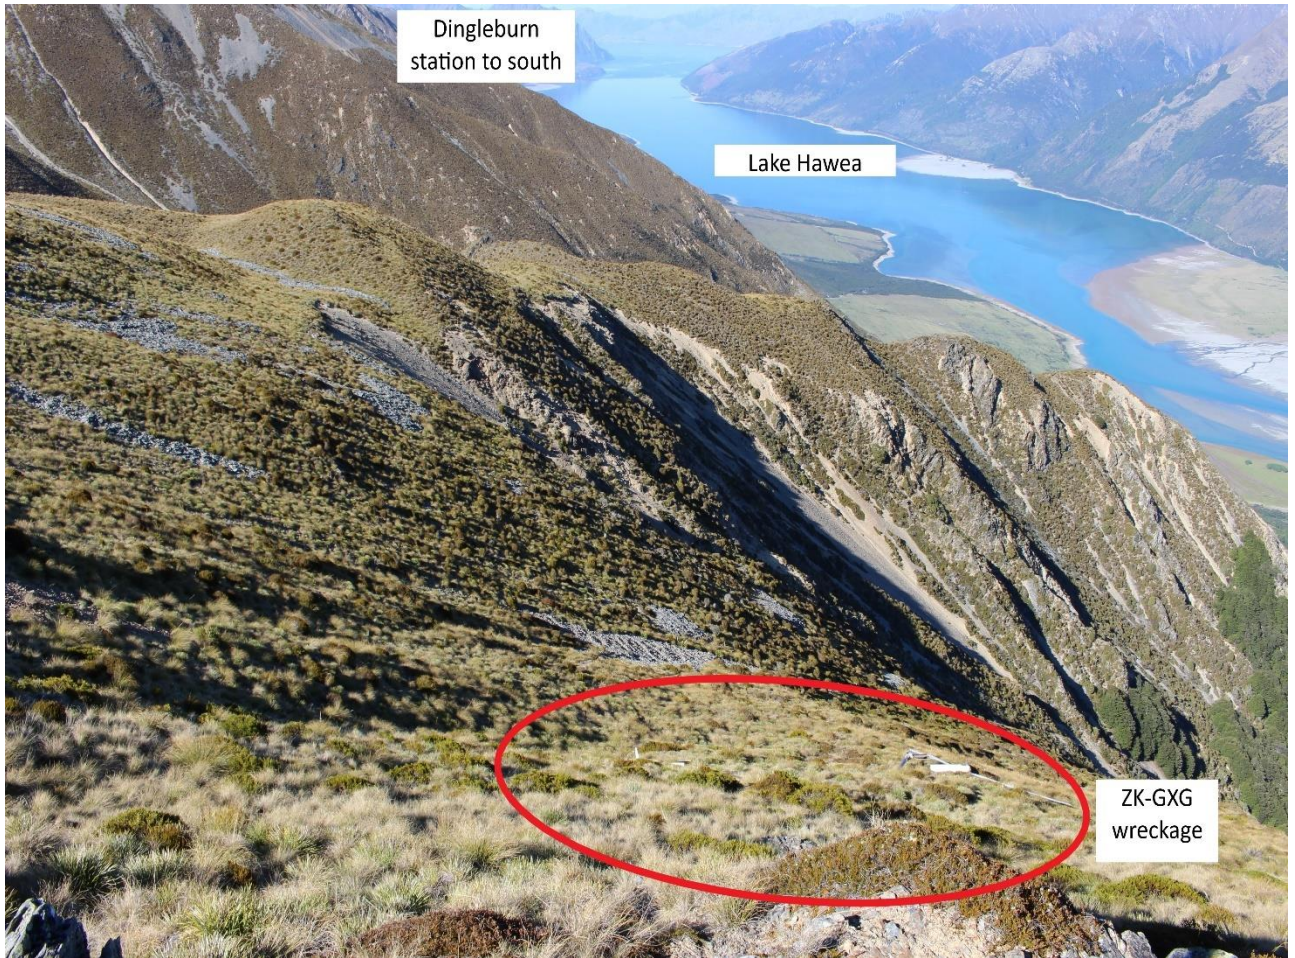
Figure 6: ZK-GXG on a 30° slope facing south. The Hunter River valley is to the right and Dingleburn Station airstrip is further south. (Source: CAA field investigation 0839 23/11/17 NZDT)
